No. 96 (April 2007) **Double Hull Oil Tankers -** Guidelines for Surveys, Assessment and Repair of Hull Structures

DOUBLE HULL OIL TANKERS

Guidelines for Surveys, Assessment and Repair of Hull Structures

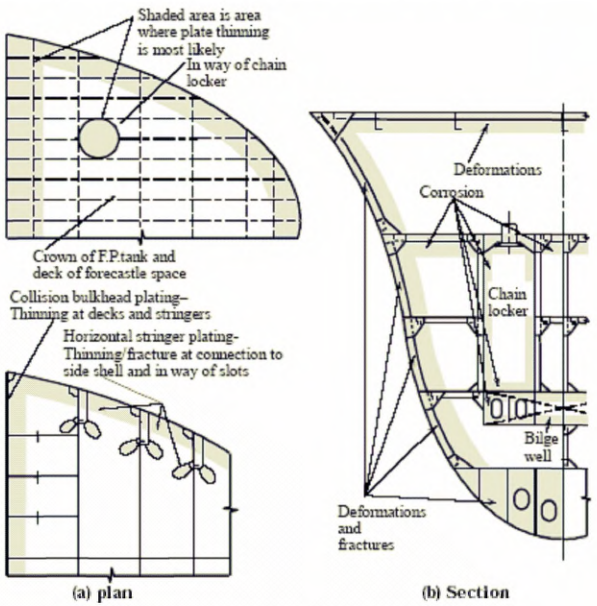
Fig 1 Fore end structure - Potential problem areas

2.3.2 Fractures are often found in transition region and reference should be made to examples provided in the other Groups.

2.3.3 Fractures that extend through the thickness of the plating or through the boundary welds may be observed during pressure testing of tanks.
