No. 96 (April 2007) **Double Hull Oil Tankers -** Guidelines for Surveys, Assessment and Repair of Hull Structures

DOUBLE HULL OIL TANKERS

Guidelines for Surveys, Assessment and Repair of Hull Structures

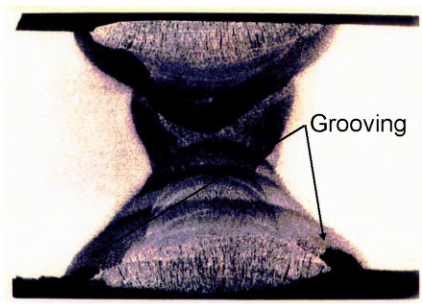
Photograph 2
Section of the grooving shown in Photograph 1

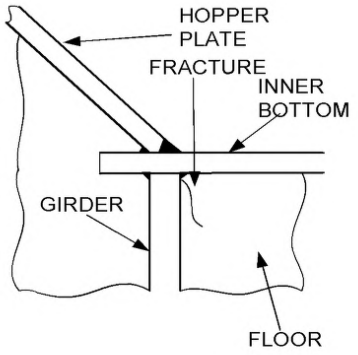
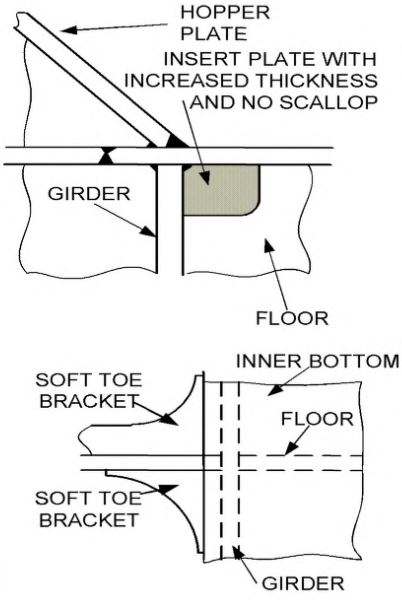
OIL Tankers	Guidelines for Surveys, Assessment and Repair of Hull Structure	
Group 1	Cargo area	Example No.
	Hopper and double bottom ballast tank	3
Detail of damage	Fracture at connection of bilge hopper plate and inner bottom

Factors which may have caused damage	**Notes on repairs**
1. Stress concentration at the knuckle.	See Sketch.

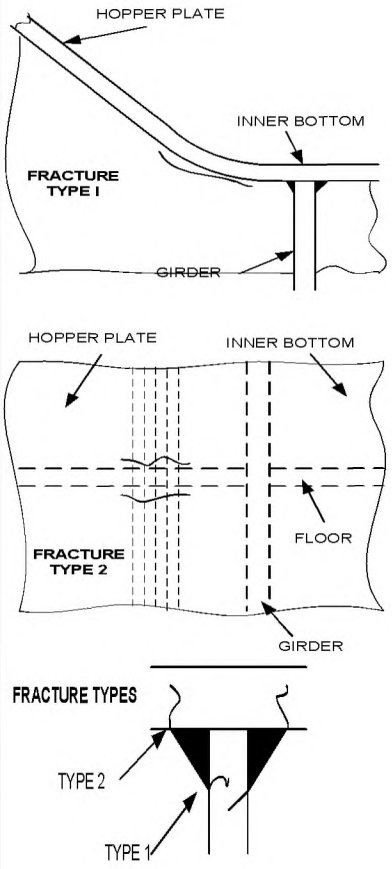
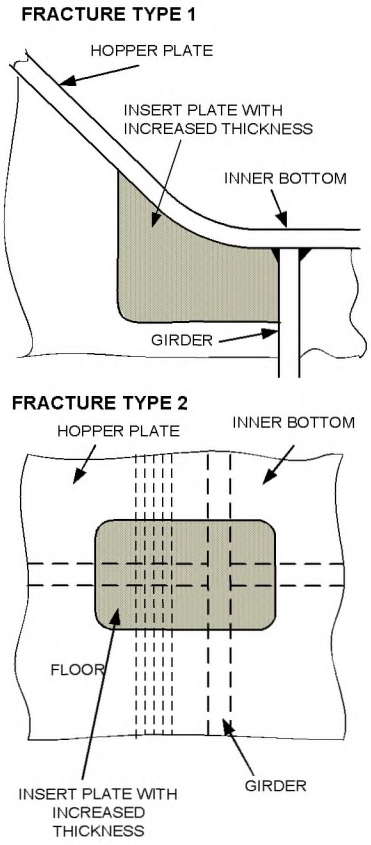
OIL Tankers	Guidelines for Surveys, Assessment and Repair of Hull Structure	
Group 1	Cargo area	Example No.
	Hopper and double bottom ballast tank	5
Detail of damage	Fractured floor and inner bottom plate in way of juncture of inner bottom to hopper plate

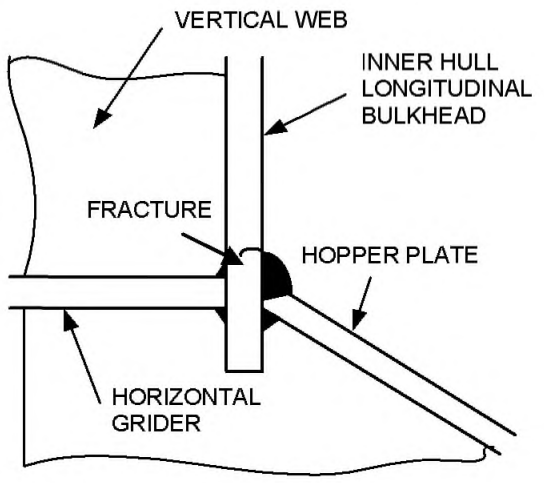
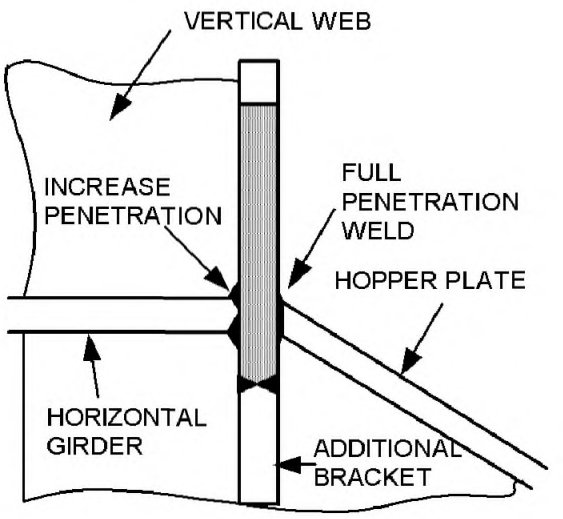
OIL Tankers	Guidelines for Surveys, Assessment and Repair of Hull Structure	
Group 1	Cargo area	Example No.
	Wing cargo tank	8
Detail of damage	Fracture at the connection of hopper plate to outside longitudinal bulkhead.

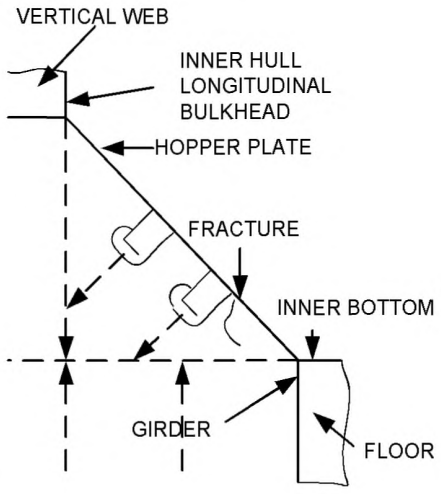
OIL Tankers	Guidelines for Surveys, Assessment and Repair of Hull Structure	
Group 1	Cargo area	Example No.
	Hopper ballast tank	10
Detail of damage	Fracture in way of cut-out in hopper plate

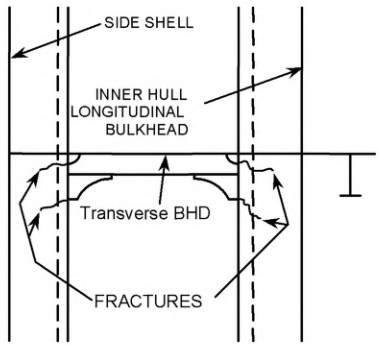
OIL Tankers	Guidelines for Surveys, Assessment and Repair of Hull Structure	
Group 2	Cargo area	Example No.
	Wing ballast tank	1
Detail of damage	Crack in way of connection of longitudinals to transverse bulkhead

1. Asymmetrical connection of bracket without backing bracket.
2. Relative deflection of adjoining transverse web against transverse bulkhead.
3. Additional biaxial bending stresses due to asymmetry of the angle bar longitudinal instead of symmetric T section.
4. Dynamic load in the vicinity of the water line.
5. Large upstand at bracket toe.

See Sketch.

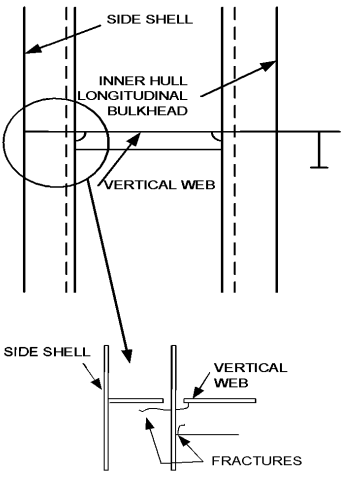
OIL Tankers	Guidelines for Surveys, Assessment and Repair of Hull Structure	
Group 2	Cargo area	Example No.
	Wing ballast tank	2
Detail of damage	Crack in way of connection of longitudinals to transverse webs

1. Asymmetrical connection of flat bar stiffener resulting in high peak stresses at the heel of the stiffener.
2. Insufficient area of connection of longitudinal to web.
3. High bending stresses in the longitudinal.
4. Additional biaxial bending stresses due to asymmetry of the longitudinal (angle bar instead of symmetric T bar).
5. Stress concentration at the square angles at heel and toe of the connections.
6. High shear stress in the transverse web.

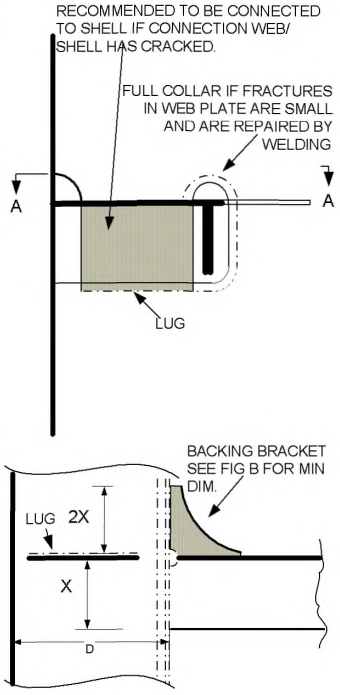
OIL Tankers	Guidelines for Surveys, Assessment and Repair of Hull Structure	
Group 2	Cargo area	Example No.
	Wing ballast tank	3
Detail of damage	Fracture in way of web and flat bar stiffener at cut outs for longitudinal stiffener connections.

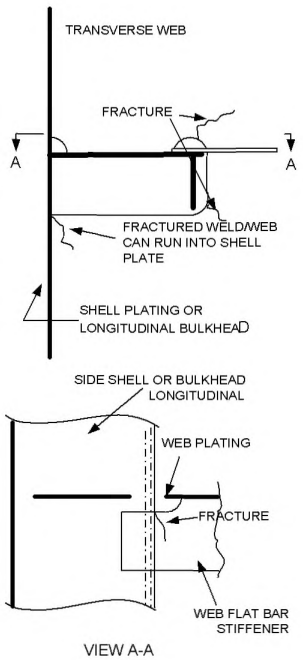
OIL Tankers	Guidelines for Surveys, Assessment and Repair of Hull Structure	
Group 2	Cargo area	Example No.
	Wing ballast tank	4
Detail of damage	Fracture in way of web and flat bar stiffener at cut outs for longitudinal stiffener connections as Example 3 but with faceplate attached to underside of web. Flat bar lap welded.

1. Asymmetrical connection of flat bar stiffener resulting in high peak stress at heel of the stiffener under fatigue loading.
2. Fabricated longitudinal with welding onto exposed edge of the web resulting in poor fatigue strength of the connection of the longitudinal to the flat bar.
3. Insufficient area of connection of longitudinal to web plate.
4. Defective weld at return around the plate thickness.
5. High localized corrosion at areas of stress concentrations such as flat bar stiffener connections, corners of cut out for longitudinal and connection of lug to shell at cut outs.
6. High shear stress in web of the transverse.
7. Dynamic seaway loads/motions.

Insert web plate.

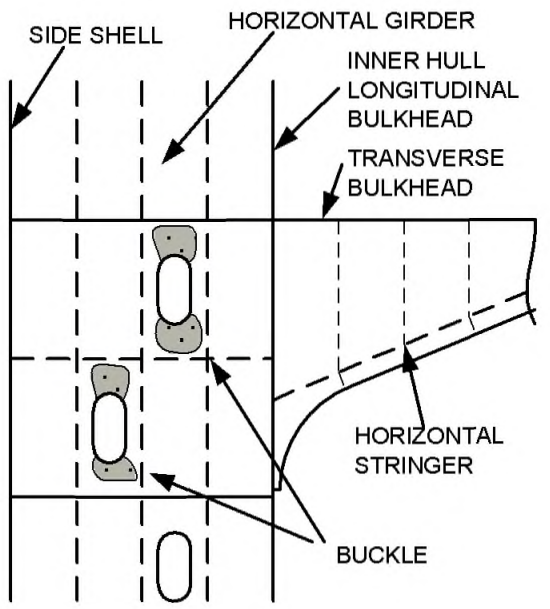
OIL Tankers	Guidelines for Surveys, Assessment and Repair of Hull Structure	
Group 2	Cargo area	Example No.
	Wing ballast tank	6
Detail of damage	Panels of side horizontal girders in way of transverse bulkhead

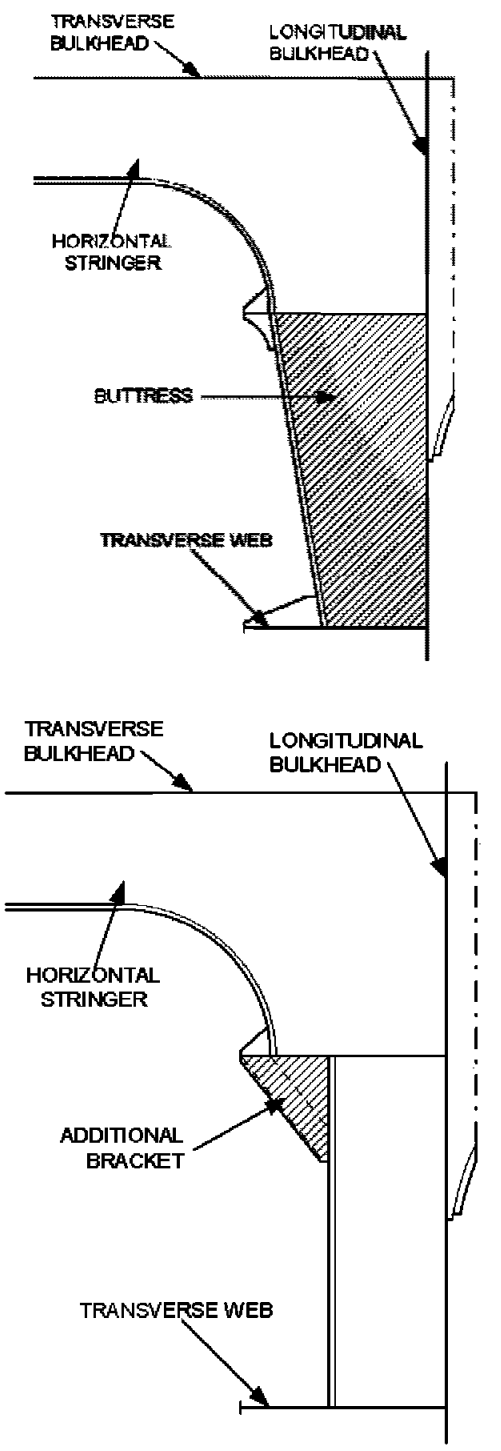
OIL Tankers	Guidelines for Surveys, Assessment and Repair of Hull Structure	
Group 2	Cargo area	Example No.
	Wing ballast tank	7
Detail of damage	Fracture at connection of horizontal stringers to transverse web frames and horizontal girders

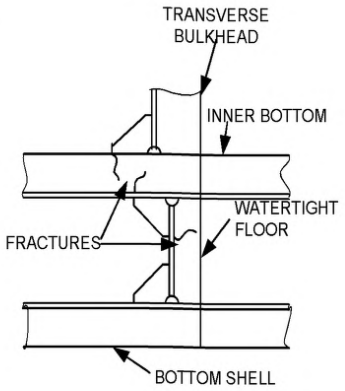
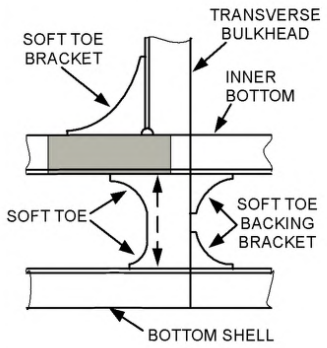
OIL Tankers	Guidelines for Surveys, Assessment and Repair of Hull Structure	
Group 3	Cargo area	Example No.
	Bottom ballast tank	1
Detail of damage	Cracks in way of longitudinals connected to watertight floors

1. Asymmetrical connection of bracket in association with a backing bracket, which is too small.
2. Relative deflection between adjacent floor and transverse bulkhead.
3. Inadequate shape of the brackets.
4. High stresses in the inner bottom longitudinal and the floor stiffener.

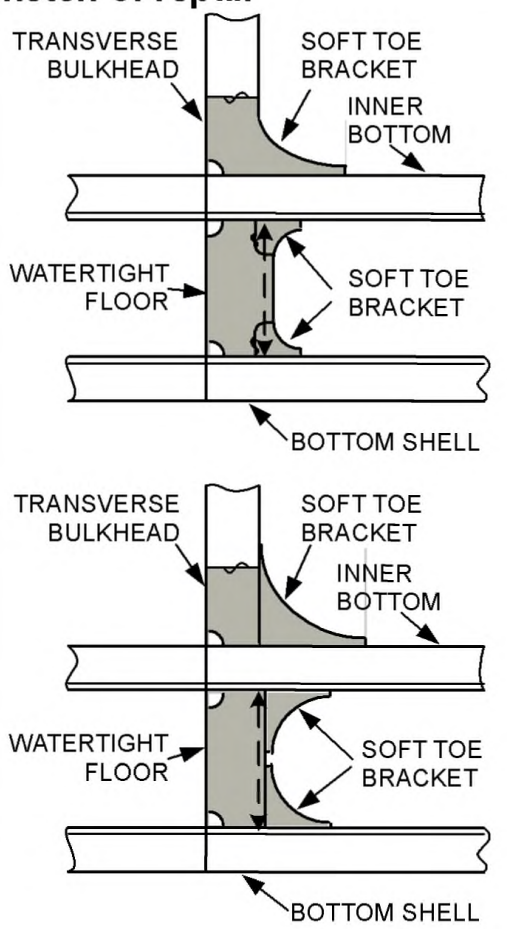
OIL Tankers	Guidelines for Surveys, Assessment and Repair of Hull Structure	
Group 3	Cargo area	Example No.
	Bottom ballast tank	2
Detail of damage	Fracture in way of stiffeners at connection of inner bottom and bottom shell to transverse bulkhead and floors.

Factors which may have caused damage	Notes on repairs
1. Misalignment between bulkhead stiffener and inner bottom longitudinal. 2. High stress concentration.	See Sketch. 1. If tank top plating is fractured, part crop and insert. 2. Proper alignment between bulkhead stiffener and inner bottom longitudinal is critical for successful repair. 3. Soft backing brackets may also be added.

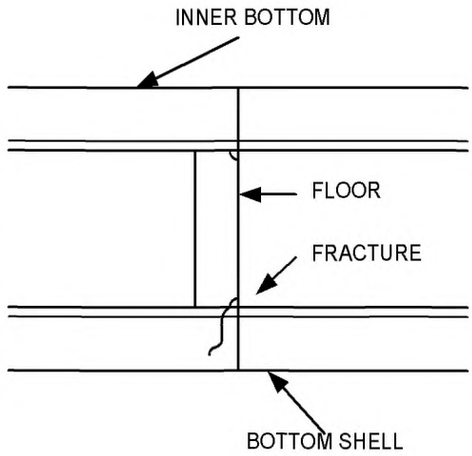
OIL Tankers	Guidelines for Surveys, Assessment and Repair of Hull Structure	
Group 3	Cargo area	Example No.
	Bottom ballast tank	3
Detail of damage	Connection of longitudinals to ordinary floors.

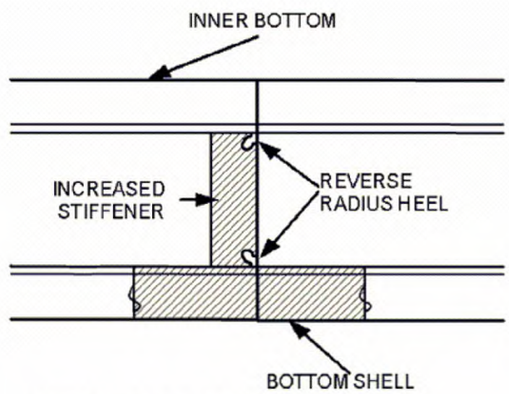
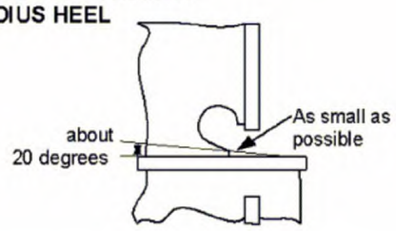
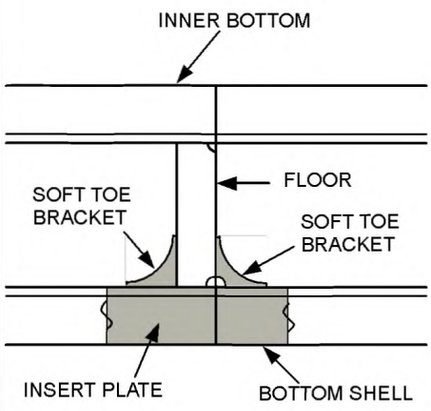
1. Asymmetrical connection.
2. Relative deflection of adjacent floor to transverse bulkhead.

See Sketch.

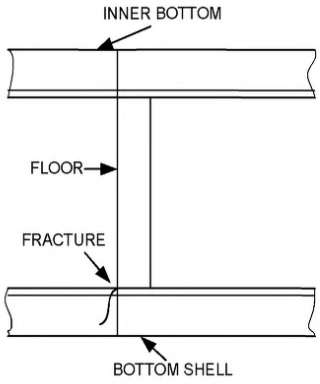
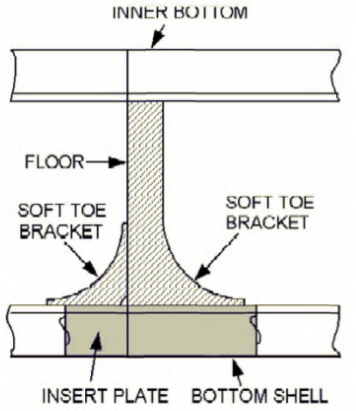
OIL Tankers	Guidelines for Surveys, Assessment and Repair of Hull Structure	
Group 3	Cargo area	Example No.
	Bottom ballast tank	4
Detail of damage	Connection of longitudinals to ordinary floors

1. Stress concentration at the connection of bottom longitudinal and stiffener on floor.

1. Butt welds in bottom longitudinal should be kept clear of the soft toe bracket toes.
2. If possible soft toe bracket and vertical stiffener should be integral.

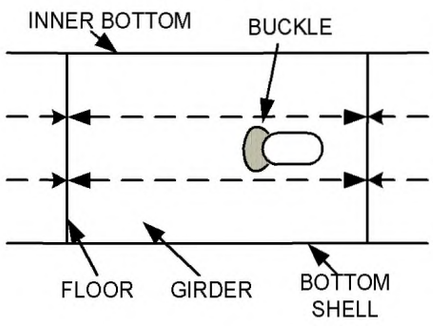
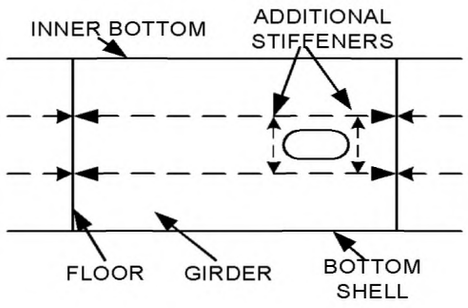
OIL Tankers	Guidelines for Surveys, Assessment and Repair of Hull Structure	
Group 3	Cargo area	Example No.
	Bottom ballast tank	5
Detail of damage	Panels of bottom girders in way of openings.

1. High shear or compressive stress in the side girder.
2. Insufficient buckling strength.

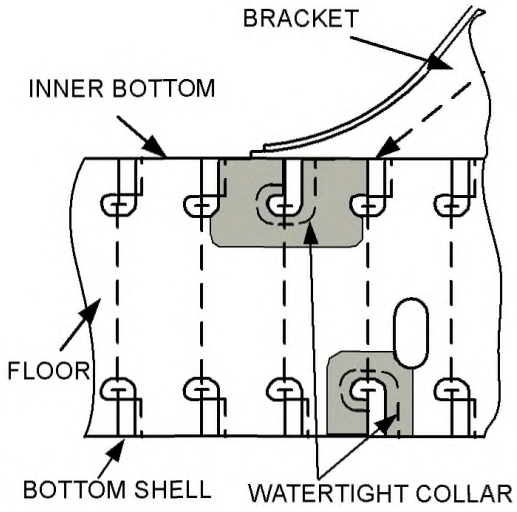
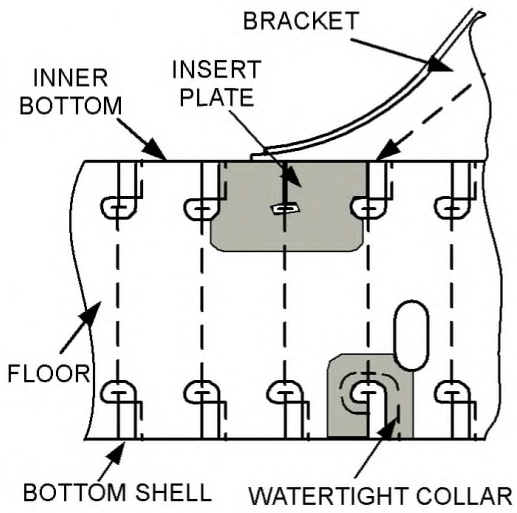
OIL Tankers	Guidelines for Surveys, Assessment and Repair of Hull Structure	
Group 3	Cargo area	Example No.
	Bottom ballast tank	6
Detail of damage	Cut-outs on floors

Above for relatively small fractures.

Above method for larger fractures.

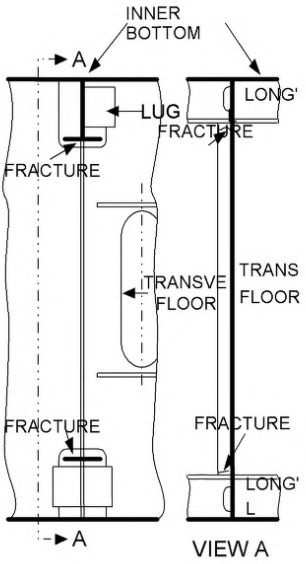
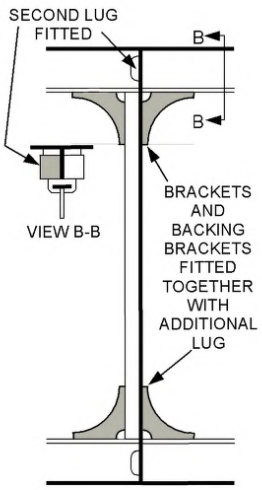
OIL Tankers	Guidelines for Surveys, Assessment and Repair of Hull Structure	
Group 3	Cargo area	Example No.
	Bottom ballast tank	7
Detail of damage	Fractured stiffener connection to bottom and inner bottom longitudinals.

1. Asymmetric connection leading to high local stresses at the connection of vertical stiffeners of the transverse floors to the inner and outer bottom longitudinals.
2. Wide slot for longitudinal leads to inefficient lug connection.
3. Sharp corners or flame-cut edges producing a notch effect.
4. Incomplete/defective weld at stiffener connection to the longitudinals.
5. Dynamic sea way loads/ship motions.

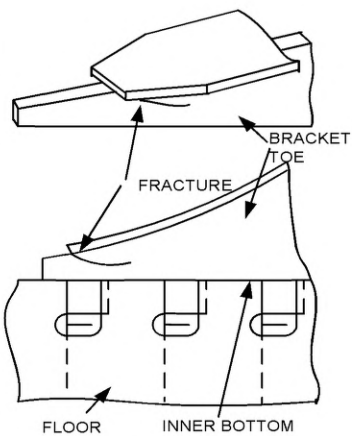
OIL Tankers	Guidelines for Surveys, Assessment and Repair of Hull Structure	
Group 4	Cargo area	Example No.
	Web Frame in cargo tank	1
Detail of damage	Fracture at toe of web frame bracket connection to inner bottom.

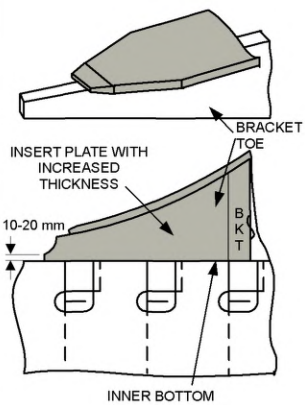
Sketch of repair

1. Inadequate tapering the toe end.
2. Insufficient tapering of flange.
3. Lateral flexing of the bracket.

Modify Face Taper

1. Breadth taper 20 degrees.
2. Breadth at toe as small as practical.
3. Thickness taper 1 in 3 to 10mm.

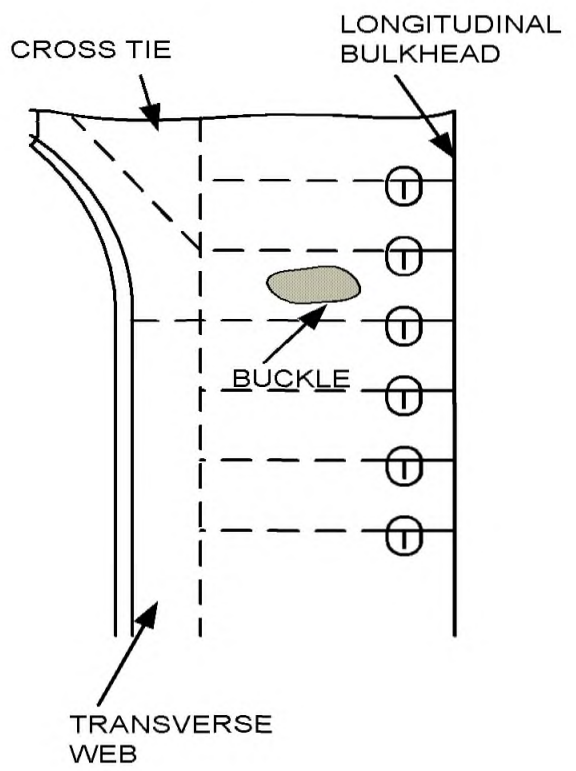
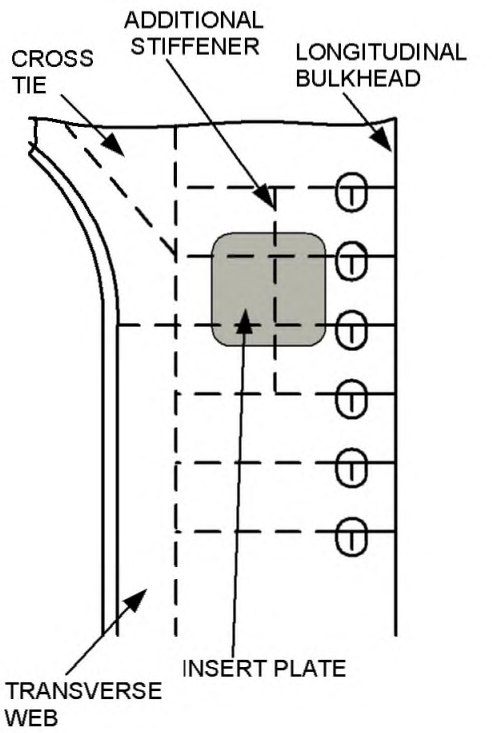
OIL Tankers	Guidelines for Surveys, Assessment and Repair of Hull Structure	
Group 4	Cargo area	Example No.
	Web Frame in cargo tank	3
Detail of damage	Buckled transverse web plates in way of cross tie.

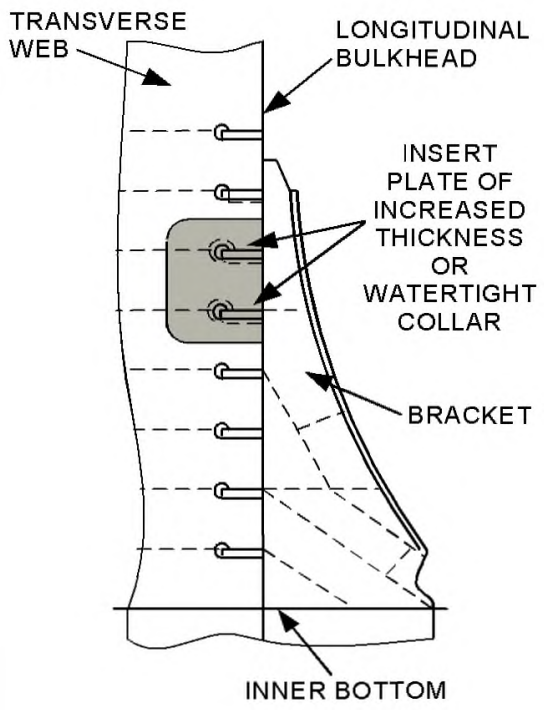
OIL Tankers	Guidelines for Surveys, Assessment and Repair of Hull Structure	
Group 4	Cargo area	Example No.
	Web Frame in cargo tank	4
Detail of damage	Cut-outs around transverse bracket end.

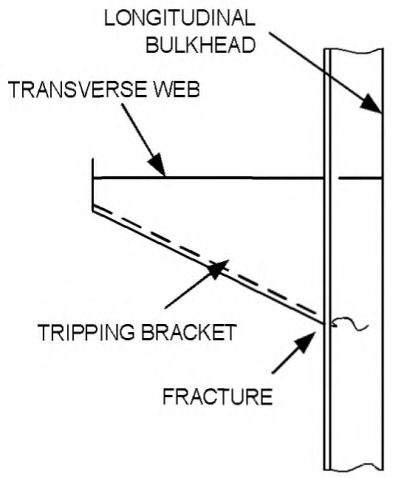
Sketch of damage

OIL Tankers	Guidelines for Surveys, Assessment and Repair of Hull Structure	
Group 4	Cargo area	Example No.
	Web Frame in cargo tank	6
Detail of damage	Tripping brackets modification of the bracket toe.

1. Stress concentrations at toe of bracket.
2. High stress in longitudinal.

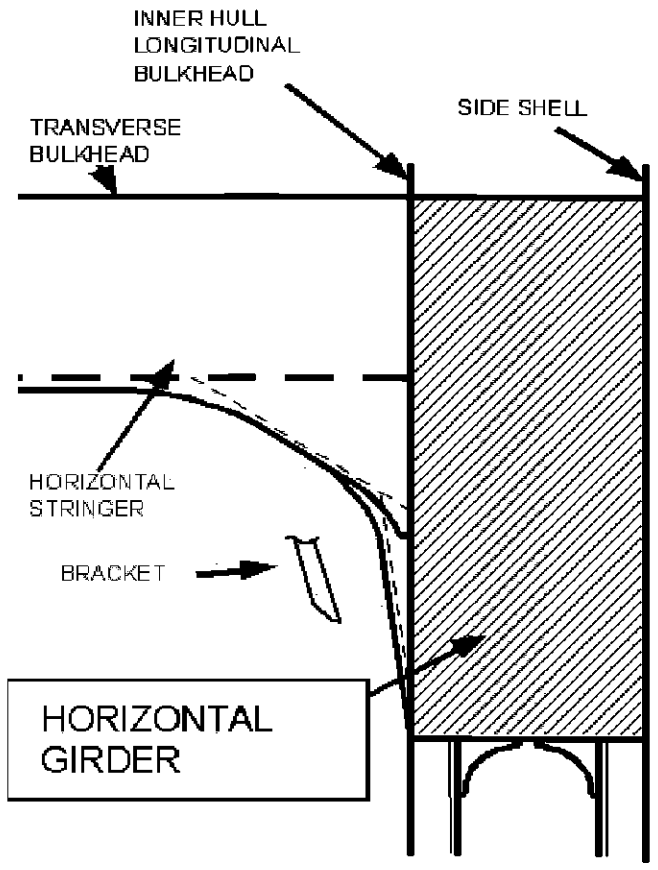
OIL Tankers	Guidelines for Surveys, Assessment and Repair of Hull Structure	
Group 5	Cargo area	Example No.
	Transverse Bulkhead in cargo tank	2
Detail of damage	Horizontal stringer in way of longitudinal BHD cracked

Factors which may have caused damage	Notes on repairs
1. Misalignment between bracket end and side girder in wing tank.	See Sketch.

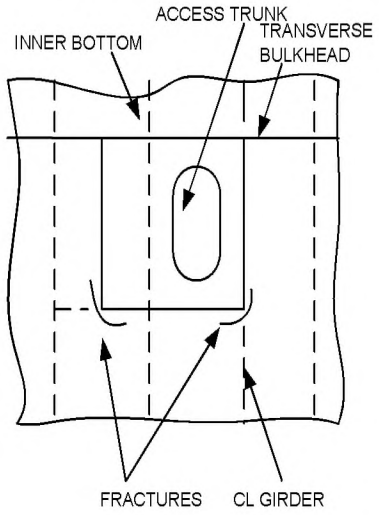
Sketch of damage

OIL Tankers	Guidelines for Surveys, Assessment and Repair of Hull Structure	
Group 5	Cargo area	Example No.
	Transverse Bulkhead in cargo tank	4
Detail of damage	Fractured inner bottom plate at the connection to access trunk wall

1. Stress concentration at the connection of trunk wall to inner bottom plate.
2. Relative deformation between horizontal stringer fitted on transverse bulkhead and inner bottom plate.
3. Static and dynamic load of cargo liquid.

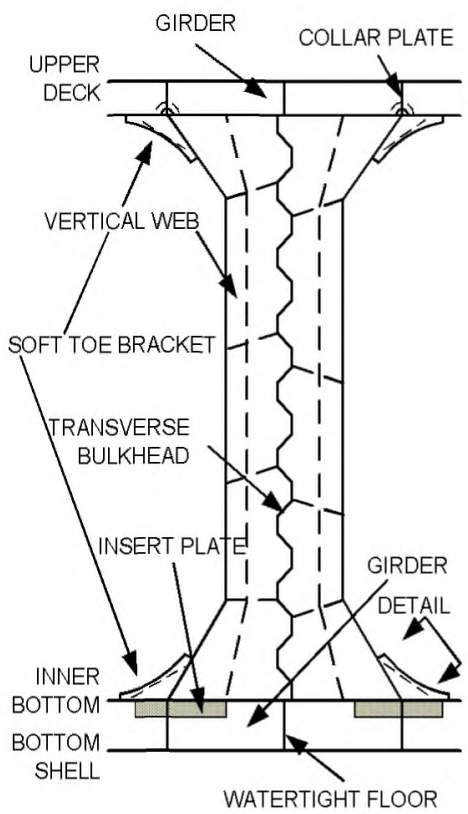
OIL Tankers	Guidelines for Surveys, Assessment and Repair of Hull Structure	
Group 5	Cargo area	Example No.
	Transverse Bulkhead in cargo tank	5
Detail of damage	Bulkhead vertical web to deck and inner bottom

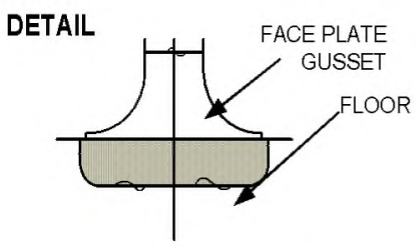
Sketch of repair

1. Stress concentration at toe of bracket due to sniped face plate and scallop in way.

See Sketch.

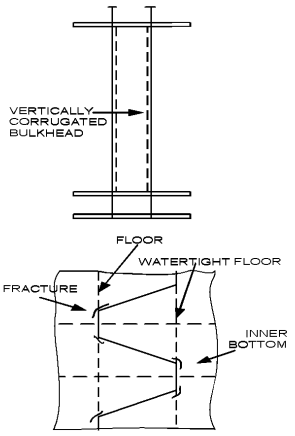
Sketch of damage

OIL Tankers	Guidelines for Surveys, Assessment and Repair of Hull Structure	
Group 5	Cargo area	Example No.
	Transverse Bulkhead in cargo tank	6
Detail of damage	Vertically corrugated bulkhead without stool, connection to deck and inner bottom

1. Stress concentration due to unsupported corrugation web.
2. High through thickness stress, lamellar tearing.
3. Weld details and dimensions.
4. Misalignment between face of corrugation and floor underneath.
5. Cut-outs and scallops or air holes increasing the stress in the floor.
6. Insufficient through thickness properties of inner bottom plate.

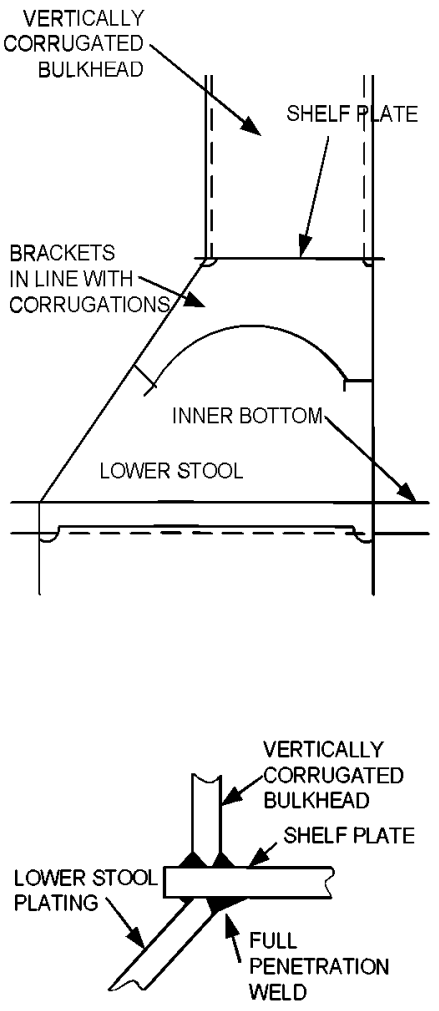
OIL Tankers	Guidelines for Surveys, Assessment and Repair of Hull Structure	
Group 5	Cargo area	Example No.
	Transverse Bulkhead in cargo tank	7
Detail of damage	Fracture at connection of vertically corrugated transverse bulkhead with stool to shelf plate and lower stool plate.

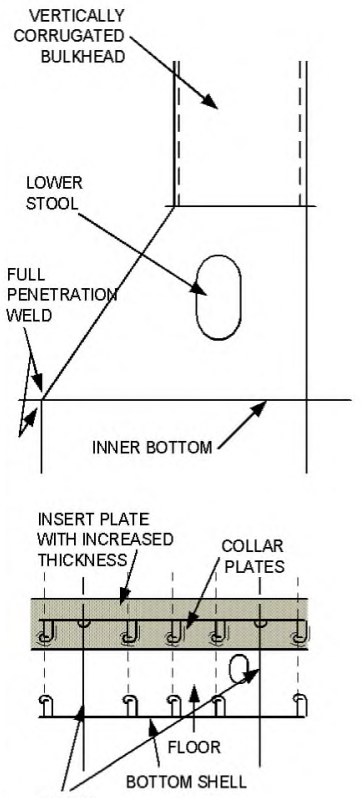
Detail of damage: Fracture at connection of lower stool plate to inner bottom tank. Lower stool plate connected to vertically corrugated transverse bulkhead.

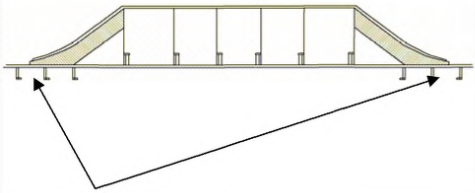
Sketch of damage

OIL Tankers	Guidelines for Surveys, Assessment and Repair of Hull Structure	
Group 6	Deck Structure	Example No. 2
Detail of damage	Fracture at ends of deck transverse

Under deck transverse is to be described as mentioned in the following "Note on repairs".
"Increase bracket length to end between under deck longitudinals and align end to under deck transverse."

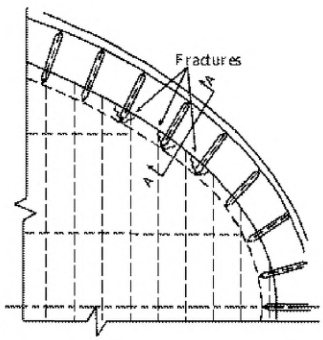
Sketch of damage

OIL Tankers	Guidelines for Surveys, Assessment and Repair of Hull Structure	
Group 7	Fore region	Example No.
Area 1	Forecastle	1
Detail of damage	Fracture in forecastle deck plating at bulwark

1. Fractured deck plating should be cropped and renewed.
2. Bracket in line with the bulwark stay to be fitted to reduce stress concentration.

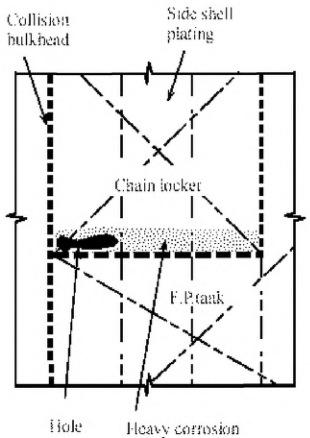
Sketch of damage

OIL Tankers	Guidelines for Surveys, Assessment and Repair of Hull Structure	
Group 7	Fore region	Example No.
Area 1	Chain locker	2
Detail of damage	Fractures in side shell plating in way of chain locker

1. Heavy corrosion in region where mud is accumulated.

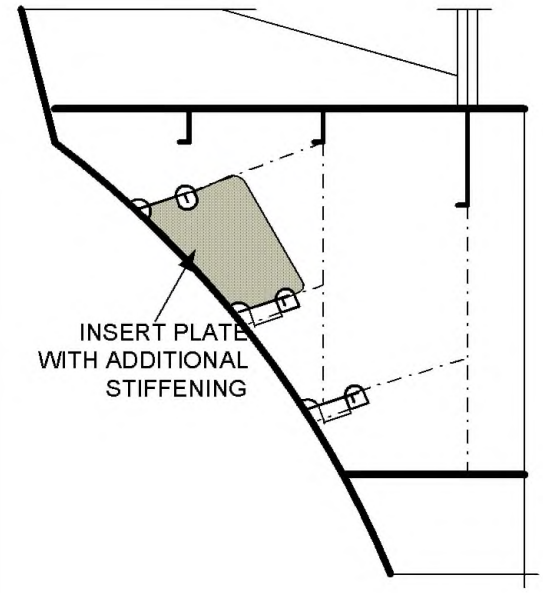
OIL Tankers	Guidelines for Surveys, Assessment and Repair of Hull Structure	
Group 7	Fore region	Example No.
Area 1	Forepeak ballast tank	7
Detail of damage	Fracture and buckle of bow transverse web frame in way of longitudinal cut-outs.

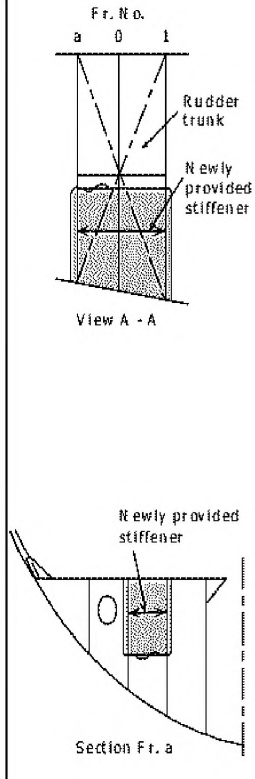
Sketch of repair

1. Vibration.

1. The fractured plating should be cropped and renewed.
2. Natural frequency of the plate between stiffeners should be changed, e.g. reinforcement by additional stiffeners.

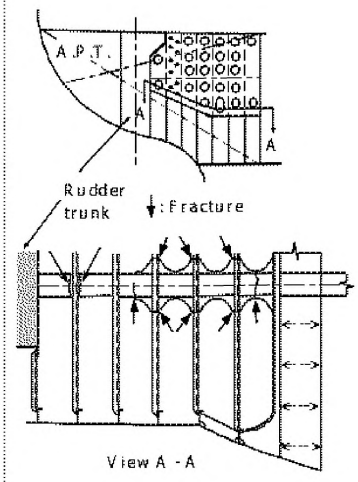
Sketch of damage

OIL Tankers	Guidelines for Surveys, Assessment and Repair of Hull Structure	
Group 7	Aft region	Example No.
Area 2	Aft peak ballast tank	10
Detail of damage	Fractures at the connection of floors and girders/side brackets

1. Vibration.

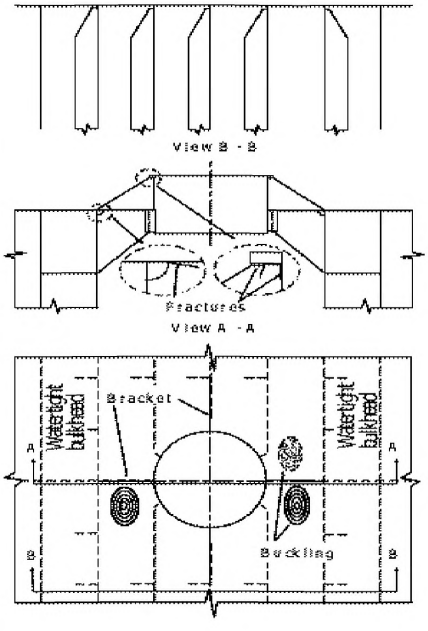
OIL Tankers	Guidelines for Surveys, Assessment and Repair of Hull Structure	
Group 7	Aft region	Example No.
Area 2	Machinery space outside engine room	12
Detail of damage	Fractures in steering gear foundation brackets and deformed deck plate

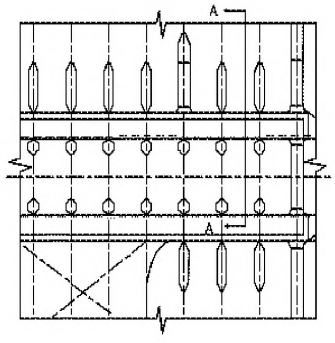
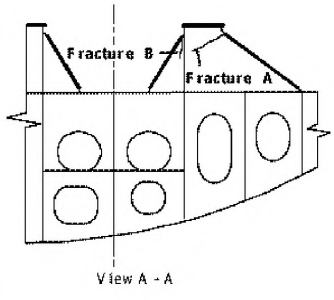
Sketch of damage

OIL Tankers	Guidelines for Surveys, Assessment and Repair of Hull Structure	
Group 8	Machinery and accommodation spaces	Example No.
Area 1	Engine room	1
Detail of damage	Fractures in brackets at main engine foundation

1. Vibration of main engine.
2. Insufficient strength of brackets at main engine foundation.
3. Insufficient pre-load of the bolts.

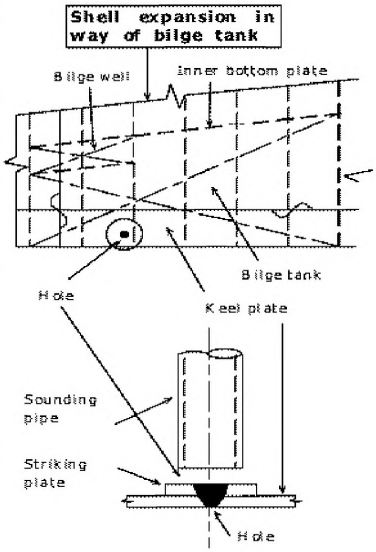
Sketch of damage

OIL Tankers	Guidelines for Surveys, Assessment and Repair of Hull Structure	
Group 8	Machinery and accommodation spaces	Example No.
Area 1	Engine room	2
Detail of damage	Corrosion in bottom plating under sounding pipe in way of bilge storage tank in engine room

1. Heavy corrosion of bottom plating under sounding pipe.
