No.76 IACS Guidelines for Surveys, Assessment and Repair of Hull Structure – Bulk Carriers

BULK CARRIERS

Guidelines for Surveys, Assessment and Repair of Hull Structure

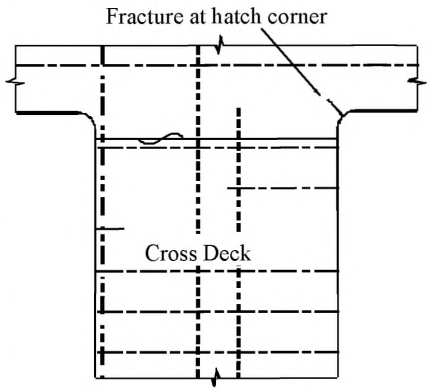
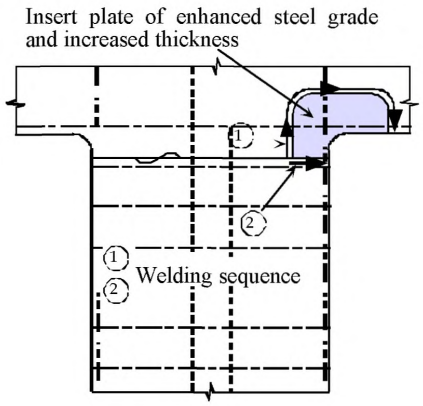
BULK CARRIERS	Guidelines for Surveys, Assessment and Repair of Hull Structure	
Part 1	**Cargo hold region**	**Example No.**
Area 1	**Deck structure**	**1**
Detail of damage	Fractures at main cargo hatch corner

1. Stress concentration at hatch corners, i.e. radius of corner.
2. Welded attachment of shedder plate close to edge of hatch corner.
3. Wire rope groove.

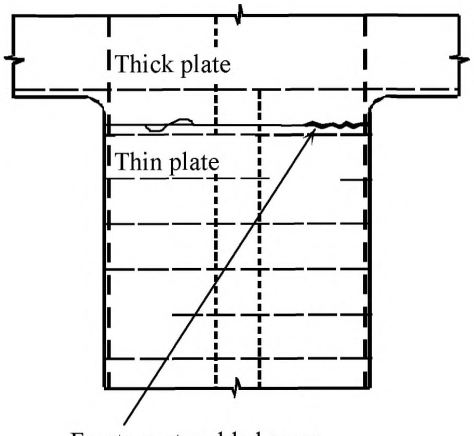
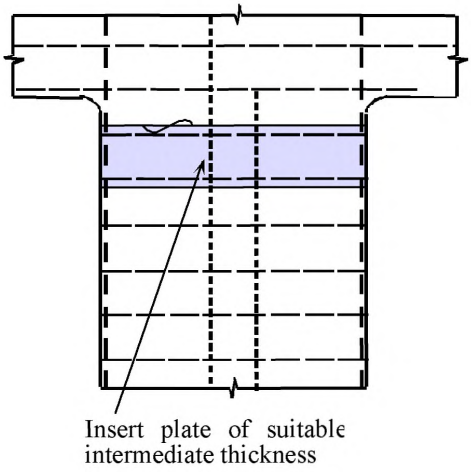
BULK CARRIERS	Guidelines for Surveys, Assessment and Repair of Hull Structure	
Part 1	**Cargo hold region**	**Example No.**
Area 1	**Deck structure**	**2-a**
Detail of damage	Fractures of welded seam between thick plate and thin plate at cross deck

1. Stress concentration created by abrupt change in deck plating thickness.
2. In-plane bending in cross deck strip due to torsional (longitudinal) movements of ship sides.
3. Welded seam not clear of tangent point of hatch corner.

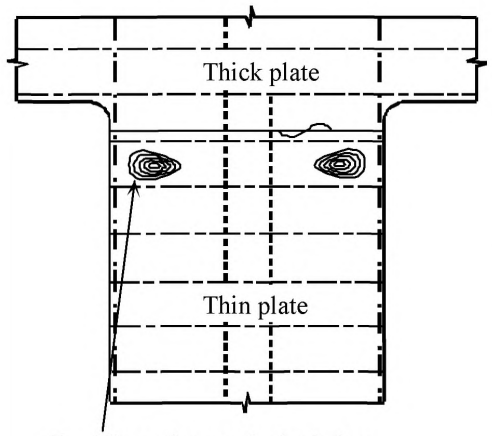
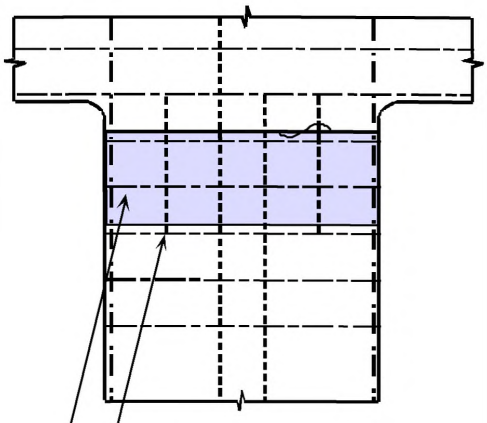
BULK CARRIERS	Guidelines for Surveys, Assessment and Repair of Hull Structure	
Part 1	**Cargo hold region**	**Example No.**
Area 1	**Deck structure**	**2-b**
Detail of damage	Plate buckling in thin plate near thick plate at cross deck

Buckling of cross deck plating (Buckling of hatch end structure should be examined. Refer to **Example 7-a**.)

Additional transverse stiffening and/or insertion of plate with suitable intermediate thickness

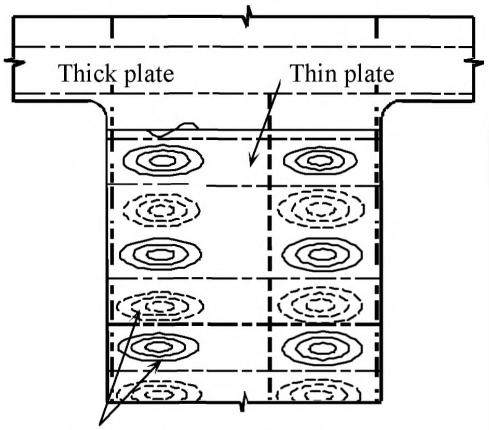
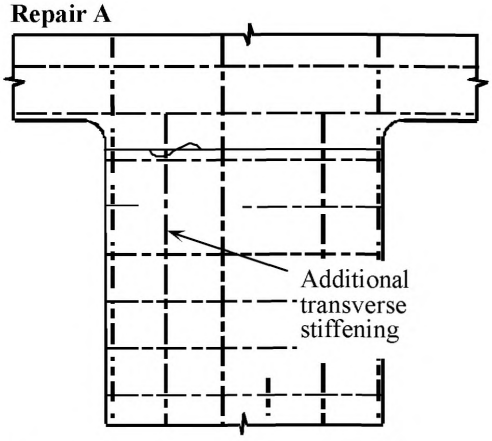
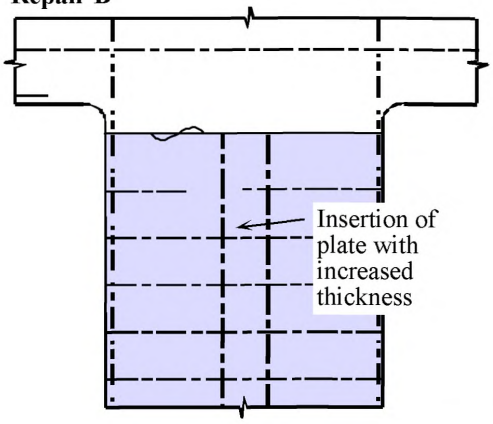
BULK CARRIERS	Guidelines for Surveys, Assessment and Repair of Hull Structure	
Part 1	Cargo hold region	Example No.
Area 1	Deck structure	2-c
Detail of damage	Overall buckling of cross deck plating

Buckling of cross deck plating (Buckling of hatch end structure should be examined. Refer to **Example 7-a.**)

1. Transverse compression of deck due to sea load.
2. Transverse compression of deck due to excessive loading in two adjacent holds.
3. Insufficient plate thickness and/or transverse stiffening.

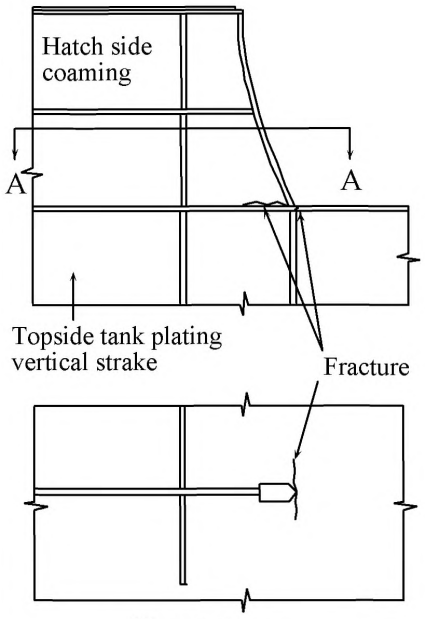
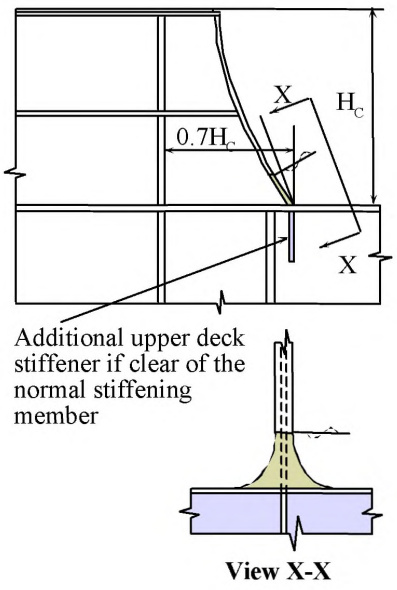
BULK CARRIERS	Guidelines for Surveys, Assessment and Repair of Hull Structure	
Part 1	**Cargo hold region**	**Example No.**
Area 1	**Deck structure**	**3-a**
Detail of damage	Fractures in the web or in the deck at the toes of the longitudinal hatch coaming termination bracket

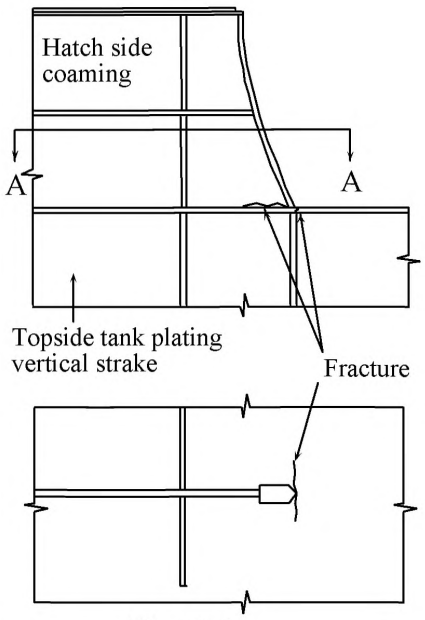
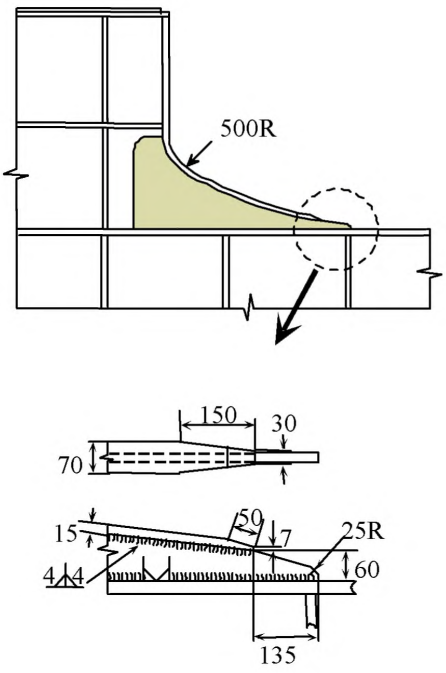
BULK CARRIERS	Guidelines for Surveys, Assessment and Repair of Hull Structure	
Part 1	**Cargo hold region**	**Example No.**
Area 1	**Deck structure**	**3-b**
Detail of damage	Fractures in the web or in the deck at the toes of the longitudinal hatch coaming termination bracket

1. This damage is caused by stress concentrations attributed to the design of the bracket.

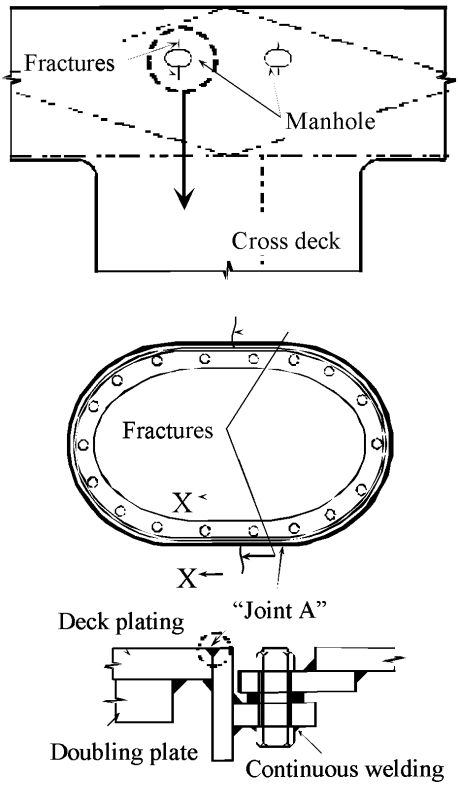
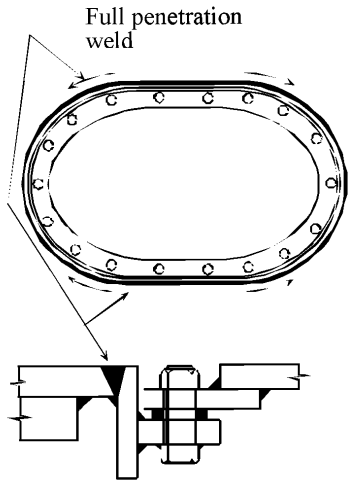
BULK CARRIERS	Guidelines for Surveys, Assessment and Repair of Hull Structure	
Part 1	Cargo hold region	Example No.
Area 1	Deck structure	4
Detail of damage	Fractures in deck plating initiated from weld of access manhole

1. Heavy weather.
2. Improper welding of joint "A".

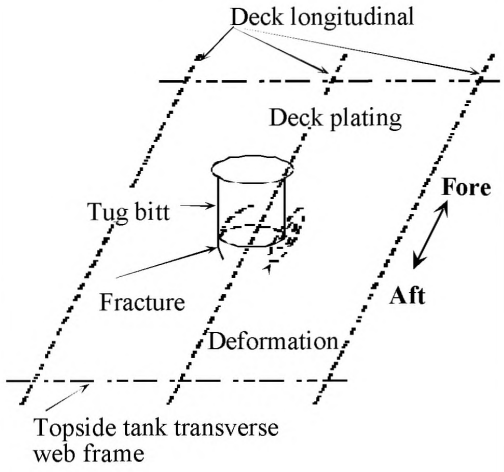
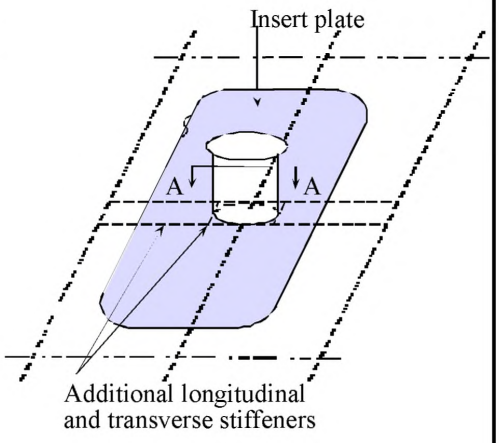
BULK CARRIERS	Guidelines for Surveys, Assessment and Repair of Hull Structure	
Part 1	Cargo hold region	Example No.
Area 1	Deck structure	5
Detail of damage	Deformed and fractured deck plating around tug bitt

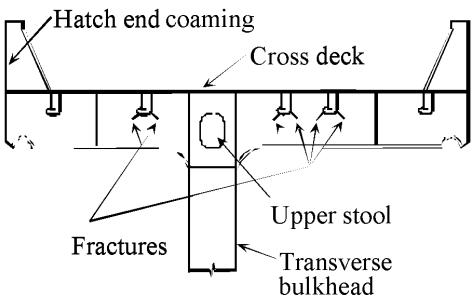
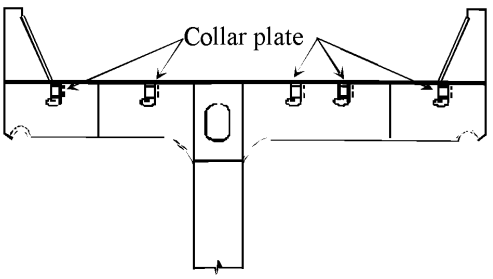
BULK CARRIERS	Guidelines for Surveys, Assessment and Repair of Hull Structure	
Part 1	**Cargo hold region**	**Example No.**
Area 1	**Deck structure**	**6**
Detail of damage	Fractures around cut-outs in cross deck girder

1. Stress concentration at the cut-outs in cross deck girder.

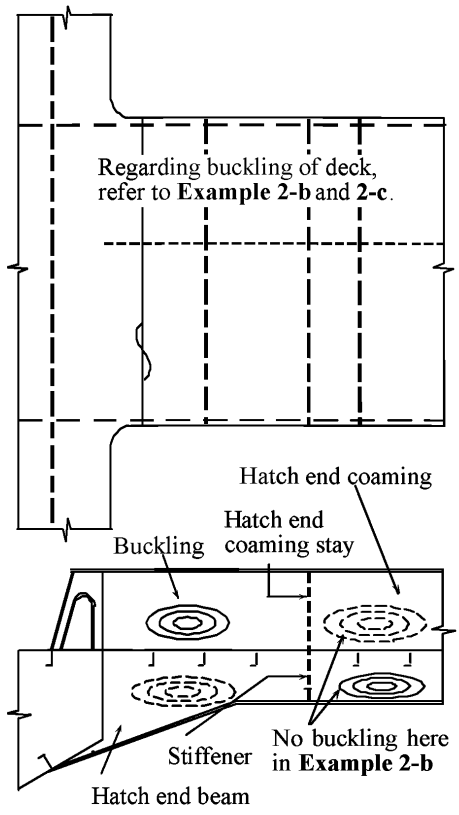
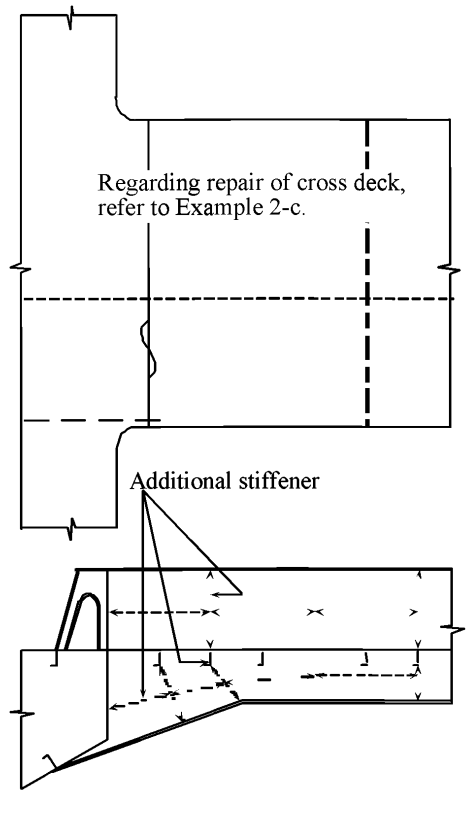
BULK CARRIERS	Guidelines for Surveys, Assessment and Repair of Hull Structure	
Part 1	**Cargo hold region**	**Example No.**
Area 1	**Deck structure**	**7-a**
Detail of damage	Buckling of hatch coaming and hatch end beam

1. Additional transverse forces due to heavy seas, and torsional loading.
2. Inadvertent overloading of cargo spaces.

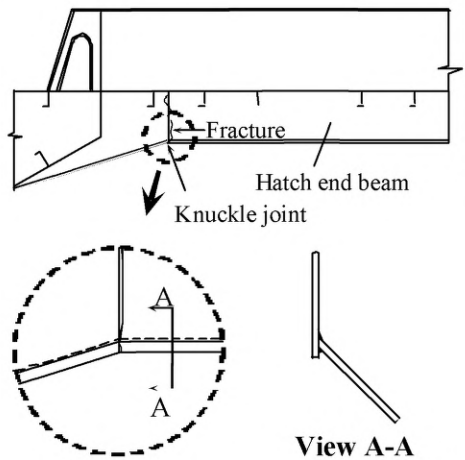
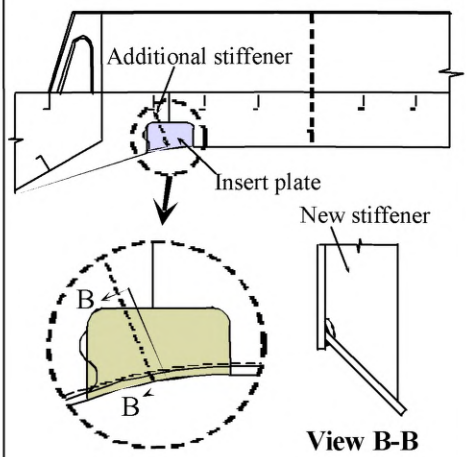
BULK CARRIERS	Guidelines for Surveys, Assessment and Repair of Hull Structure	
Part 1	**Cargo hold region**	**Example No.**
Area 1	**Deck structure**	**7-b**
Detail of damage	Fractures in hatch end beam at knuckle joint

1. Stress concentration at knuckle joint.

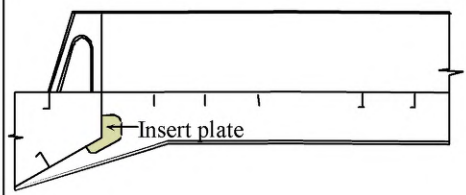
1. Misalignment of the hatch end beam with transverse web frame in topside tank.
2. Stress concentration.

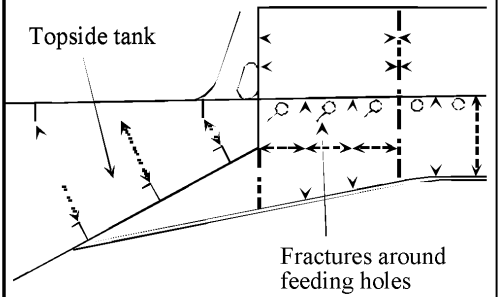
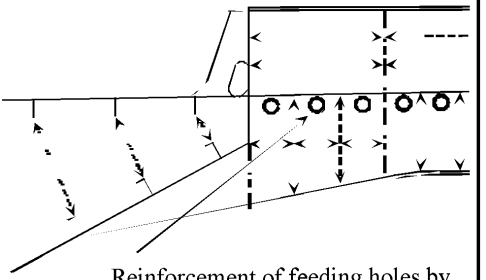
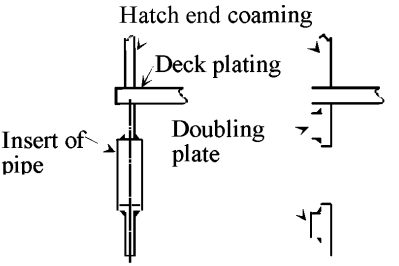
BULK CARRIERS	Guidelines for Surveys, Assessment and Repair of Hull Structure	
Part 1	**Cargo hold region**	**Example No.**
Area 1	**Deck structure**	**9**
Detail of damage	Fractures in hatch end beam around feeding holes

Reinforcement of feeding holes by doubling plate or insert of pipe. See "Detail" below.

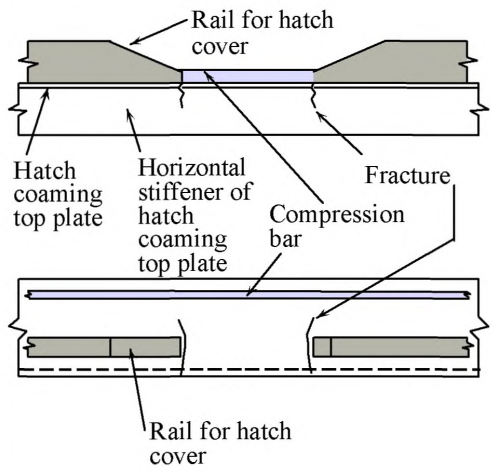
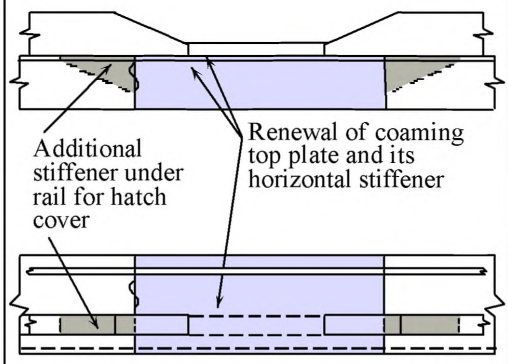
BULK CARRIERS	Guidelines for Surveys, Assessment and Repair of Hull Structure	
Part 1	**Cargo hold region**	**Example No.**
Area 1	**Deck structure**	**10-a**
Detail of damage	Fractures in hatch coaming top plate at the termination of rail for hatch cover

1. Stress concentration at the termination of the rail for hatch cover due to poor design.

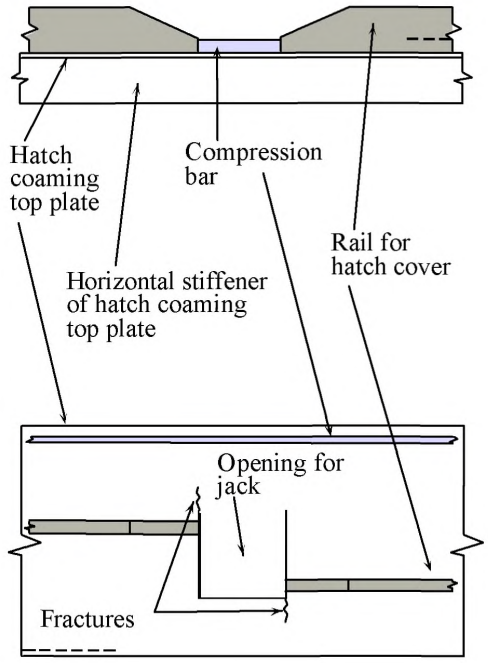
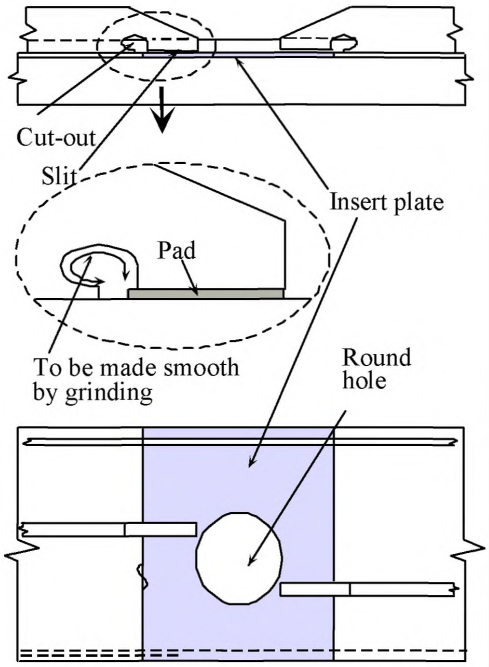
BULK CARRIERS	Guidelines for Surveys, Assessment and Repair of Hull Structure	
Part 1	Cargo hold region	Example No.
Area 1	Deck structure	10-b
Detail of damage	Fractures in hatch coaming top plate at the termination of rail for hatch cover

1. Stress concentration at the termination of the rail for hatch cover due to poor design of opening.

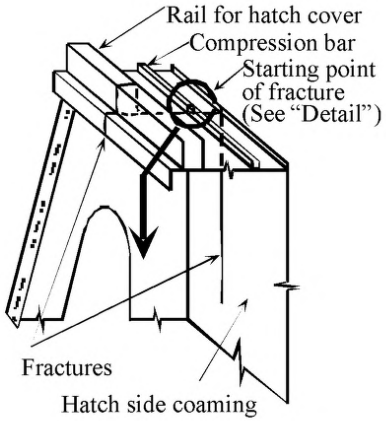
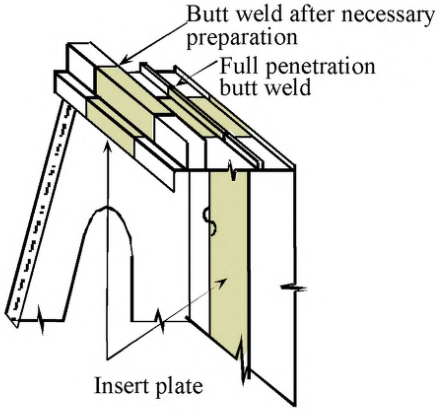
BULK CARRIERS	Guidelines for Surveys, Assessment and Repair of Hull Structure	
Part 1	**Cargo hold region**	**Example No.**
Area 1	**Deck structure**	**11**
Detail of damage	Fractures in hatch coaming top plate initiated from butt weld of compression bar

1. Heavy weather
2. Insufficient preparation of weld of compression bar and/or rail (Although the compression bar and rail are not longitudinal strength members, they subject same longitudinal stress as longitudinal members)
3. Crack may initiate from insufficient penetration of weld of rail for hatch cover.

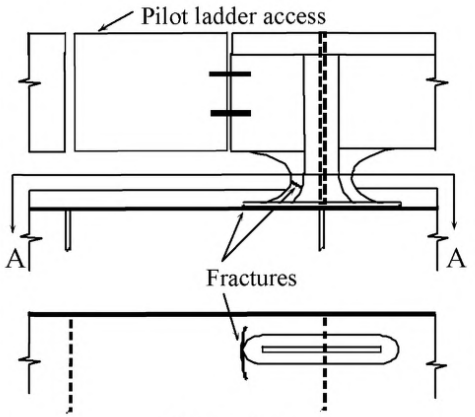
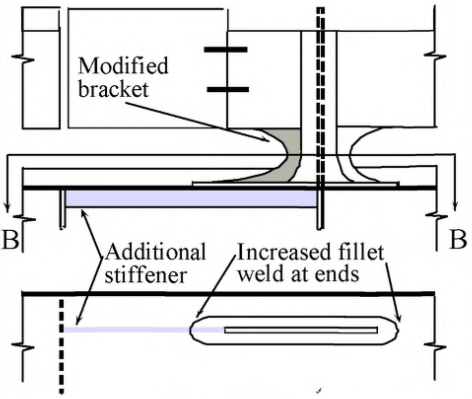
BULK CARRIERS	Guidelines for Surveys, Assessment and Repair of Hull Structure	
Part 1	**Cargo hold region**	**Example No.**
Area 1	**Deck structure**	**12**
Detail of damage	Fractures in deck plating at the pilot ladder access of bulwarks

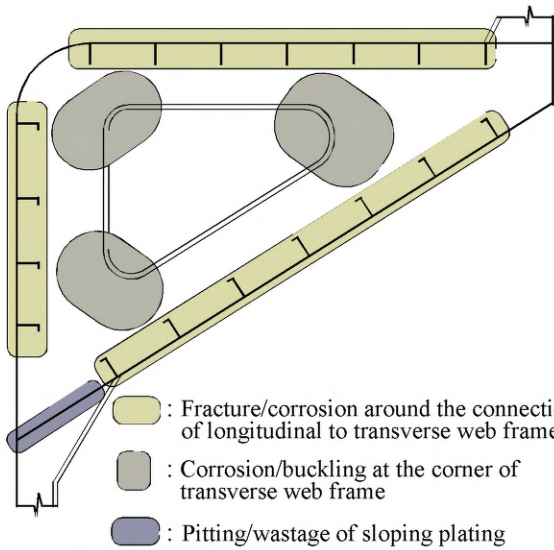
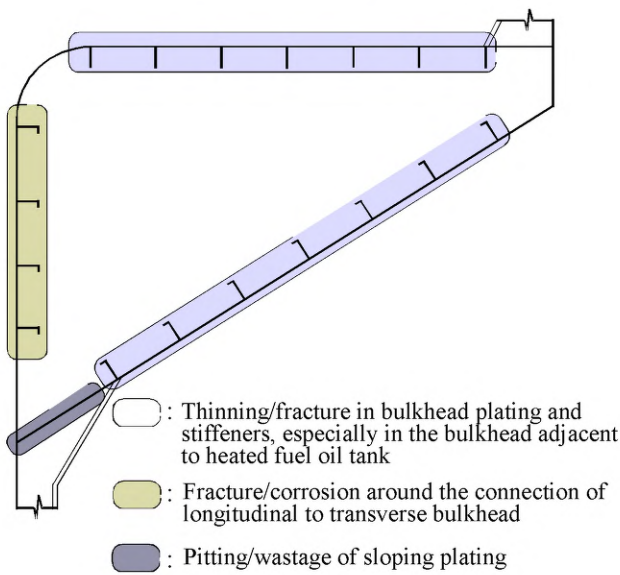
Figure 1 Topside tank - Potential problem areas

(c) Areas susceptible to coating breakdown
Back side of face plate of longitudinal
Welded joint
Edge of access opening

(d) Areas subjected to poor drainage
Web of side and sloping longitudinals

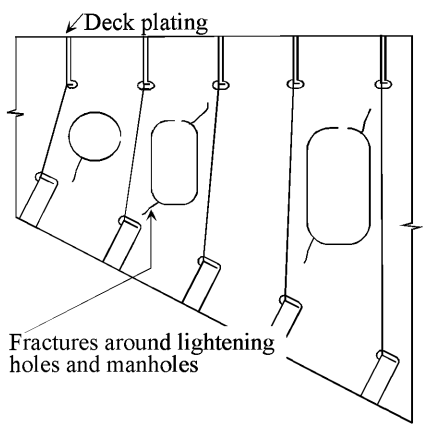
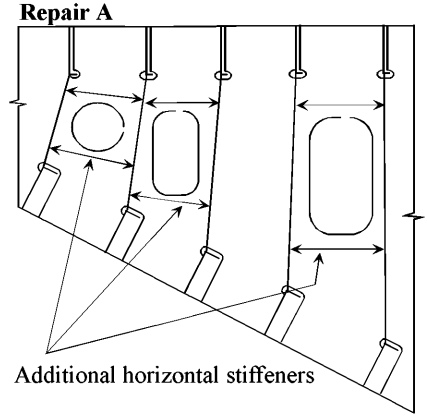
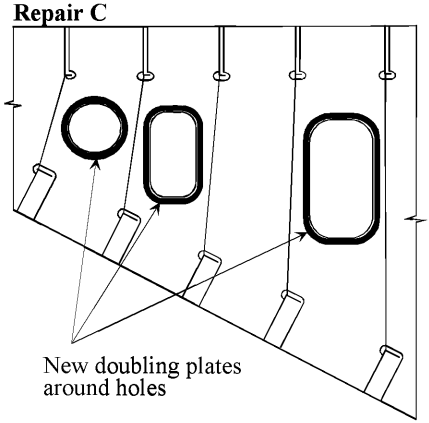
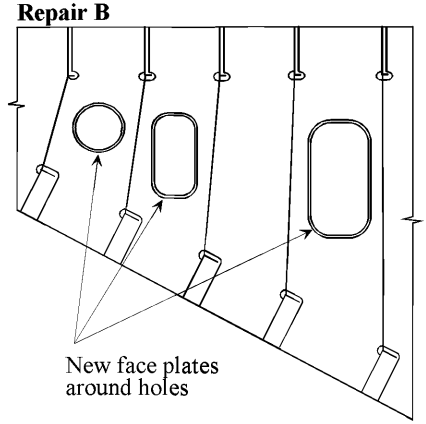
BULK CARRIERS	Guidelines for Surveys, Assessment and Repair of Hull Structure	
Part 1	Cargo hold region	Example No.
Area 2	Topside tank structure	1
Detail of damage	Fractures around unstiffened lightening holes and manholes in wash bulkhead

1. General levels of corrosion and presence of stress concentration.

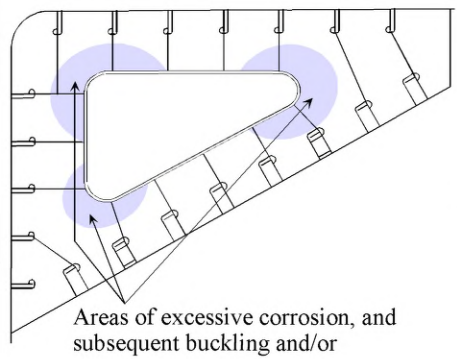
BULK CARRIERS	Guidelines for Surveys, Assessment and Repair of Hull Structure	
Part 1	**Cargo hold region**	**Example No.**
Area 2	**Topside tank structure**	**2-a**
Detail of damage	Thinning and subsequent buckling of web plating in the vicinity of the radii of the opening

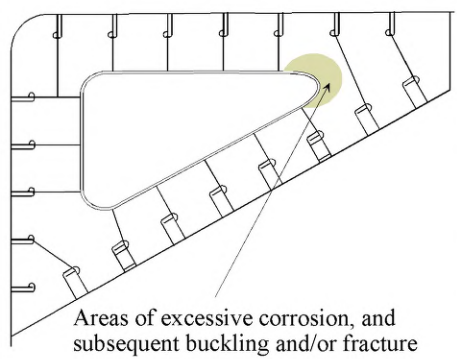
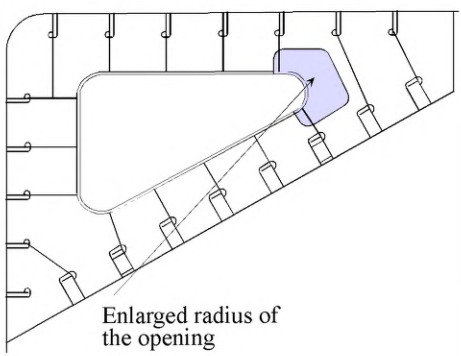
BULK CARRIERS	Guidelines for Surveys, Assessment and Repair of Hull Structure	
Part 1	Cargo hold region	Example No.
Area 2	Topside tank structure	2-b
Detail of damage	Thinning and subsequent buckling of web plating in the vicinity of the radii of the opening

1. Corrosion caused by stress concentration at the corner due to insufficient radius for the opening.

1. Corroded/buckled plating is to be cropped and parts renewed with plating of increased thickness and additional stiffeners are preferable to minimize deflection.
2. An attempt should be made to improve the design of the radius if felt necessary.

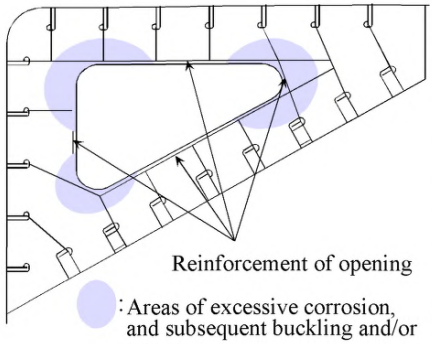
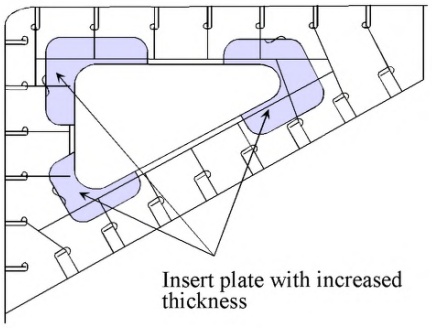
BULK CARRIERS	Guidelines for Surveys, Assessment and Repair of Hull Structure	
Part 1	**Cargo hold region**	**Example No.**
Area 2	**Topside tank structure**	**2-c**
Detail of damage	Thinning and subsequent buckling of web plating in the vicinity of the radii of the opening

1. Additional stresses at the free edge of transverse web. (In **Example 2-a - 2-c** face plate is provided for the reinforcement of the opening.)

1. Corroded/buckled plating is to be cropped and part renewed with plating of increased thickness.

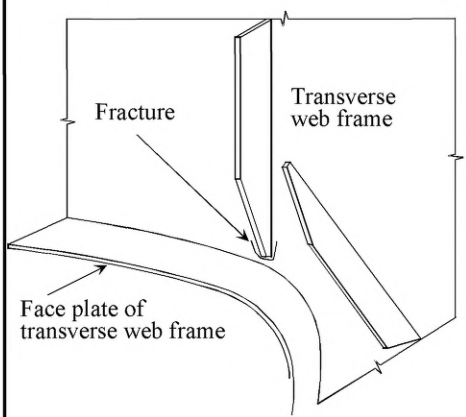
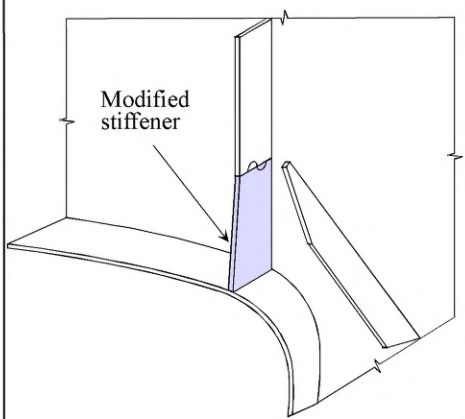
BULK CARRIERS	Guidelines for Surveys, Assessment and Repair of Hull Structure	
Part 1	**Cargo hold region**	**Example No.**
Area 2	**Topside tank structure**	**3**
Detail of damage	Fractures in transverse web at sniped end of stiffener

1. Stress concentration.

1. Fracture can be veed-out and welded provided the plating is not generally corroded. If necessary, fractured plating should be cropped and renewed.
2. Excessive stress concentration at the end of stiffener should be avoided.

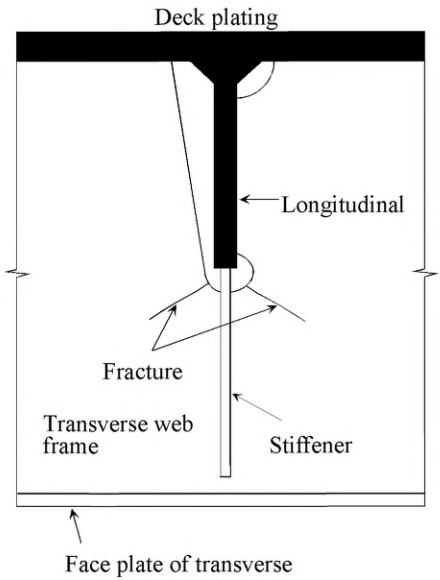
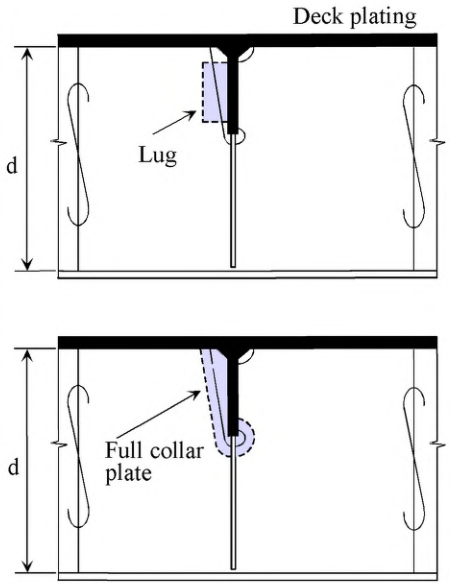
BULK CARRIERS	Guidelines for Surveys, Assessment and Repair of Hull Structure	
Part 1	**Cargo hold region**	**Example No.**
Area 2	**Topside tank structure**	**4-a**
Detail of damage	Fractures at slots in way of transverse web frame

1. Damage may be created by local shear stress concentrations due to large cut-outs for notch.
2. Also deficient welds (fillet welds between deck longitudinal and stiffener).

(Note) Full collar plate where the depth of cut-out is more than 0.4 times the depth of web frame (0.4d) and in an areas of high shear stress

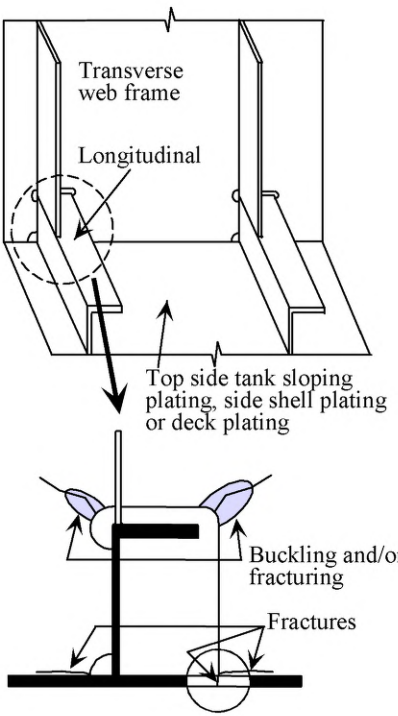
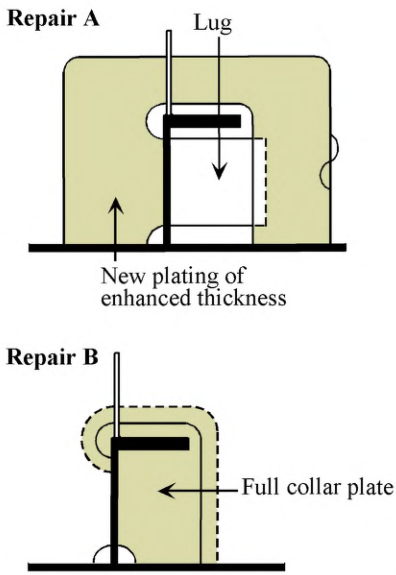
BULK CARRIERS	Guidelines for Surveys, Assessment and Repair of Hull Structure	
Part 1	**Cargo hold region**	**Example No.**
Area 2	**Topside tank structure**	**4-b**
Detail of damage	Fractures and buckling at slots in way of transverse web frame

1. Damage can be caused by general levels of corrosion and presence of stress concentration associated with the presence of a cut-out.

1. If fractures are significant then crop and part renew the plating otherwise the fracture can be veed-out and welded provided the plating is not generally corroded.
2. **Repair A** Lug should be considered.
3. **Repair B** Full collar plate should be considered where the depth of cut-out is more than 0.4 times the depth of web frame and in an area of high shear stress or the existing lug proves to be ineffective.

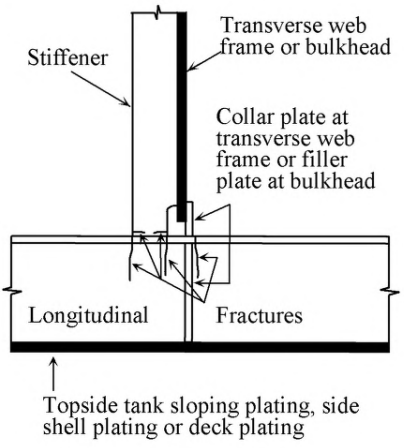
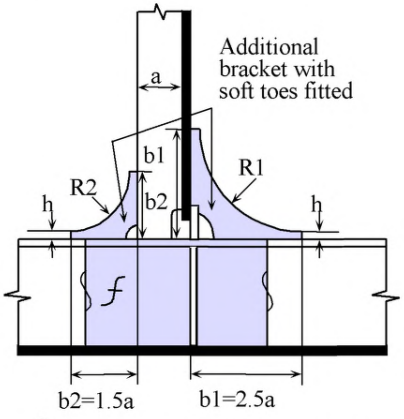
BULK CARRIERS	Guidelines for Surveys, Assessment and Repair of Hull Structure	
Part 1	**Cargo hold region**	**Example No.**
Area 2	**Topside tank structure**	**5**
Detail of damage	Fractures in longitudinal at transverse web frame or bulkhead

1. Damage can be caused by stress concentrations leading to accelerated fatigue in this region.

f: Where required, the longitudinal to be cropped and part renewed

1. For a slope at toes max. 1:3, R1=(b1-h)x 1.6 and R2=(b2-h)x 1.6
2. Soft toe bracket to be welded first to longitudinal
3. Scallop in bracket to be as small as possible, recommended max. 35mm
4. If toes of brackets are ground smooth, full penetration welds in way to be provided
5. Maximum length to thickness ratio =50:1 for unstiffened bracket edge
6. Toe height, h, to be as small as possible (10-15mm)

1. If fracture extends to over one third of the depth of the longitudinal, then crop and part renew. Otherwise the fracture can be veed-out and welded.

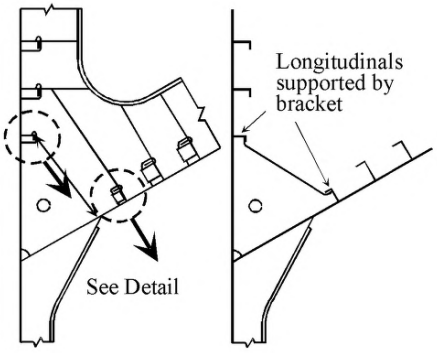
BULK CARRIERS	Guidelines for Surveys, Assessment and Repair of Hull Structure	
Part 1	**Cargo hold region**	**Example No.**
Area 2	**Topside tank structure**	**6**
Detail of damage	Fractures in the lowest longitudinal at transverse web frame

1. Insufficient scantling for torsional rigidity (The lowest longitudinal is usually supported by bracket(s) as shown in the above and smaller scantling may be adopted. However, the lowest longitudinal undergoes torsion from side shell frame through bracket(s) and may suffer fracture.)

1. Fractured part to be cropped and renewed.
2. Size of bracket should be increased

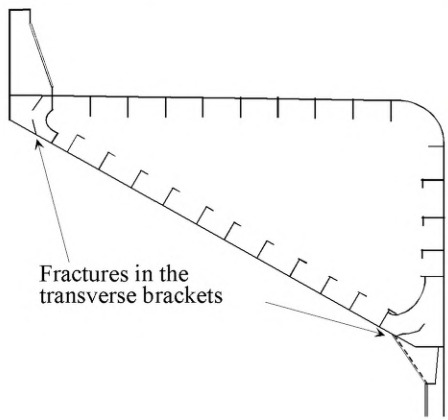
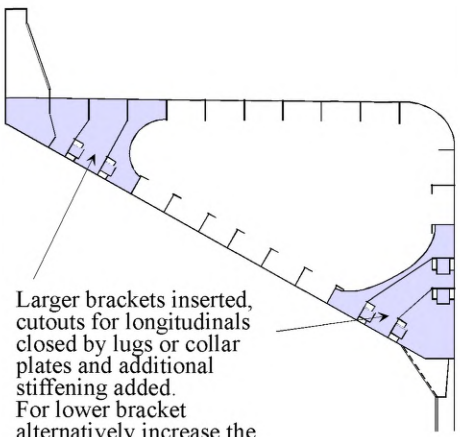
BULK CARRIERS	Guidelines for Surveys, Assessment and Repair of Hull Structure	
Part 1	**Cargo hold region**	**Example No.**
Area 2	**Topside tank structure**	**7-a**
Detail of damage	Fractures in transverse brackets

1. General levels of corrosion and presence of stress concentrations.
2. Misalignment of the brackets with adjoining structure, e.g. side shell frame brackets and/or coaming brackets.
3. High shear stresses due to insufficient bracket size.
4. Inadvertent overloading.

1. If the damage is caused by misalignment with the side shell frame brackets or the hatch coaming brackets the misalignment is to be rectified and the replacement by larger brackets incorporated only if considered necessary.

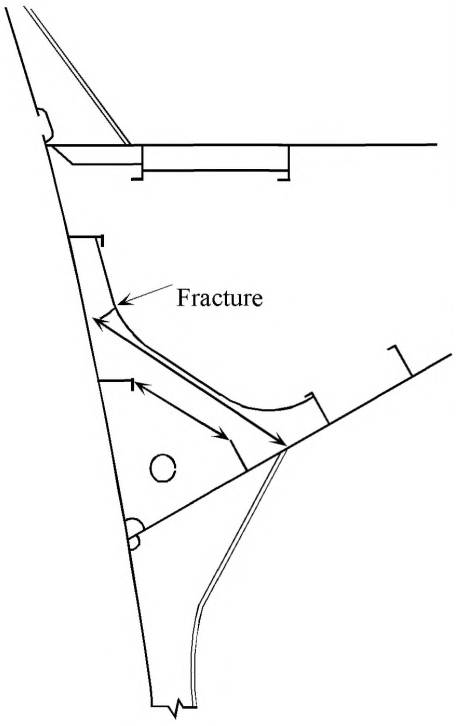
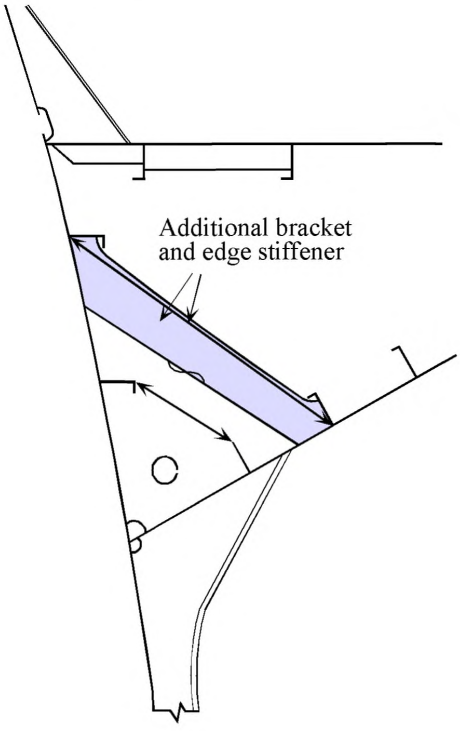
BULK CARRIERS	Guidelines for Surveys, Assessment and Repair of Hull Structure	
Part 1	Cargo hold region	Example No.
Area 2	Topside tank structure	7-b
Detail of damage	Fractures in transverse bracket

1. Insufficient strength.
2. Corrosion.

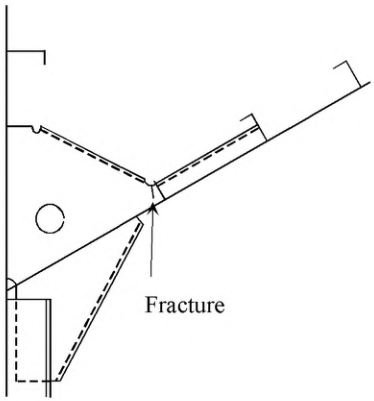
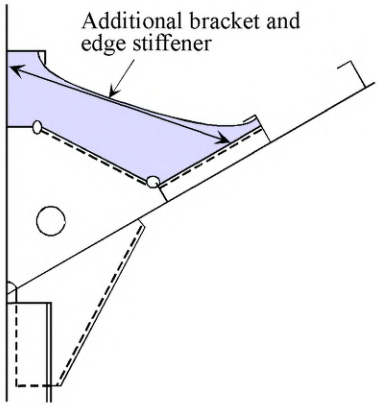
BULK CARRIERS	Guidelines for Surveys, Assessment and Repair of Hull Structure	
Part 1	Cargo hold region	Example No.
Area 2	Topside tank structure	7-c
Detail of damage	Fractures at toes of transverse bracket

1. Stress concentration due to the shape of the bracket.

1. Cracked weld to be veed-out and rewelded.

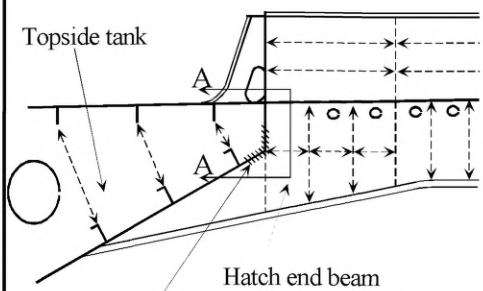
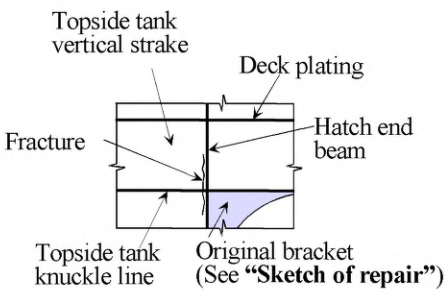
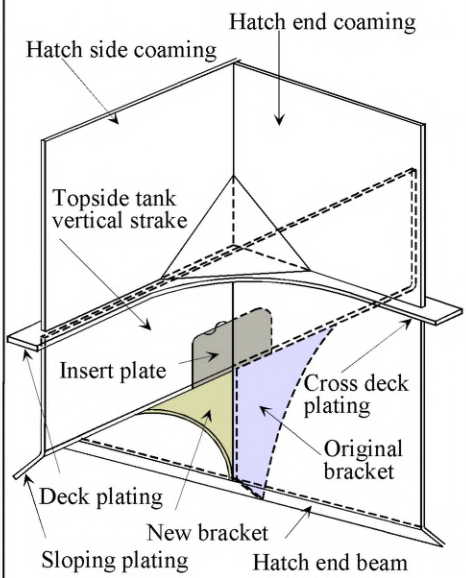
BULK CARRIERS	Guidelines for Surveys, Assessment and Repair of Hull Structure	
Part 1	**Cargo hold region**	**Example No.**
Area 2	**Topside tank structure**	**8**
Detail of damage	Fractures in sloping plating and vertical strake initiated from the connection of topside tank to hatch end beam

1. Stress concentration at the connection of hatch end beam to topside tank.

1. Fractured part to be cropped and renewed with increased thickness.
2. Additional bracket should be considered for reinforcement.

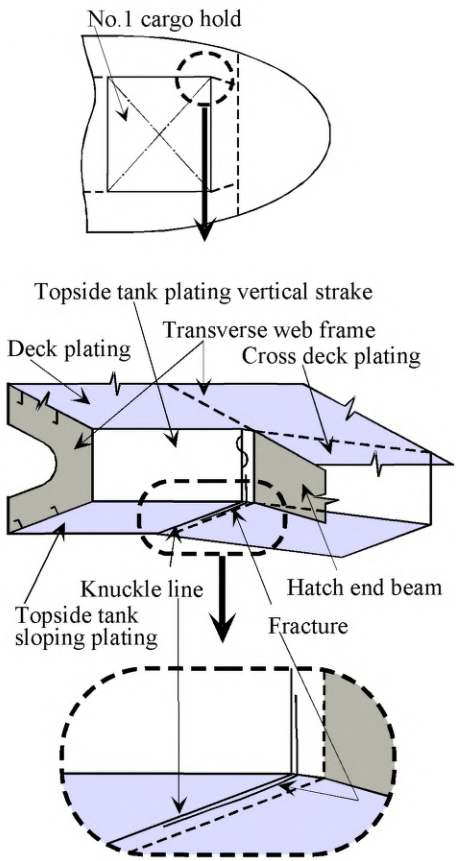
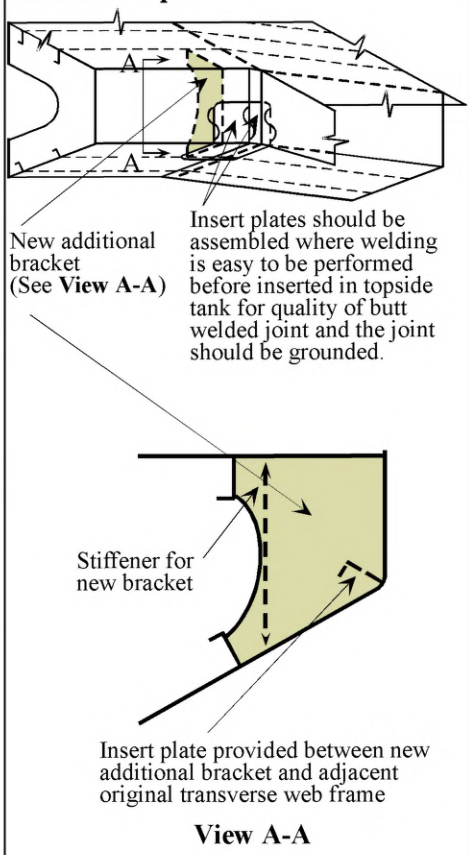
BULK CARRIERS	Guidelines for Surveys, Assessment and Repair of Hull Structure	
Part 1	Cargo hold region	Example No.
Area 2	Topside tank structure	9
Detail of damage	Fractures in sloping plating at knuckle

1. Insufficient strength.
2. Additional stress induced by knuckle.

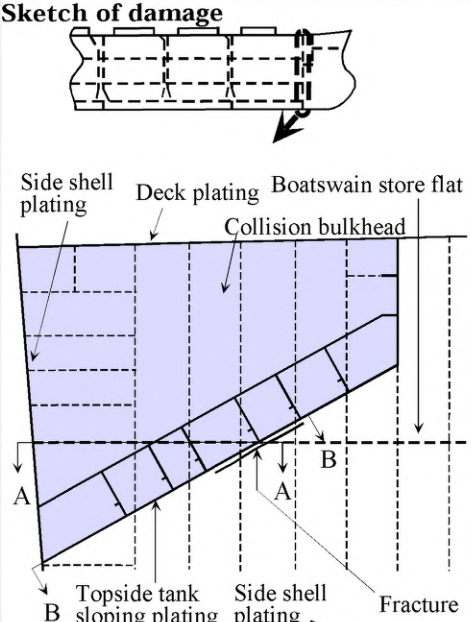
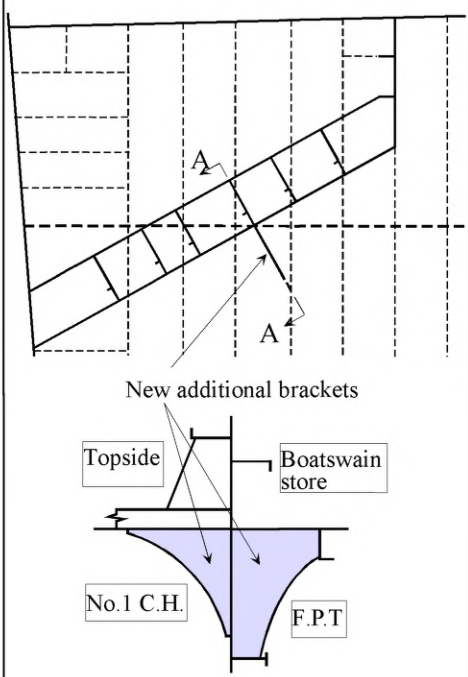
BULK CARRIERS	Guidelines for Surveys, Assessment and Repair of Hull Structure	
Part 1	**Cargo hold region**	**Example No.**
Area 2	**Topside tank structure**	**10**
Detail of damage	Fractures in way of collision bulkhead at intersection with topside tank structure in foremost cargo hold

1. Damage caused by hard spot at intersection of the topside tank sloping plating and boatswain's store deck plating (fore peak tank top plating).

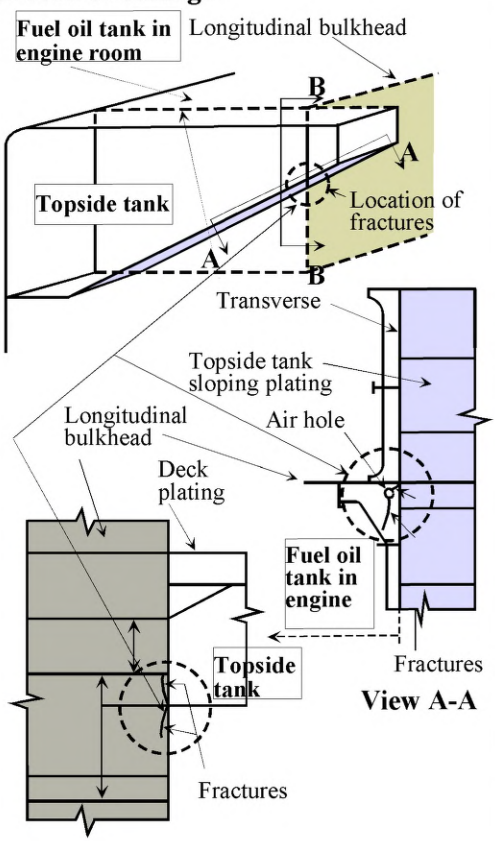
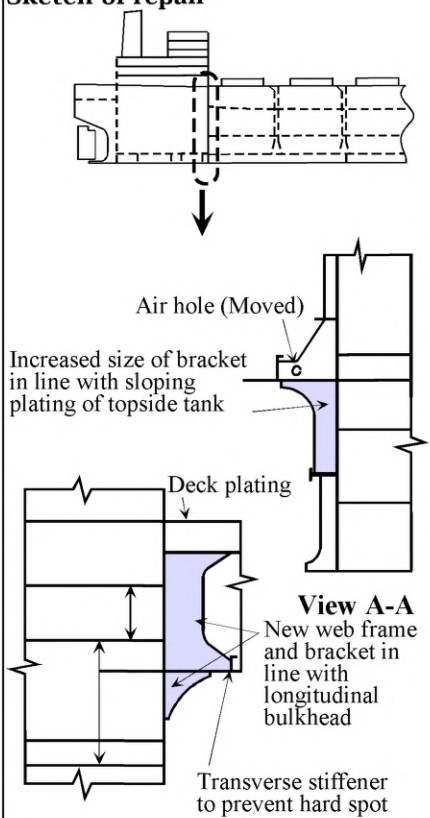
1. Damage caused by hard spot at intersection of the topside tank sloping plating and longitudinal bulkhead of the fuel oil tank in engine room.

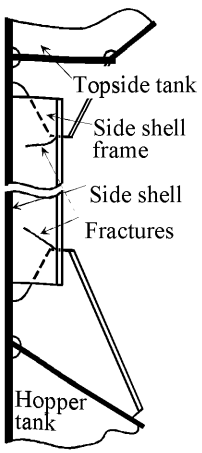
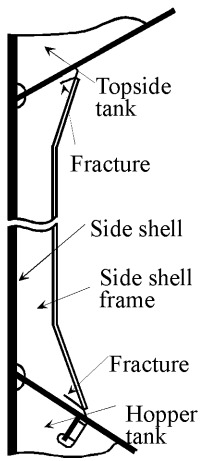
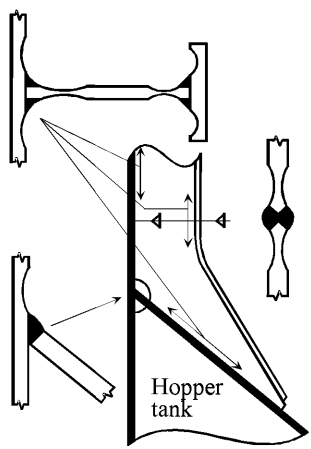
Figure 2 Damages to side shell frame - Potential problem areas

(Note) The type of bracket configuration used will, to a large extent, dictate the location and extent of fracture. Where separate brackets are employed, the fracture location is normally at the bracket toe position on the frames, whereas with integral brackets the location is at the toe position on the hopper and topside tank.

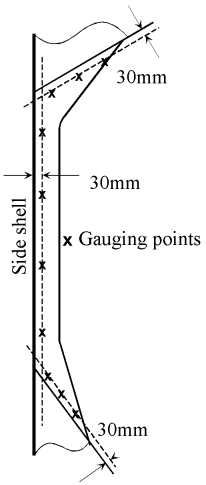
Figure 3
Representative gauging locations on the side shell frame - Potential problem areas

2.1.2 It is not unusual to find highly localised corrosion on uncoated side shell frames and their end connections. The loss in the thickness is normally greater close to the side shell plating rather than near the faceplate, and consequently representative thickness measurements should be in that area (See **Figure 3**). This situation, if not remedied, can result in loss of support to the shell plating and hence large inboard deflections. In many cases such deflections of the side shell plating can generate fractures in the shell plating and fracturing and buckling of the frame web plates and eventually result in detachment of the end brackets from the hopper tank.

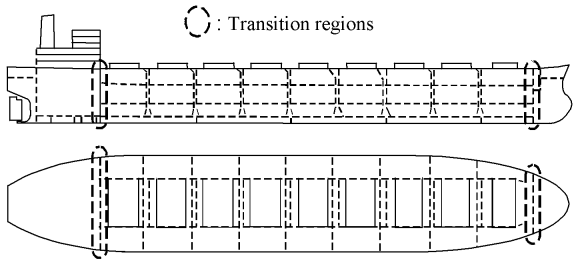
Figure 4 Transition regions - Potential problem area

1.5 The structure at the transition regions at the fore and aft ends of the ship are subject to stress concentrations due to structural discontinuities. The side shell plating at the transition regions is also subject to panting. The lack of continuity of the longitudinal structure, and the increased slenderness and flexibility of the side structure, makes the structure at the transition regions more prone to fracture damages.

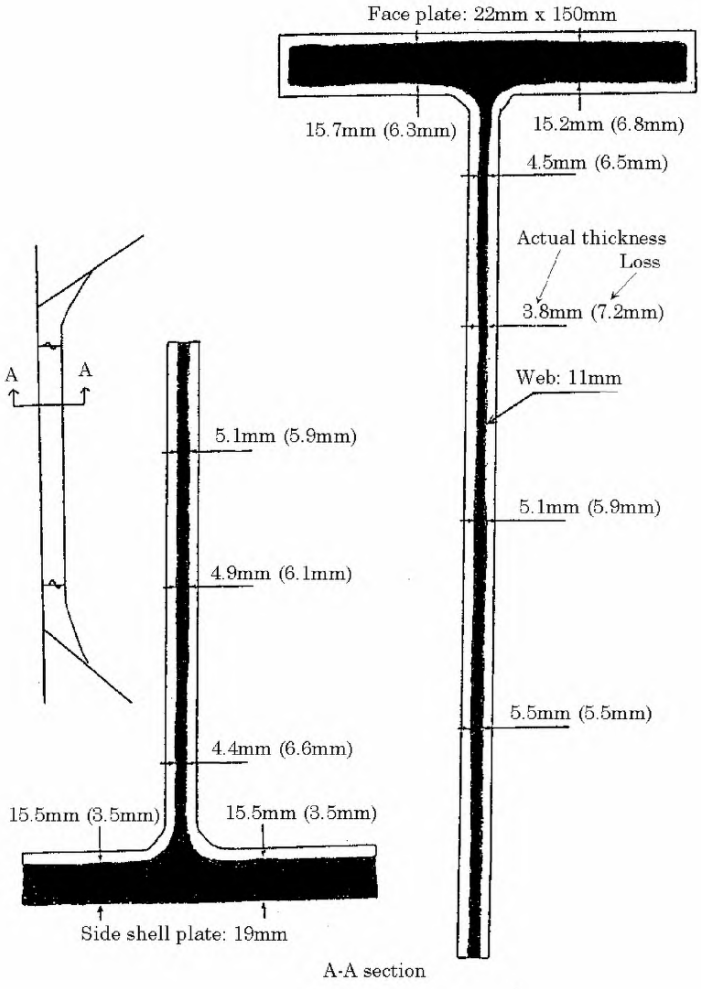
Figure 5 Uniform corrosion of side shell frame

2.1.1 Attention is drawn to the fact that side shell frames may be significantly weakened by loss of thickness although diminution and deformations may not be apparent. Inspection should be made after the removal of any scale or rust deposit. Thickness measurements may be necessary, particularly if the corrosion is smooth and uniform, to determine the condition of the structure (See **Figure 5**).

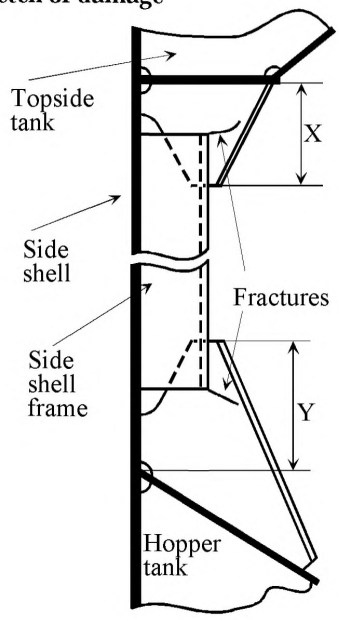
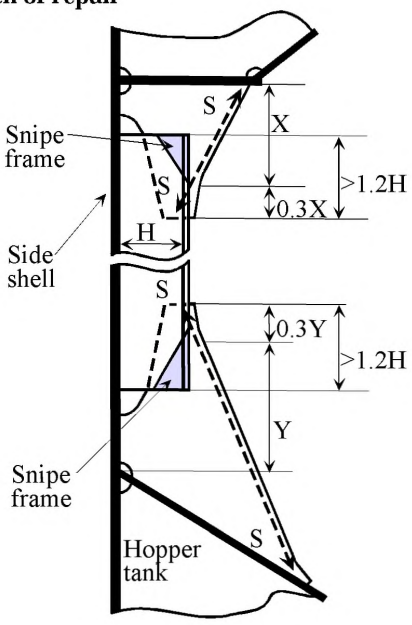
BULK CARRIERS	Guidelines for Surveys, Assessment and Repair of Hull Structure	
Part 1	Cargo hold region	Example No.
Area 3	Cargo hold side structure	1-a
Detail of damage	Fractures in brackets at termination of frame

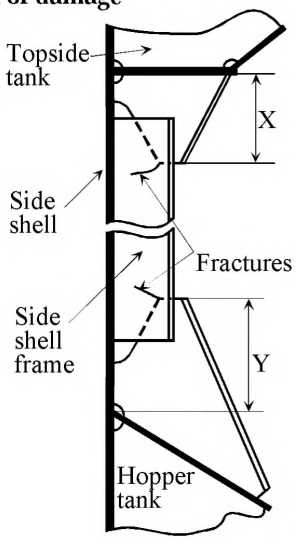
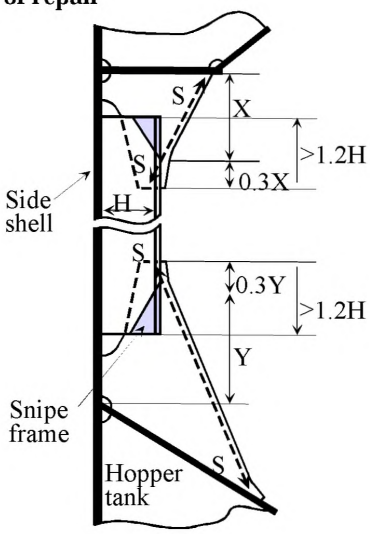
BULK CARRIERS	Guidelines for Surveys, Assessment and Repair of Hull Structure	
Part 1	Cargo hold region	Example No.
Area 3	Cargo hold side structure	1-b
Detail of damage	Fractures in side shell frame at bracket's toe
