No.76 IACS Guidelines for Surveys, Assessment and Repair of Hull Structure – Bulk Carriers

BULK CARRIERS

Guidelines for Surveys, Assessment and Repair of Hull Structure

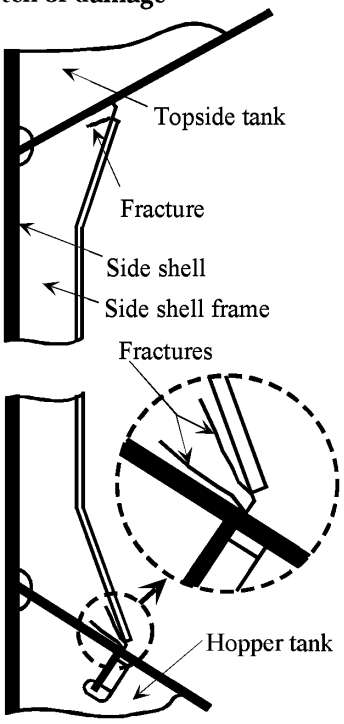
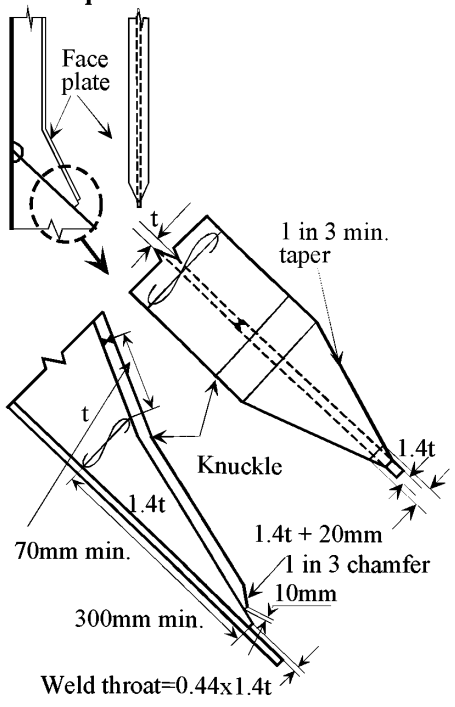
BULK CARRIERS	Guidelines for Surveys, Assessment and Repair of Hull Structure	
Part 1	Cargo hold region	Example No.
Area 3	Cargo hold side structure	2
Detail of damage	Fractures in side shell frame at bracket's toe

1. This type of damage is caused due to stress concentration.

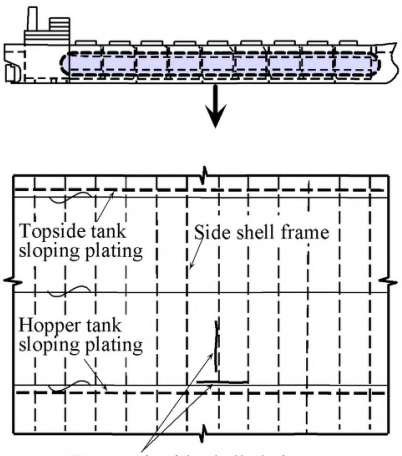
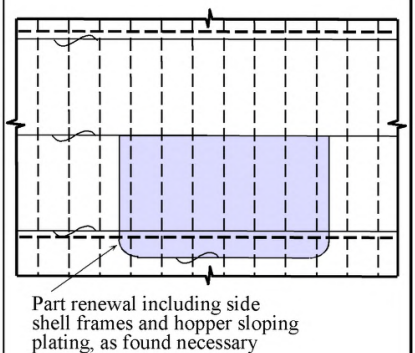
BULK CARRIERS	Guidelines for Surveys, Assessment and Repair of Hull Structure	
Part 1	Cargo hold region	Example No.
Area 3	Cargo hold side structure	3
Detail of damage	Fractures in side shell frame/lower bracket and side shell plating near hopper

1. Heavy corrosion (grooving). Refer to **Figure 2 (c)**.

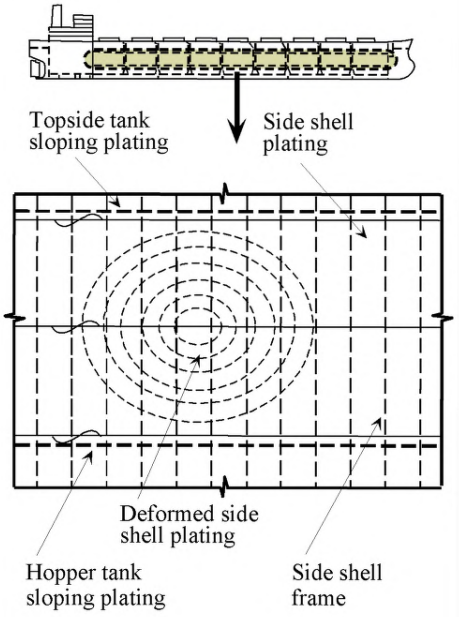
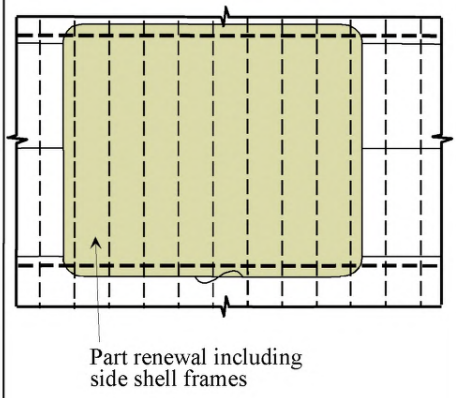
BULK CARRIERS	Guidelines for Surveys, Assessment and Repair of Hull Structure	
Part 1	Cargo hold region	Example No.
Area 3	Cargo hold side structure	4
Detail of damage	Deformation of side shell plating

1. Insufficient stiffness of side shell frames due to buckling and/or detachment of side shell frames due to corrosion.
2. Heavy weather.

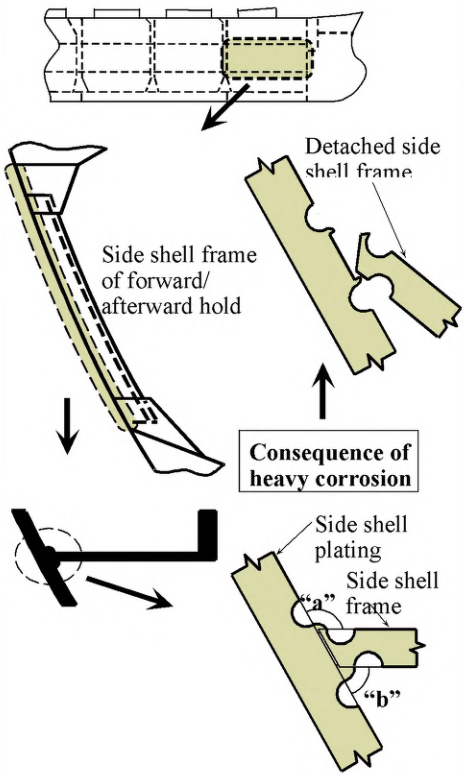
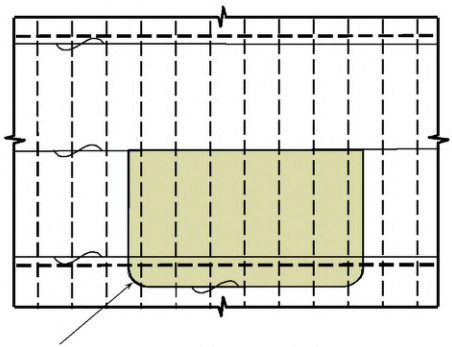
BULK CARRIERS	Guidelines for Surveys, Assessment and Repair of Hull Structure	
Part 1	Cargo hold region	Example No.
Area 3	Cargo hold side structure	5
Detail of damage	Adverse effect of corrosion on the frame of forward/afterward hold

1. Part renewal including side shell frames and hopper plating, as found necessary
2. Deep penetration welding at the connections of side shell frames to side shell plating

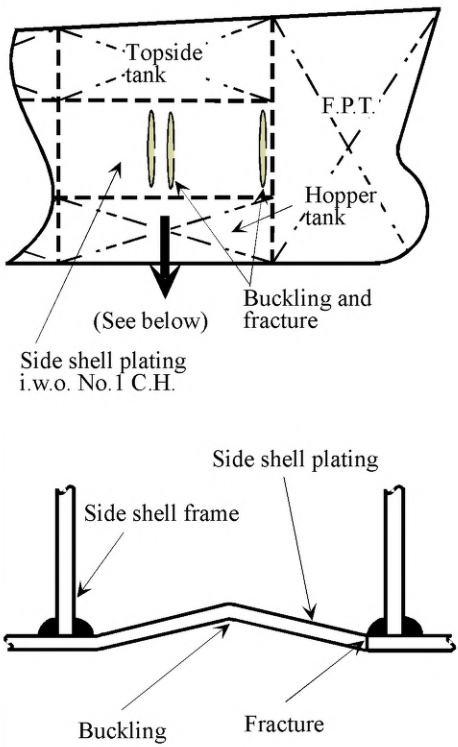
BULK CARRIERS	Guidelines for Surveys, Assessment and Repair of Hull Structure	
Part 1	Cargo hold region	Example No.
Area 3	Cargo hold side structure	6
Detail of damage	Buckling and fractures of side shell plating in foremost cargo hold

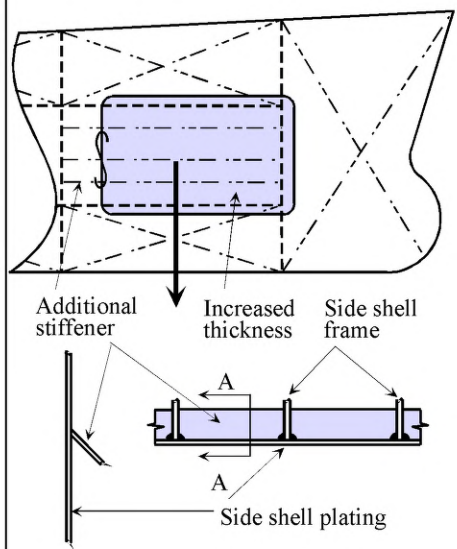
Sketch of repair

Notes on possible cause of damage

1. Heavy weather.
2. Insufficient buckling strength due to high tensile steel or heavy uniform corrosion.
3. Inadequate transition structure.

Notes on repairs

1. Buckled/fractured side shell plating is to be cropped and renewed.
2. Reinforcement by thicker side shell plating and/or additional stiffeners should be considered.

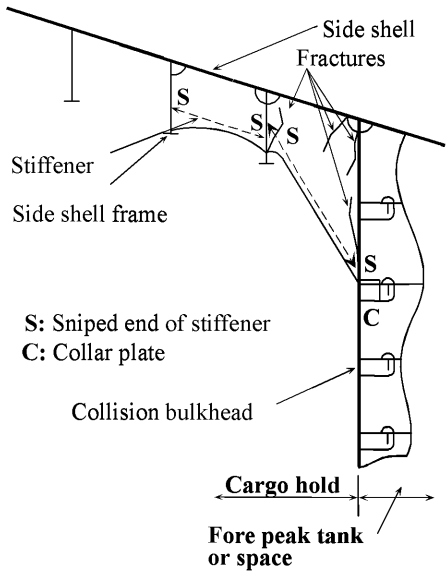
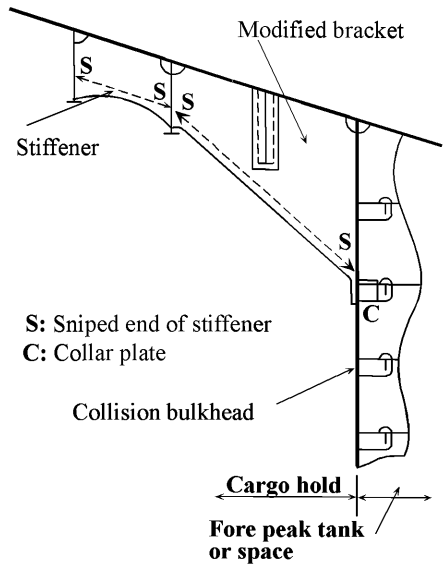
BULK CARRIERS	Guidelines for Surveys, Assessment and Repair of Hull Structure	
Part 1	Cargo hold region	Example No.
Area 3	Cargo hold side structure	7
Detail of damage	Fractures at the supporting brackets in way of the collision bulkhead

Notes on possible cause of damage

1. Insufficient bracket size resulting in high stress due to load cantilevered from side frame.
2. Stress concentration at toe of bracket and misalignment between bracket and stringer in fore peak tank or space.

Notes on repairs

1. The extended bracket arm connection to the collision bulkhead is to have a soft toe, and any cut-outs for stiffeners in the fore peak tank or space are to be collared when situated in the vicinity of the bracket toe.
2. When fractures have extended into the side shell or bulkhead plating, the plating is to be cropped and part renewed.

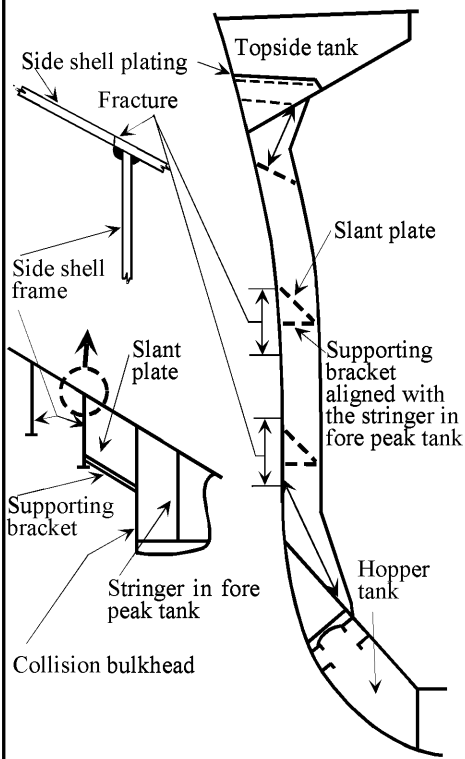
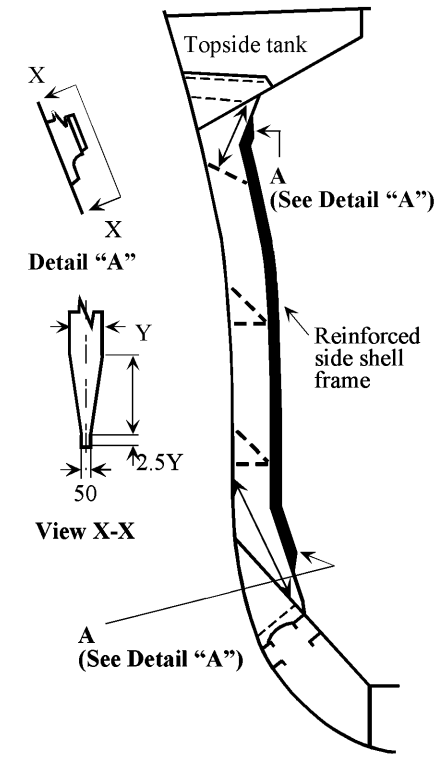
1. Damage caused by stress concentration leading to fatigue fracture in side shell. This has been exacerbated because of the greater flexibility of the hold structure in relation to the structure forward of the collision bulkhead.

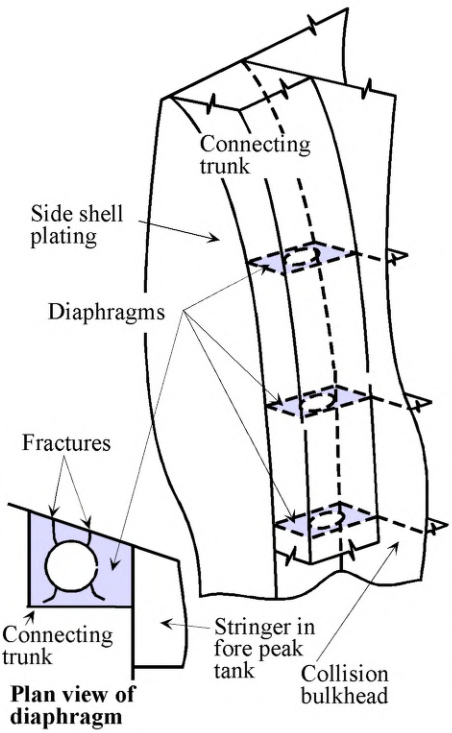
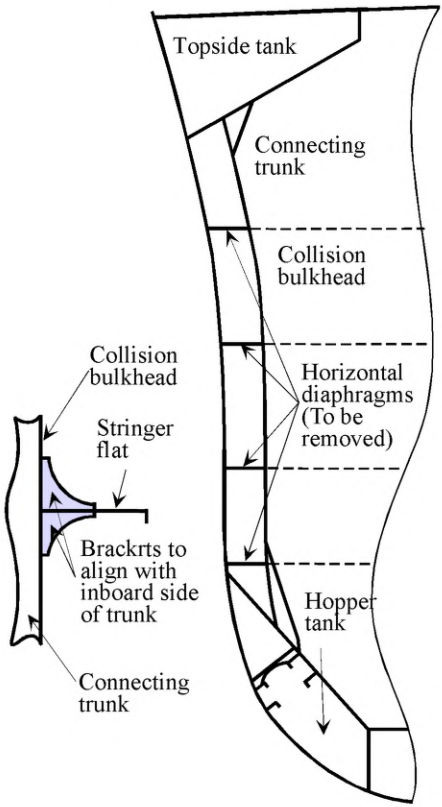
1. Damage caused by stress concentration resulting from the discontinuity created by the trunk and diaphragm structure. This has been exacerbated because of the greater flexibility of the hold structure in relation to the trunk and structure forward of the collision bulkhead.

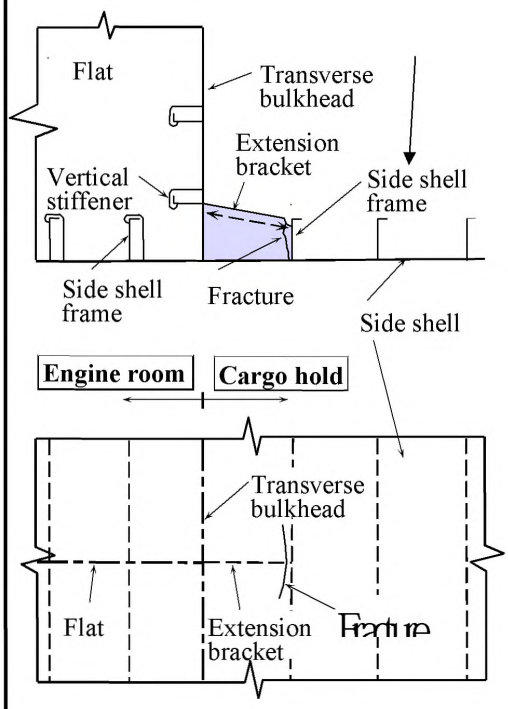
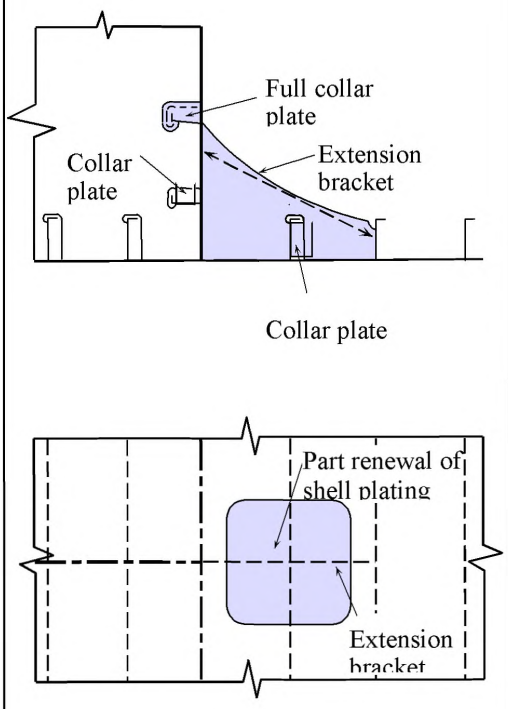
1. Damage caused by stress concentration leading to fatigue fracture on side shell. This will be exacerbated because of the greater flexibility of the hold structure in relation to the engine room structure.

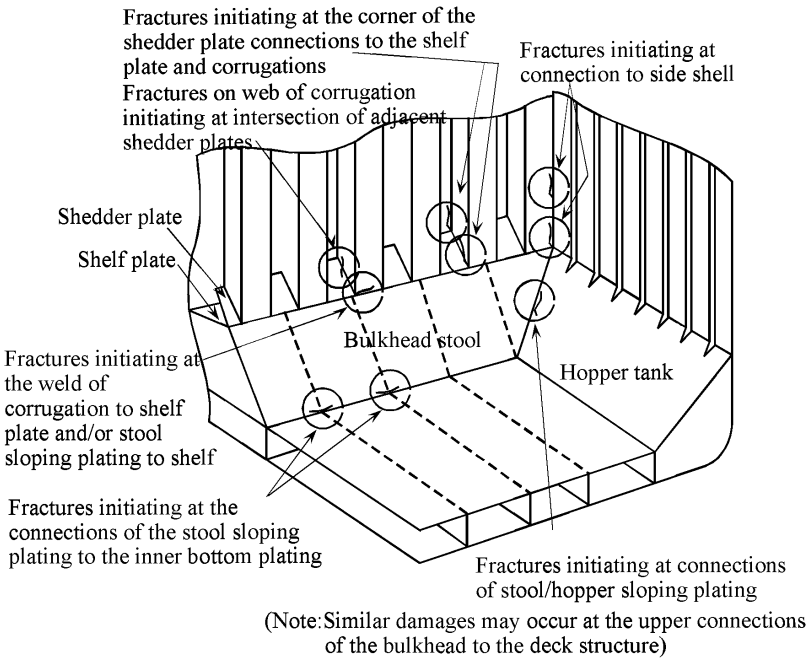
Figure 2 Typical fracturing at the connection of transverse bulkhead structure

2.3.1 Fractures usually occur at the boundaries of corrugations and bulkhead stools particularly in way of shelf plates, shedder plates, deck, inner bottom, etc. (See **Figure 2**).

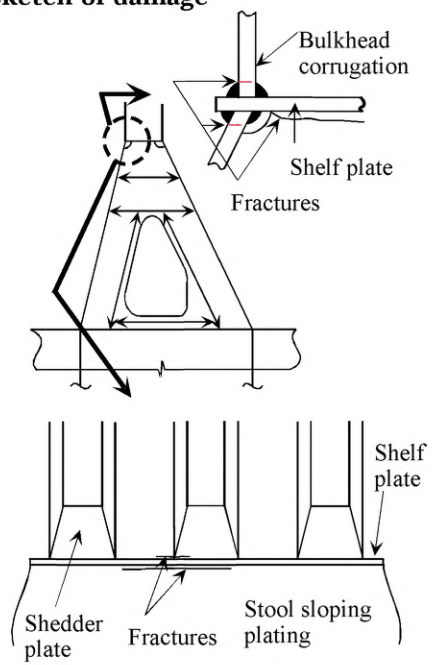
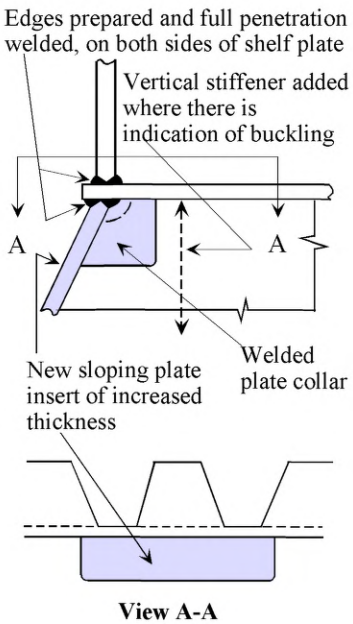
BULK CARRIERS	Guidelines for Surveys, Assessment and Repair of Hull Structure	
Part 1	**Cargo hold region**	**Example No.**
Area 4	**Transverse bulkhead and associated structure in cargo hold**	**1-a**
Detail of damage	Fractures at weld connections to stool shelf plate

Notes on possible cause of damage

1. Stress concentrations at welds adjacent to the scallops.
2. Inadequate welding area connecting corrugation flange to shelf plate or similarly sloping stool plating to shelf plate.
3. Inadequate thickness of sloping plating in relation to corrugation flange thickness.
4. Stress concentration at knuckle of corrugation where web is not supported by bracket inside the stool.

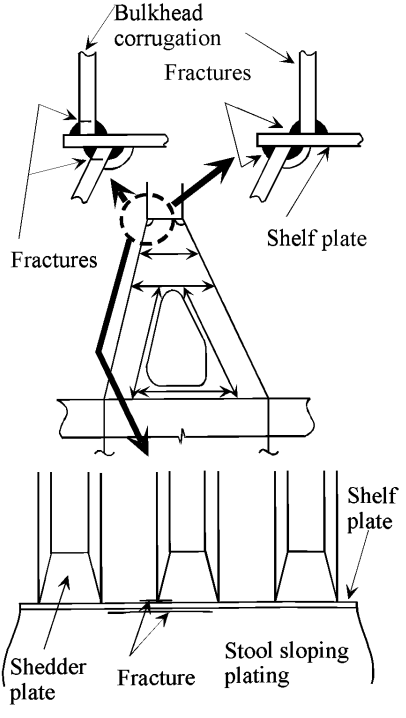
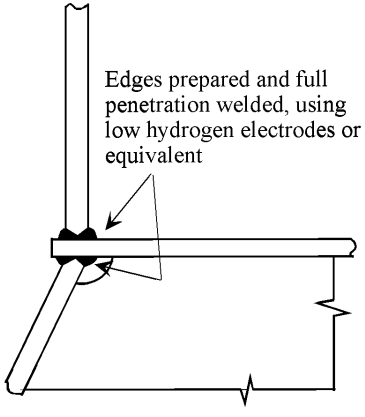
BULK CARRIERS	Guidelines for Surveys, Assessment and Repair of Hull Structure	
Part 1	Cargo hold region	Example No.
Area 4	Transverse bulkhead and associated structure in cargo hold	1-b
Detail of damage	Fractures at weld connections to stool shelf plate

Notes on possible cause of damage

1. Misalignment between corrugation flange and sloping stool plating.
2. Inadequate welding area connecting corrugation flange to shelf plate or similarly sloping stool plating to shelf plate.

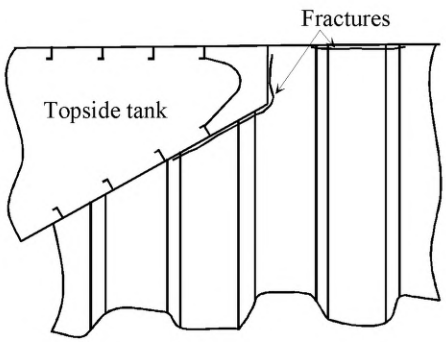
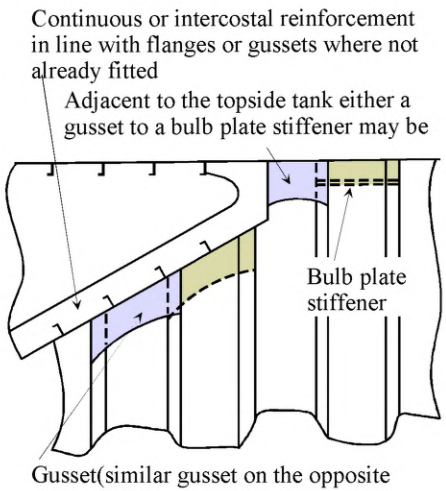
BULK CARRIERS	Guidelines for Surveys, Assessment and Repair of Hull Structure	
Part 1	Cargo hold region	Example No.
Area 4	Transverse bulkhead and associated structure in cargo hold	2
Detail of damage	Fractures at the upper boundaries to topside tanks

Notes on possible cause of damage

1. Damage due to poor design and/or defective welds.

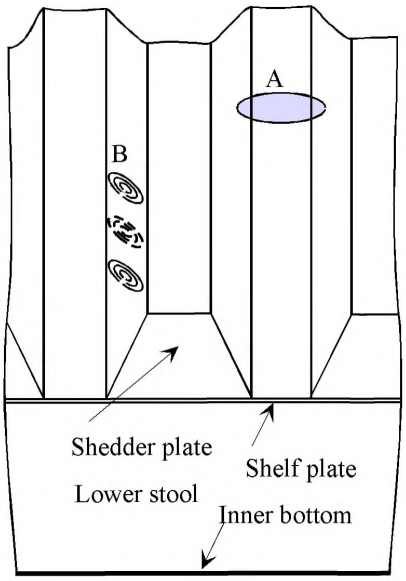
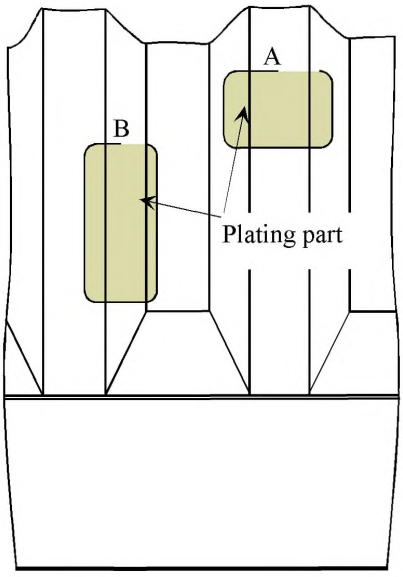
BULK CARRIERS	Guidelines for Surveys, Assessment and Repair of Hull Structure	
Part 1	Cargo hold region	Example No.
Area 4	Transverse bulkhead and associated structure in cargo hold	3
Detail of damage	Indentation and buckling of vertical corrugation

Notes on possible cause of damage

1. Damages by mechanical abuse during cargo handling e.g. grab damage.
2. Damage resulting from thickness reduction by corrosion.
3. Buckling caused by bending or shear, see locations A and B respectively above, with a minimum reduction in thickness could be caused by underdesign or overloading. If this cause is suspected, the Classification Society concerned shall be contacted before proceeding with repairs.

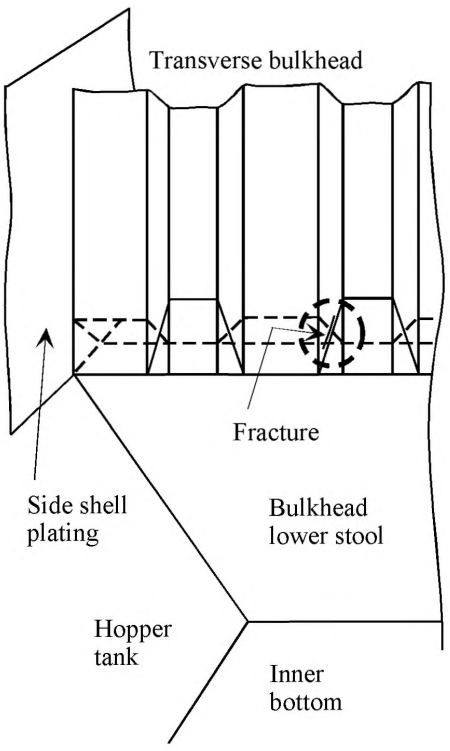
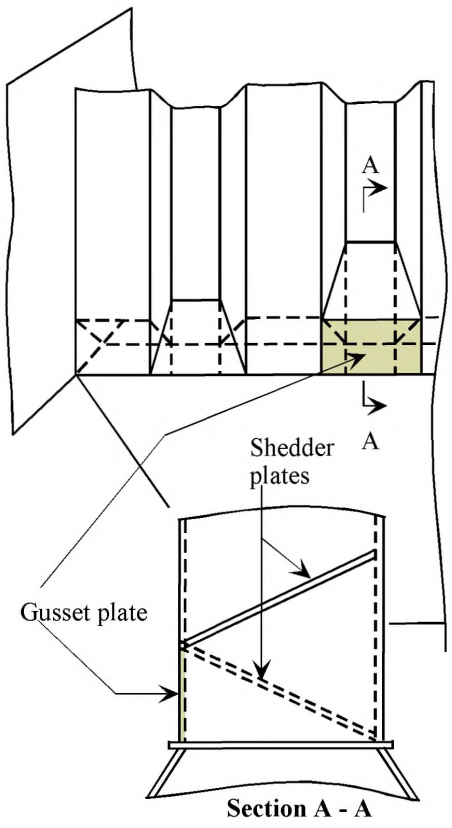
1. Damage due to stress concentrations at intersection of shedder plates. This can be exacerbated by corrosion and reduction in thickness of the corrugation web plating.

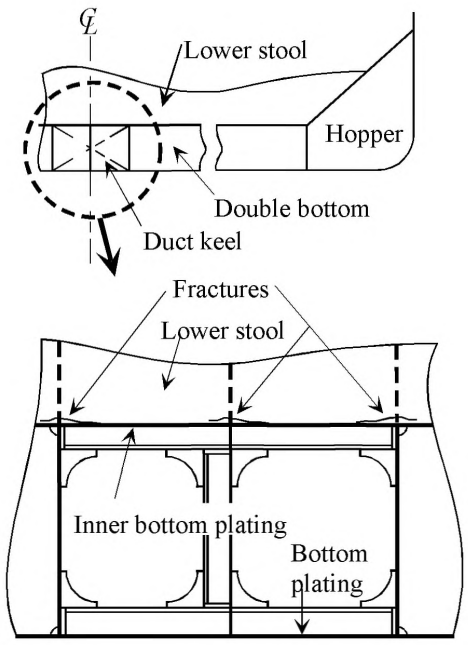
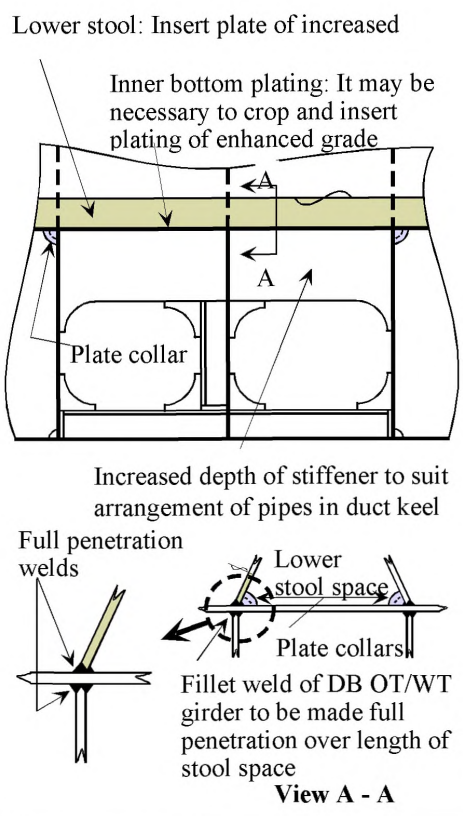
1. This type of failure is more likely to occur at the boundaries of the ballast hold.
2. The fractures arise because of stress concentration in way of cut-outs and exacerbated by the flexibility of the inner bottom structure in way of the duct keel.

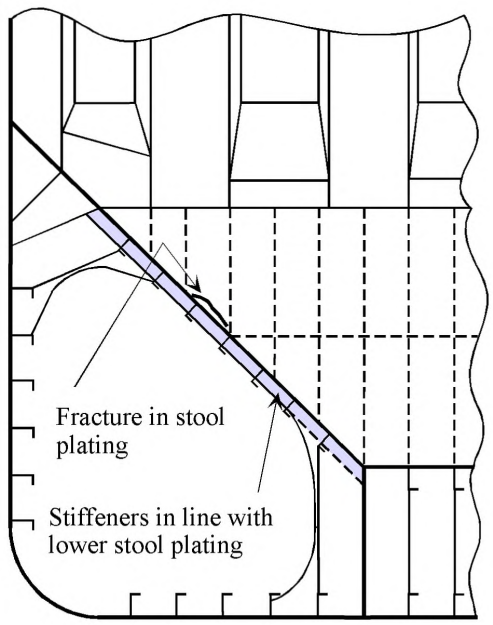
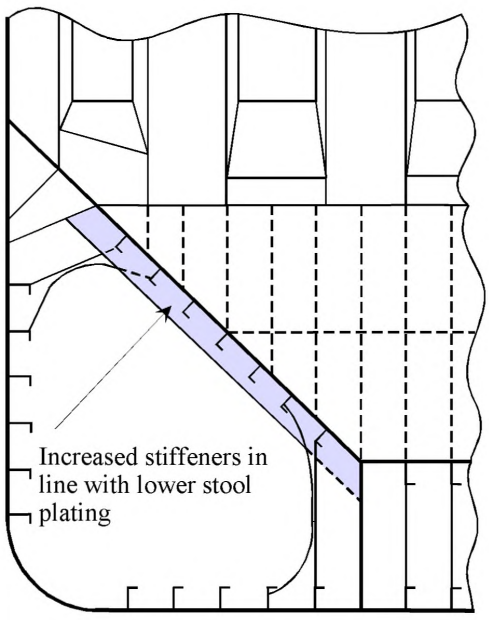
1. Insufficient strength of the connection
2. Corrosion

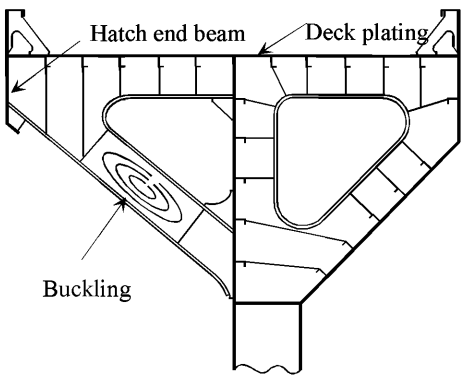
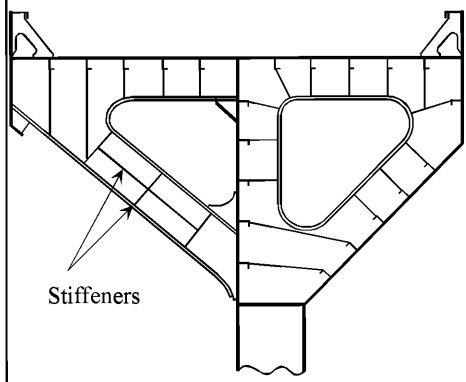
BULK CARRIERS	Guidelines for Surveys, Assessment and Repair of Hull Structure	
Part 1	**Cargo hold region**	**Example No.**
Area 4	**Transverse bulkhead and associated structure in cargo hold**	**7**
Detail of damage	Buckling of strut supporting hatch end beam

Notes on possible cause of damage

1. Insufficient strength
2. Partial ballast loading in ballast cargo hold (sloshing)
3. Corrosion

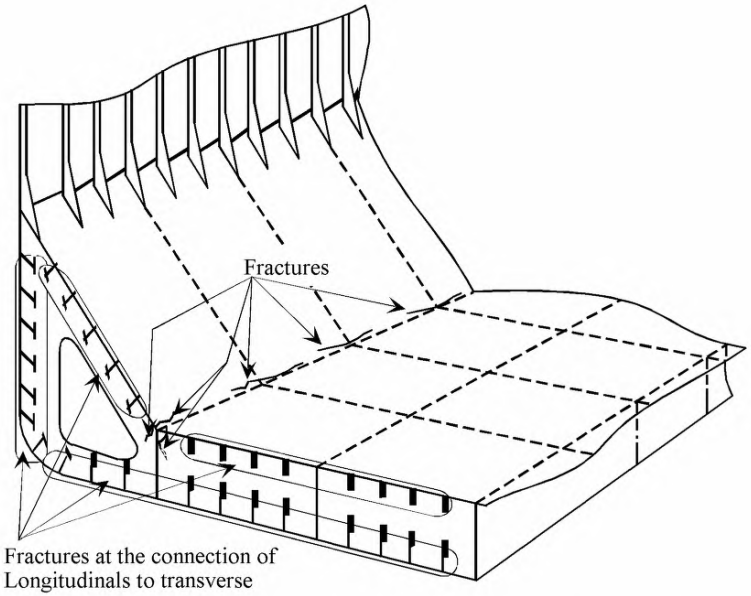
Figure 1 Typical fractures in the connection of hopper sloping plating to inner bottom (tank top) and longitudinals to transverse (or transverse bulkhead)

extend through the thickness of the plating or through the welds may be observed during pressure testing of the double bottom tanks (See **Figure 1** and **2** of **Area 4**).

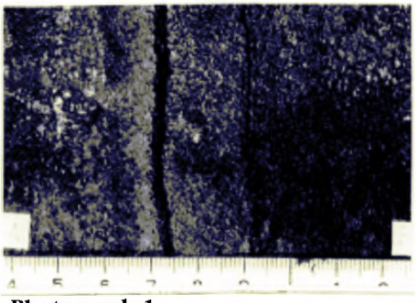
4.1.2 Severe grooving along welding of bottom plating is often found (See **Photographs 1** and **2**). This grooving can be accelerated by poor maintenance of the protective coating and/or sacrificial anodes fitted to the bottom plating.

Photograph 1
Grooving corrosion of welding of bottom plating

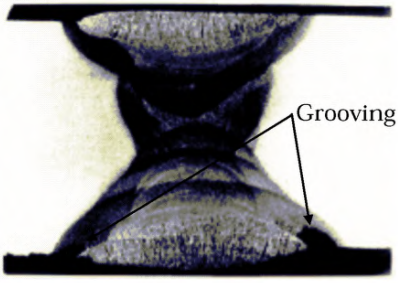
Photograph 2
Section of the grooving shown in Photograph 1

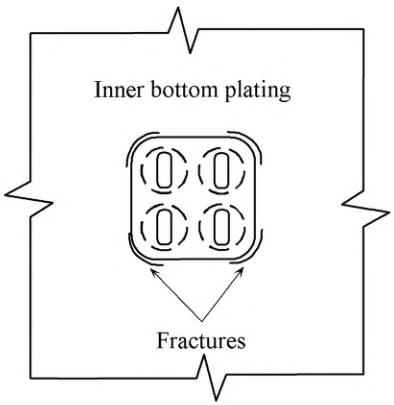
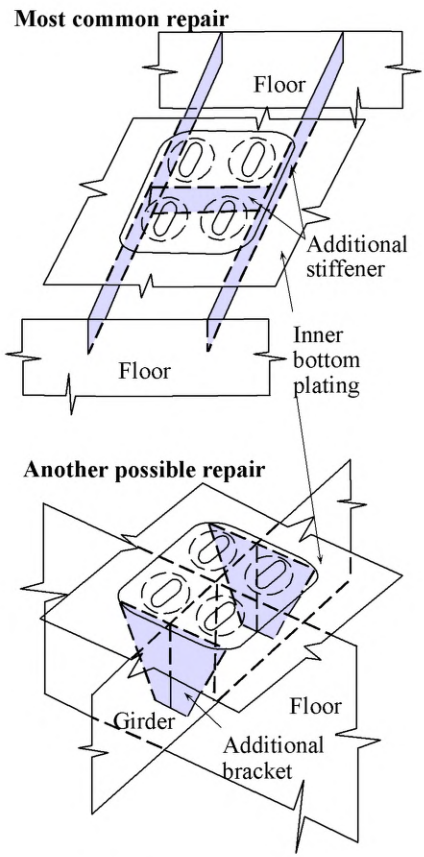
BULK CARRIERS	Guidelines for Surveys, Assessment and Repair of Hull Structure	
Part 1	Cargo hold region	Example No.
Area 5	Double bottom structure including hopper	1
Detail of damage	Fractures in inner bottom plating around container bottom pocket

Notes on possible cause of damage

1. Pocket is not supported correctly by floor, longitudinal and/or stiffener.

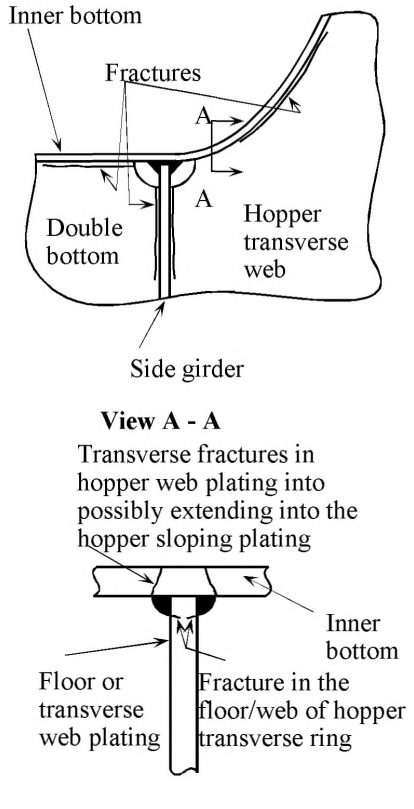
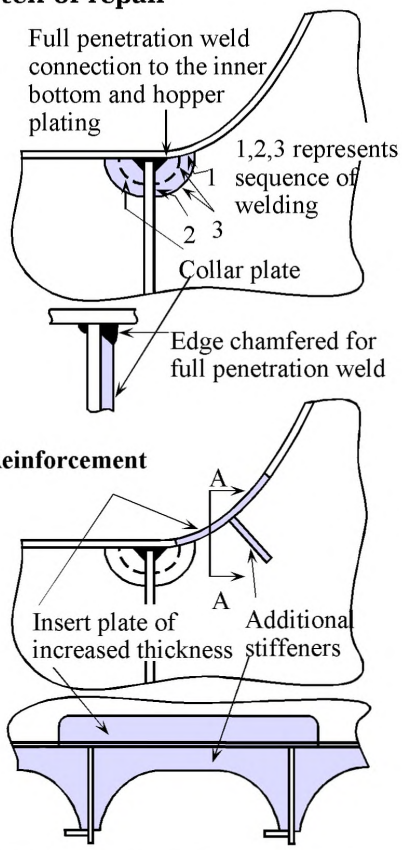
1. The damage is partly due to stress concentrations at the edges of the weld created by the presence of cut-outs and local stress variations caused by the deflections in the inner bottom/hopper plating.

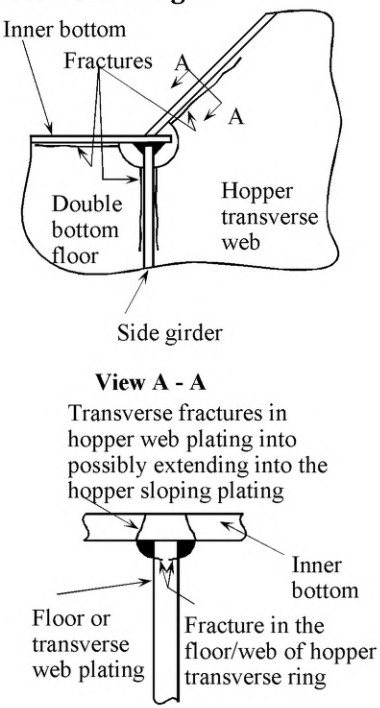
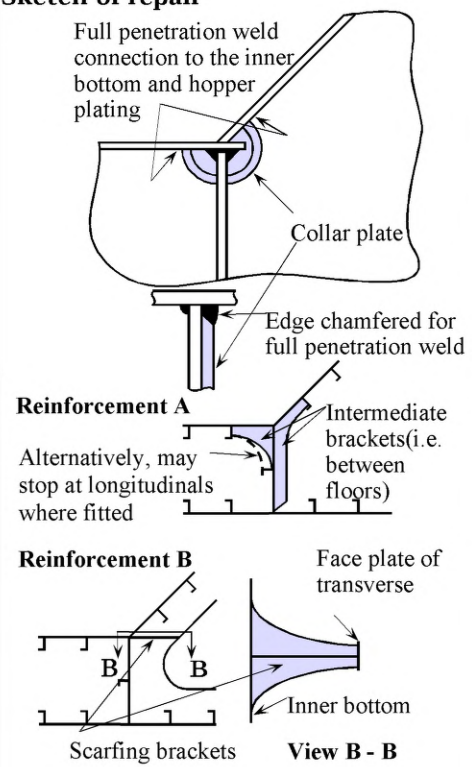
1. The damage is partly due to stress concentration at the edges of the weld .created by the presence of the deflections in the inner bottom/hopper plating.

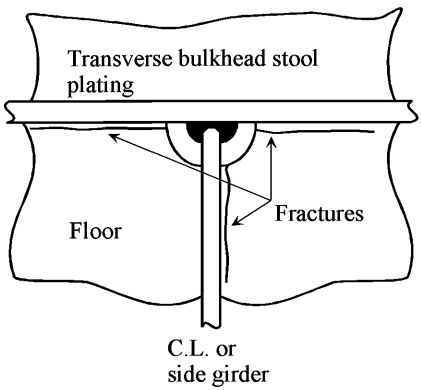
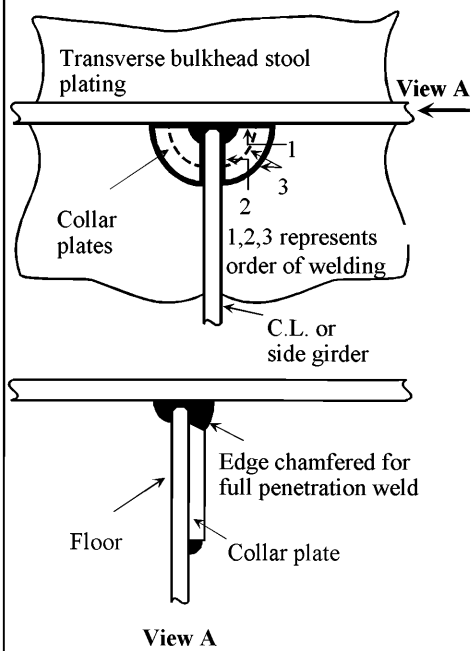
Notes on possible cause of damage

1. Stress concentration at the welds due to scallops.

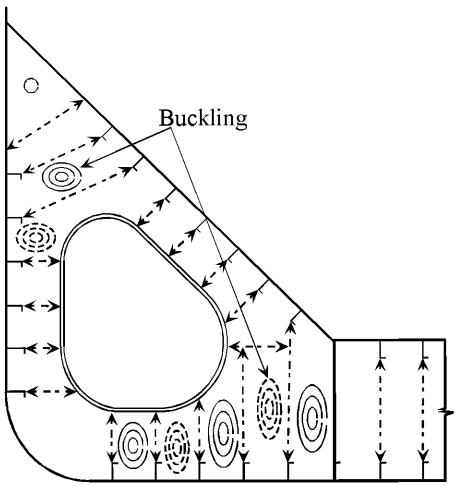
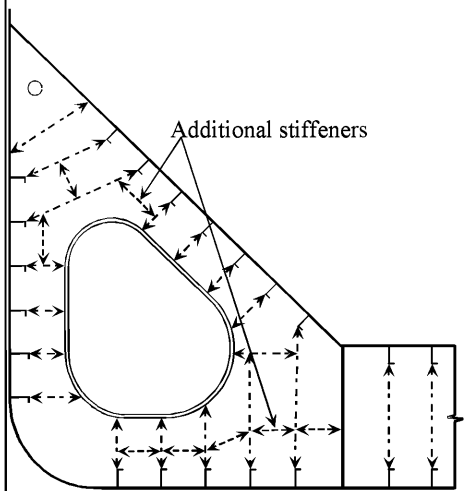
BULK CARRIERS	Guidelines for Surveys, Assessment and Repair of Hull Structure	
Part 1	Cargo hold region	Example No.
Area 5	Double bottom tank structure including hopper	10
Detail of damage	Buckling of transverse web

Notes on possible cause of damage

1. Insufficient buckling strength of transverse web plating.
2. Corrosion of high stress area.

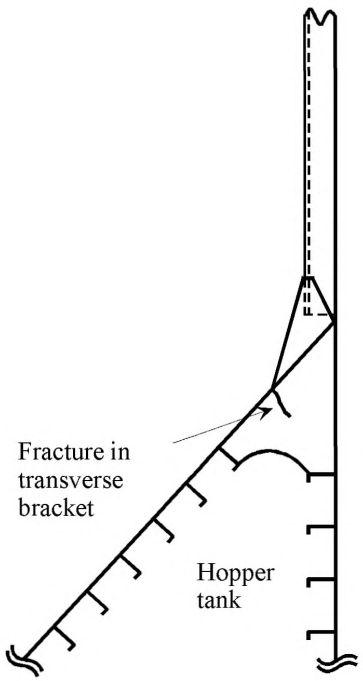
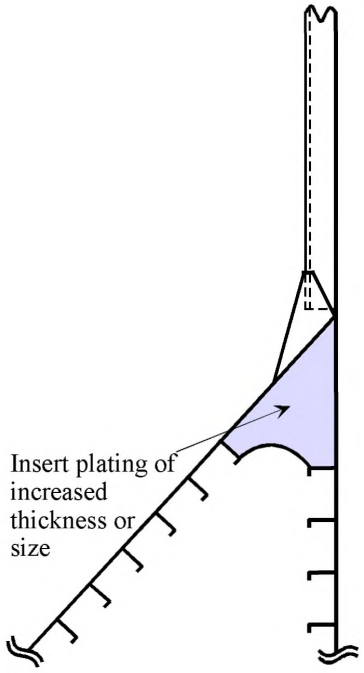
BULK CARRIERS	Guidelines for Surveys, Assessment and Repair of Hull Structure	
Part 1	Cargo hold region	Example No.
Area 5	Double bottom tank structure including hopper	11
Detail of damage	Fractures at weld connection of transverse brackets

Notes on possible cause of damage

1. General levels of corrosion and presence of stress concentration.
2. Misalignment of the brackets with adjoining structure e.g. frame brackets.
3. High shear stresses due to insufficient bracket.
4. Inadvertent overloading.

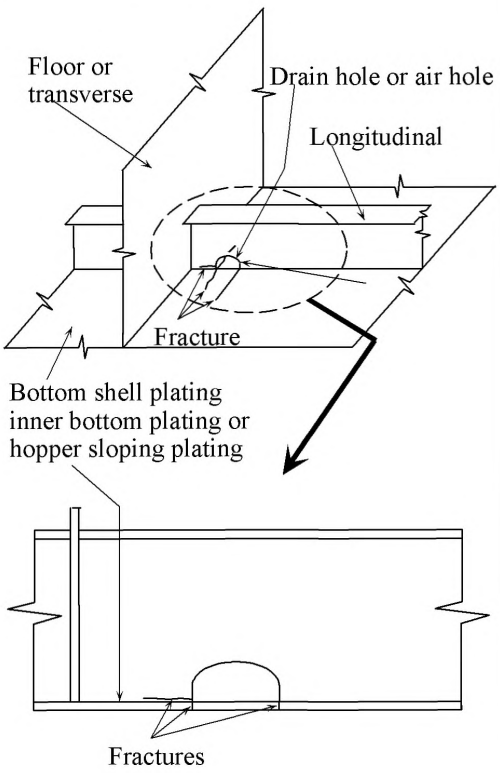
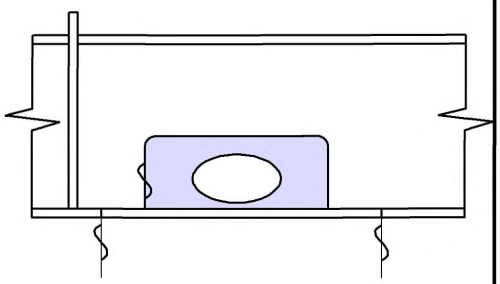
BULK CARRIERS	Guidelines for Surveys, Assessment and Repair of Hull Structure	
Part 1	Cargo hold region	Example No.
Area 5	Double bottom tank structure including hopper	12
Detail of damage	Fractures in bottom shell/side shell/hopper sloping plating at the corner drain hole/air hole in longitudinal

Notes on possible cause of damage

1. Stress concentration and/or corrosion due to stress concentration at the corner of drain hole/air hole.

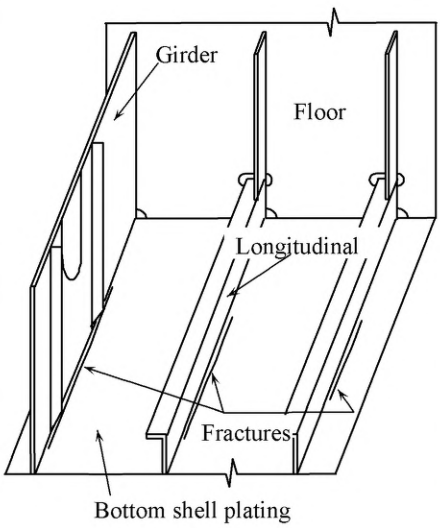
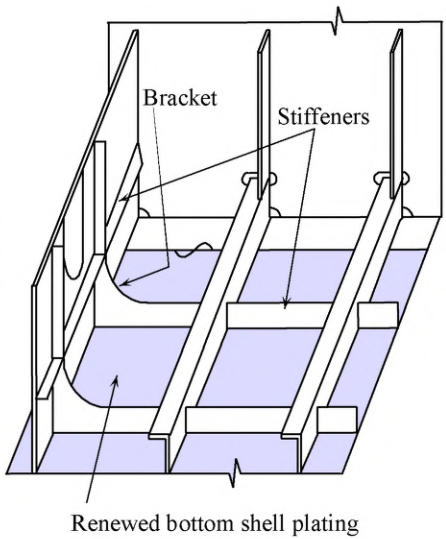
BULK CARRIERS	Guidelines for Surveys, Assessment and Repair of Hull Structure	
Part 1	**Cargo hold region**	**Example No.**
Area 5	**Double bottom tank structure including hopper**	**13**
Detail of damage	Fractures in bottom plating along side girder and/or bottom longitudinal

Notes on possible cause of damage

1. Vibration.

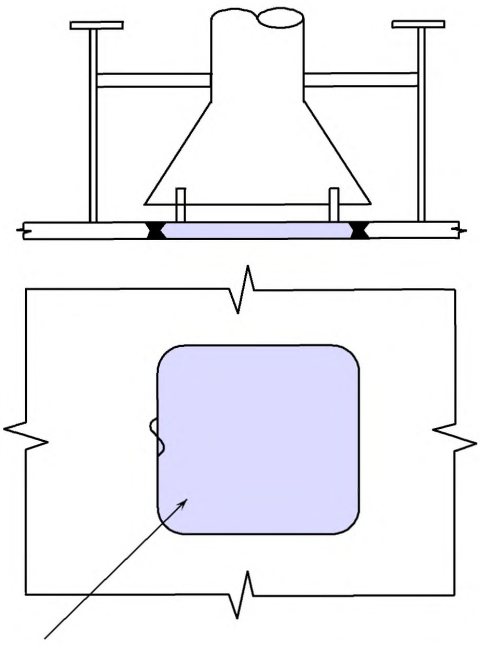
1. High flow rate associated with insufficient corrosion prevention system.
2. Galvanic action between dissimilar metals.

1. Insert to have round corners
2. Non-destructive examination to be applied after welding based on the Society's rules

1. Affected plating should be cropped and part renewed. Thicker plate and suitable beveling should be considered.
2. If the corrosion is limited to a small area,
   i. e. pitting corrosion, repair by welding is acceptable.

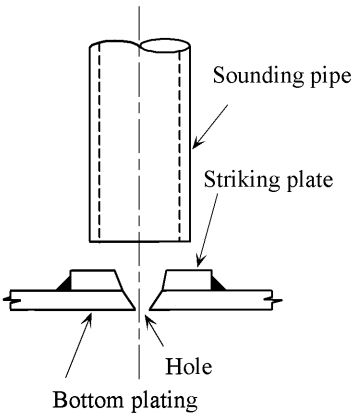
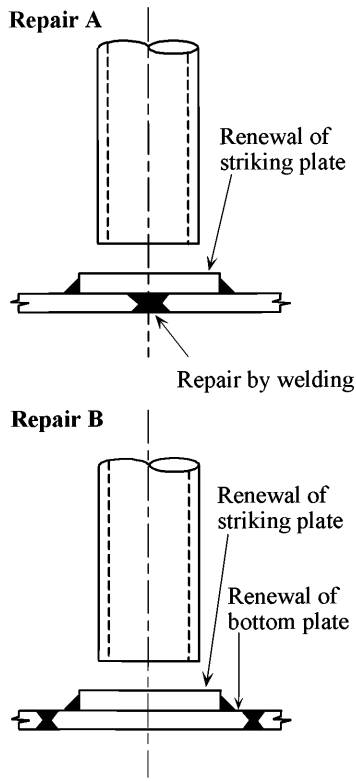
BULK CARRIERS	Guidelines for Surveys, Assessment and Repair of Hull Structure	
Part 1	**Cargo hold region**	**Example No.**
Area 5	**Double bottom tank structure including hopper**	**15**
Detail of damage	Corrosion in bottom plating below sounding pipe

1. Accelerated corrosion of striking plate by the striking of the weight of the sounding tape.

1. Corroded bottom plating should be welded or partly cropped and renewed if considered necessary.
2. Corroded striking plate should be renewed.

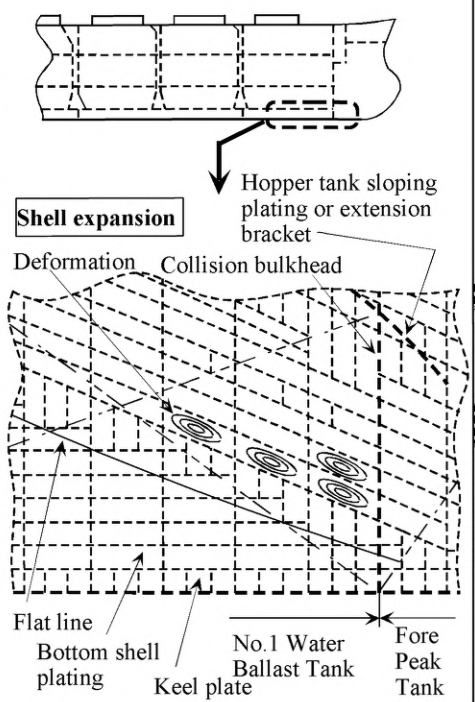
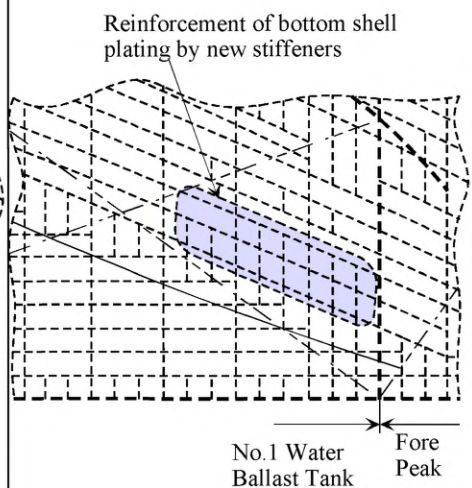
BULK CARRIERS	Guidelines for Surveys, Assessment and Repair of Hull Structure	
Part 1	**Cargo hold region**	**Example No.**
Area 5	**Double bottom structure including hopper**	**16**
Detail of damage	Deformation of forward bottom shell plate due to slamming

1. Heavy weather.
2. Poor design for slamming.
3. Poor operation, i.e. negligence of heavy ballast.

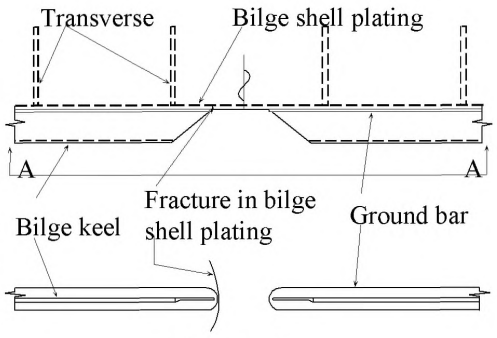
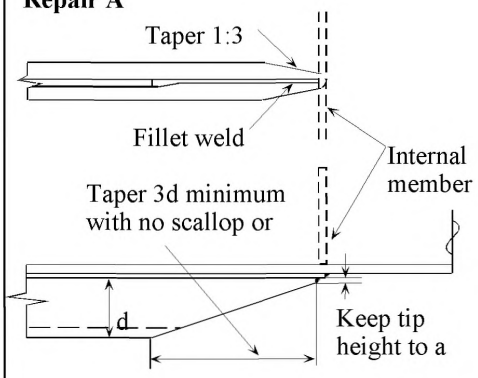
BULK CARRIERS	Guidelines for Surveys, Assessment and Repair of Hull Structure	
Part 1	Cargo hold region	Example No.
Area 5	Double bottom structure including hopper	17
Detail of damage	Fractures in shell plating at the termination of bilge keel

1. Fractured plating is to be cropped and renewed.
2. Reduction of stress concentration of the bilge keel end should be considered.
   Repair A: Modification of the detail of end
   Repair B: New internal stiffeners
   Repair C: Continuous ground bar (in connection with **Repair A**)
3. Instead of **Repair A** or **B** continuous ground bar and bilge keel should be considered.

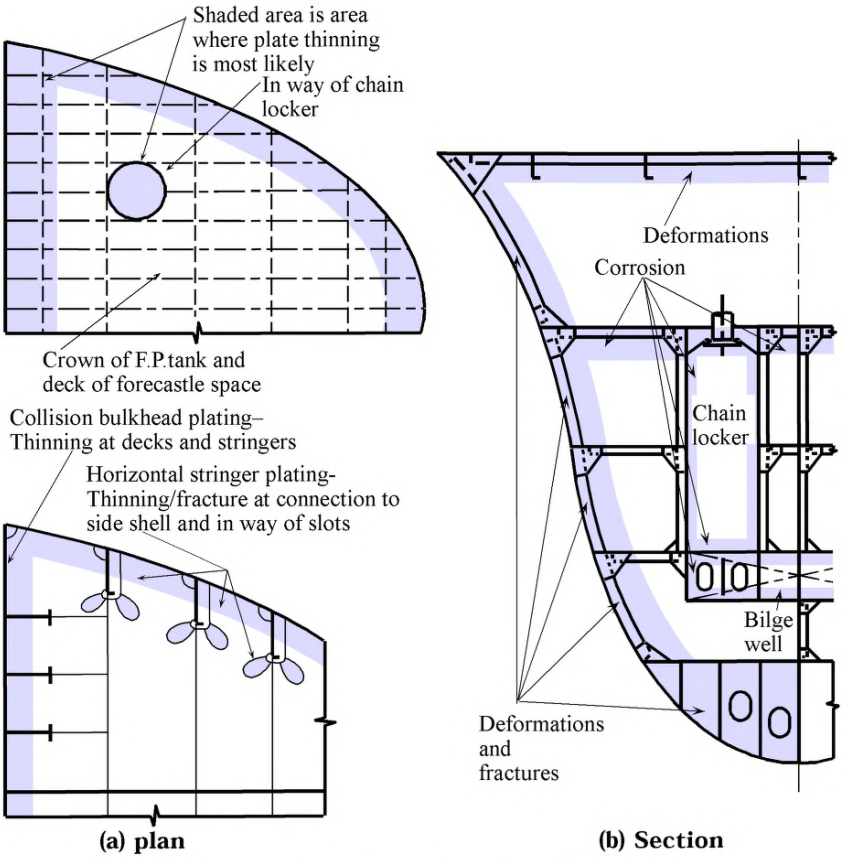
Fig 1 Fore end structure - Potential problem areas

2.1.1 Wastage (and possible subsequent fractures) is more likely to be initiated at the locations as indicated in **Figure 1** and particular attention should be given to these areas. A close-up inspection should be carried out with selection of representative thickness measurements to determine the extent of corrosion.

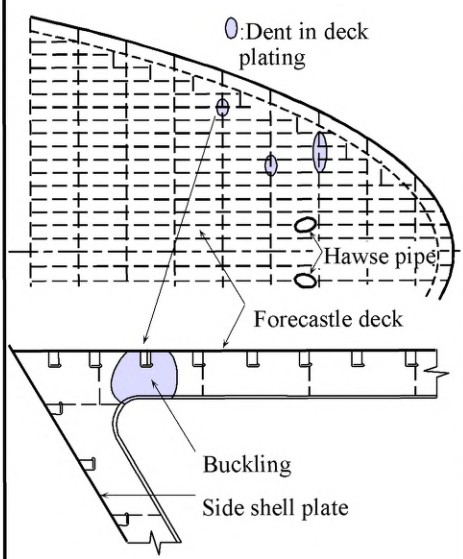
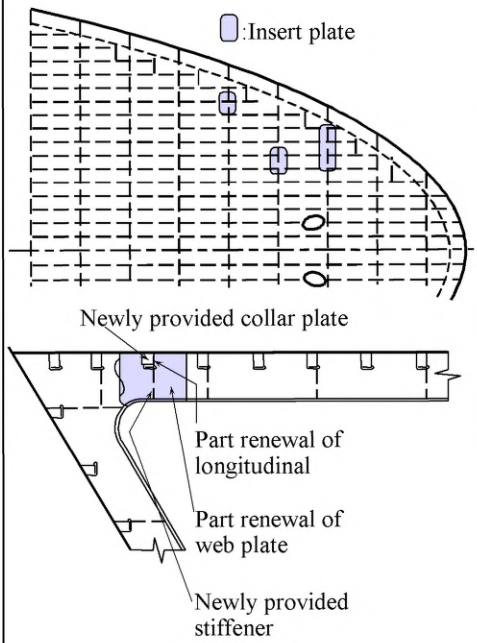
BULK CARRIERS	Guidelines for Surveys, Assessment and Repair of Hull Structure	
Part 2	Fore and aft end regions	Example No.
Area 1	Fore end structure	1
Detail of damage	Deformation of forecastle deck

1. Green sea on deck.
2. Insufficient strength.

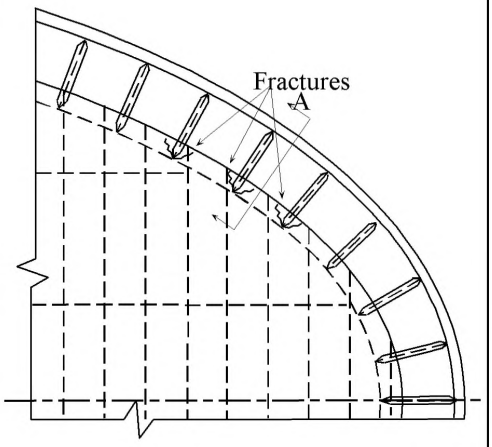
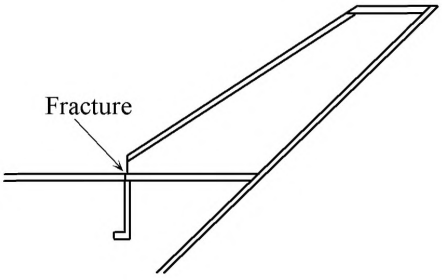
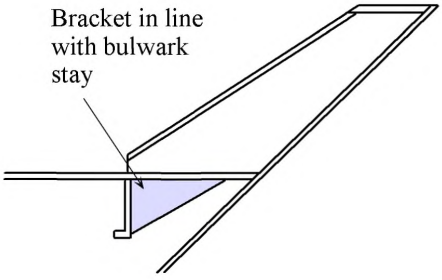
BULK CARRIERS	Guidelines for Surveys, Assessment and Repair of Hull Structure	
Part 2	Fore and aft end regions	Example No.
Area 1	Fore end structure	2
Detail of damage	Fractures in forecastle deck plating at bulwark

1. Fractured deck plating should be cropped and renewed.
2. Bracket in line with the bulwark stay to be fitted to reduce stress concentration.

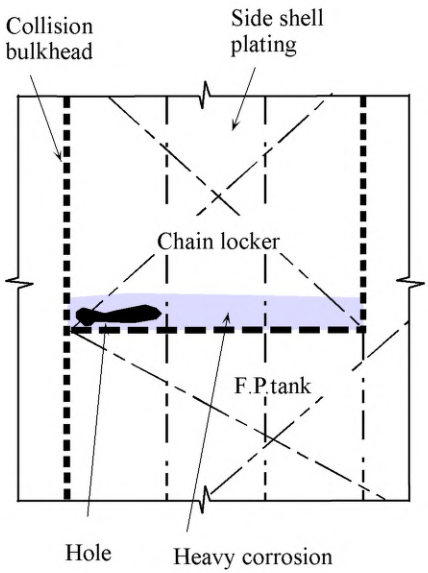
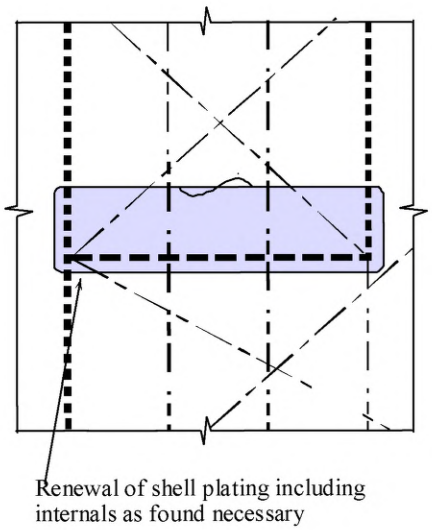
BULK CARRIERS	Guidelines for Surveys, Assessment and Repair of Hull Structure	
Part 2	Fore and aft end regions	Example No.
Area 1	Fore end structure	3
Detail of damage	Fractures in side shell plating in way of chain locker

1. Heavy corrosion in region where mud is accumulated.

1. Corroded plating should be cropped and renewed.
2. Protective coating should be applied.

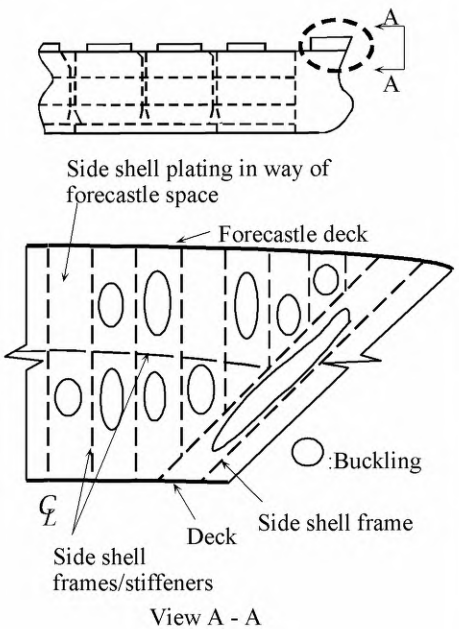
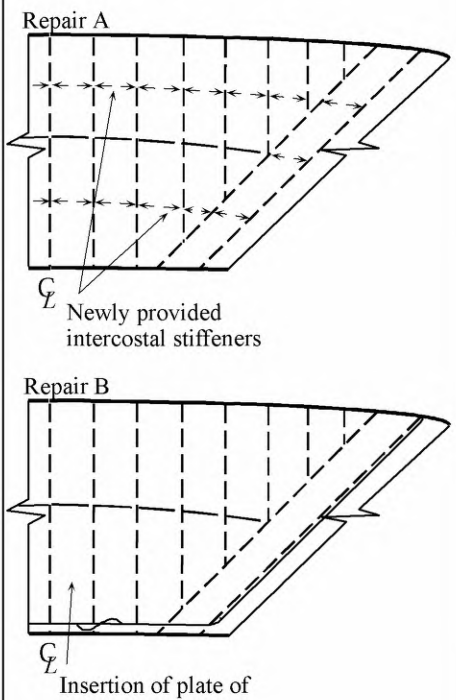
1. Heavy weather.
2. Insufficient strength.
