No.76 IACS Guidelines for Surveys, Assessment and Repair of Hull Structure – Bulk Carriers

BULK CARRIERS

Guidelines for Surveys, Assessment and Repair of Hull Structure

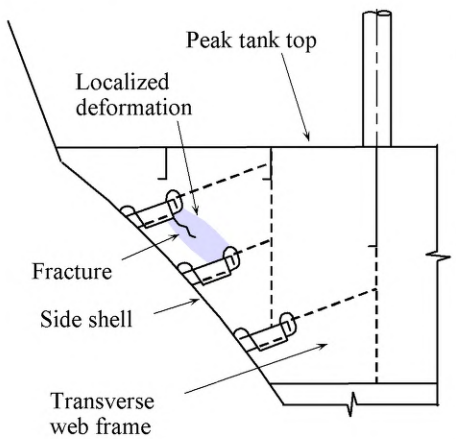
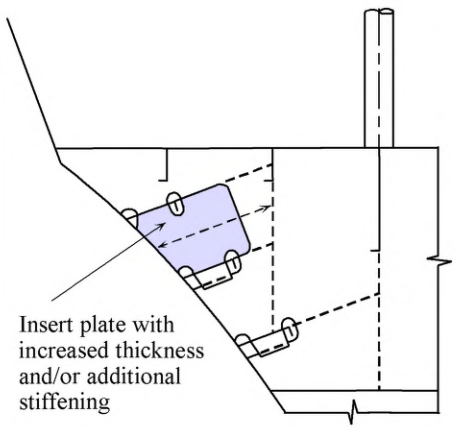
BULK CARRIERS	Guidelines for Surveys, Assessment and Repair of Hull Structure	
Part 2	Fore and aft end regions	Example No.
Area 1	Fore end structure	5
Detail of damage	Fracture and deformation of bow transverse web in way of cut-outs for side longitudinals

1. Localized material wastage in way of coating failure at cut-outs and sharp edges due to working of the structure.
2. Dynamic seaway loading in way of bow flare.

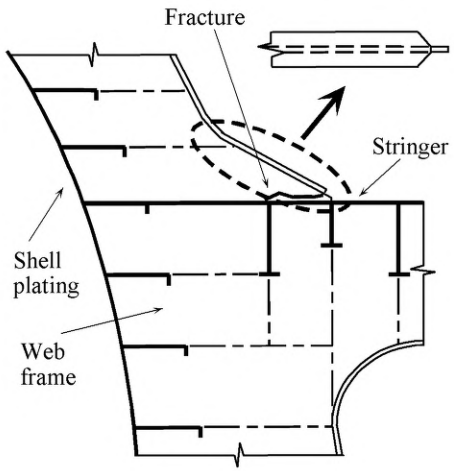
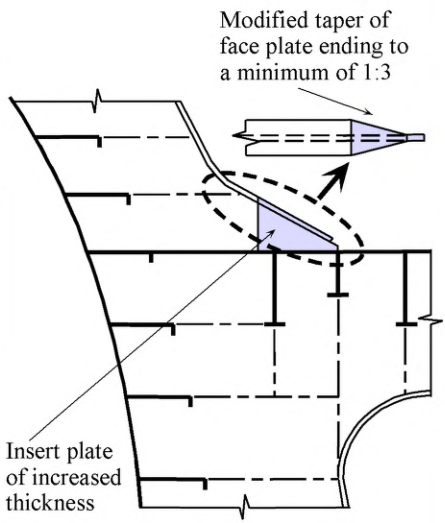
BULK CARRIERS	Guidelines for Surveys, Assessment and Repair of Hull Structure	
Part 2	Fore and aft end regions	Example No.
Area 1	Fore end structure	6
Detail of damage	Fractures at toe of web frame bracket connection to stringer platform bracket

1. Inadequate bracket forming the web frame connection to the stringer.
2. Localized material wastage in way of coating failure at bracket due to flexing of the structure.
3. Dynamic seaway loading in way of bow flare.

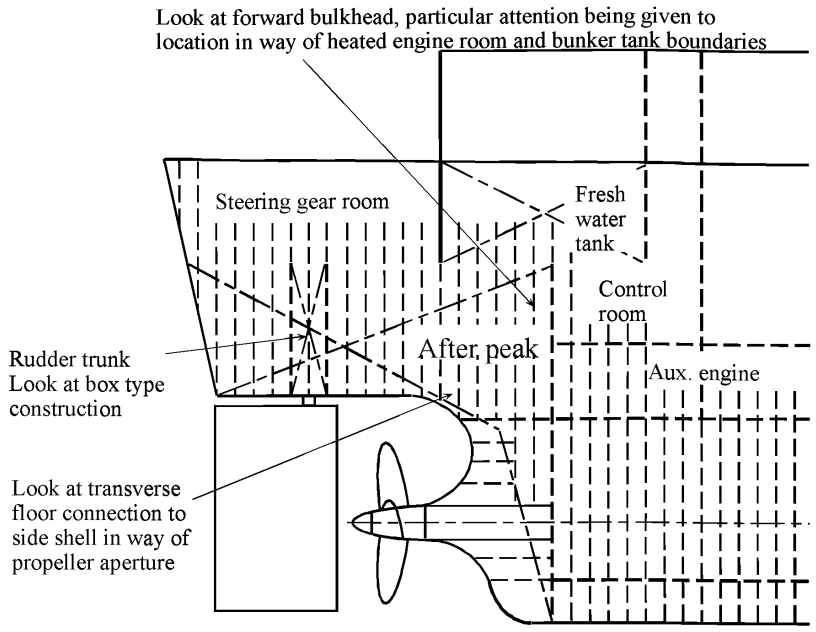
Figure 1 Aft end structure - Potential problem areas

2.3.1 Fractures in weld at floor connections and other locations in the aft peak tank and rudder trunk space can normally only be found by close-up inspection.

2.3.2 The structure supporting the rudder carrier may fracture and/or deform due to excessive load on the rudder. Bolts connecting the rudder carrier to the steering gear flat may also suffer damage under such load.

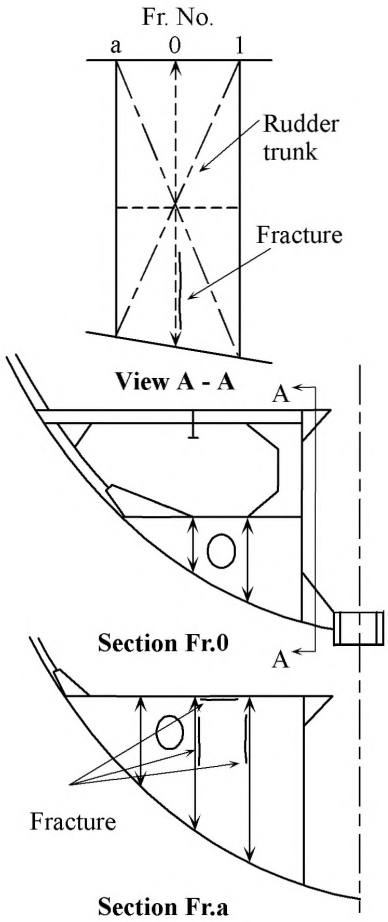
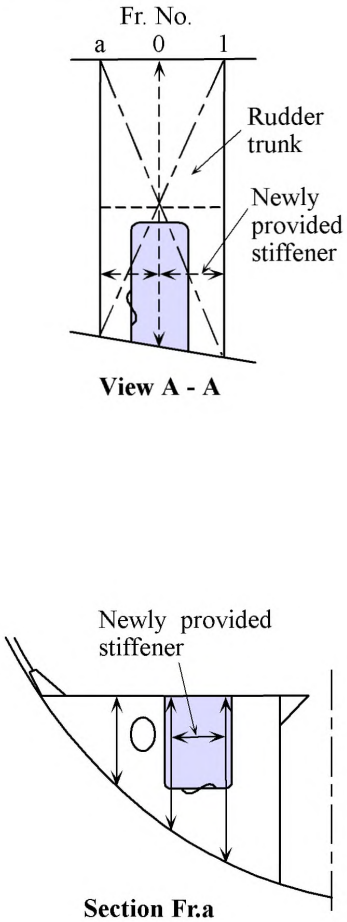
1. Vibration.

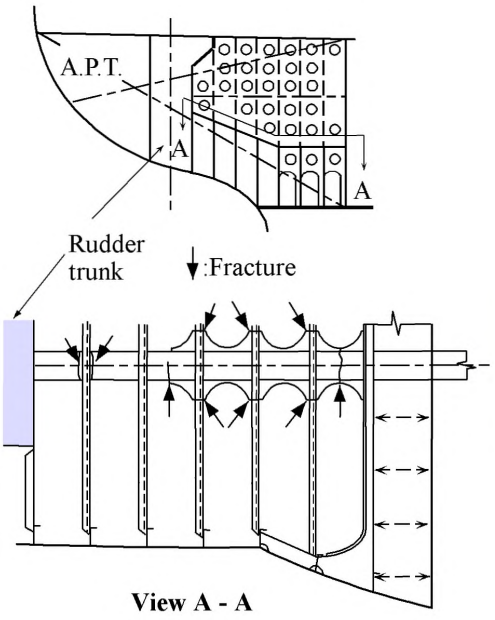
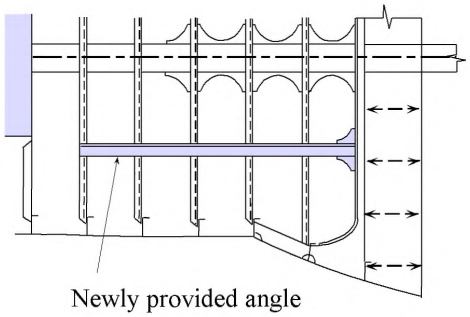
BULK CARRIERS	Guidelines for Surveys, Assessment and Repair of Hull Structure	
Part 2	Fore and aft end regions	Example No.
Area 2	Aft end structure	2
Detail of damage	Fractures at the connection of floors and girders/side brackets

1. Vibration.

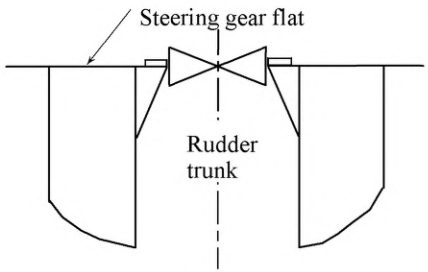
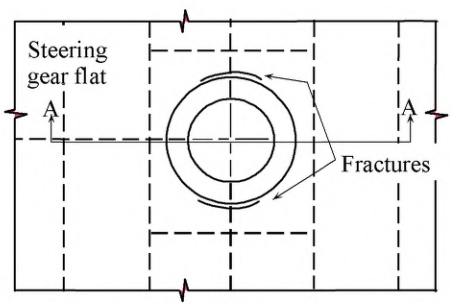
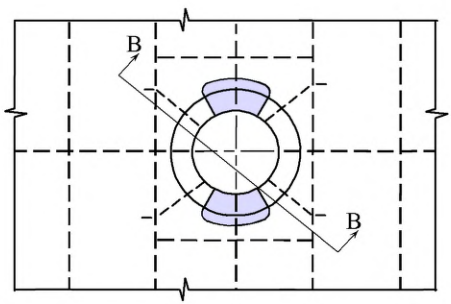
BULK CARRIERS	Guidelines for Surveys, Assessment and Repair of Hull Structure	
Part 2	Fore and aft end regions	Example No.
Area 2	Aft end structure	3-a
Detail of damage	Fractures in flat where rudder carrier is installed in steering gear room

1. Inadequate design.

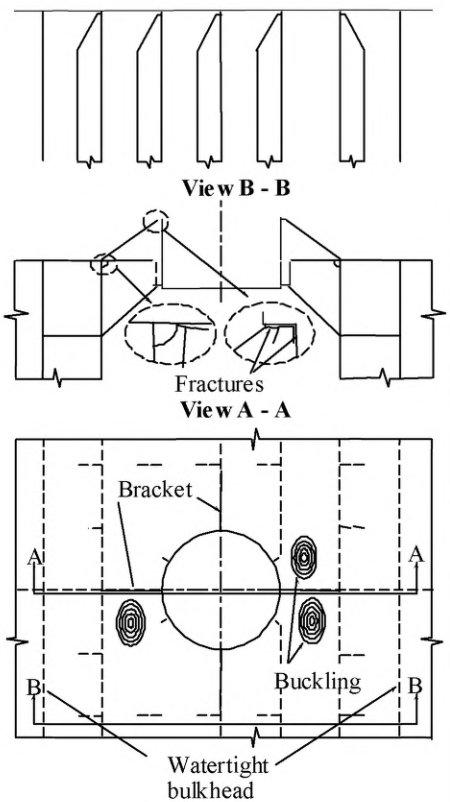
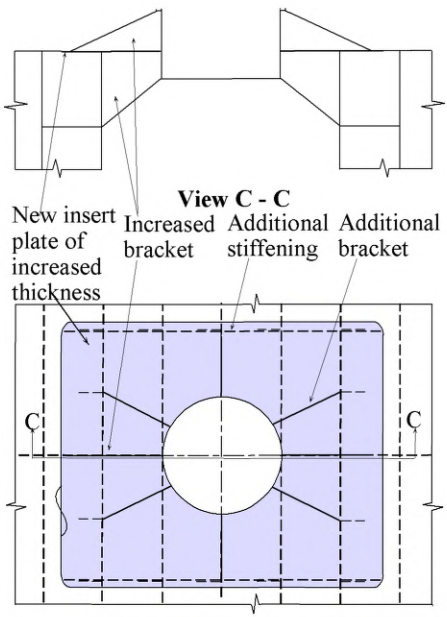
1. Insufficient deck strengthening (missing base plate).
2. Insufficient strengthening of steering gear foundation.
3. Bolts of steering gear were not sufficiently pre-loaded.

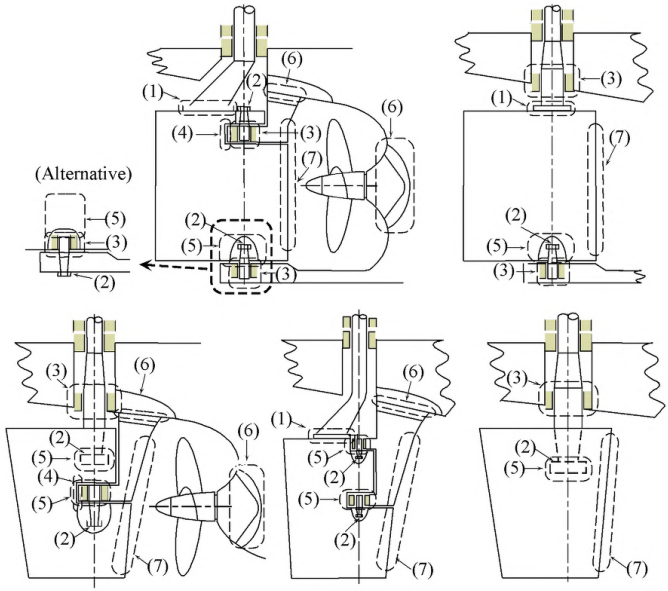
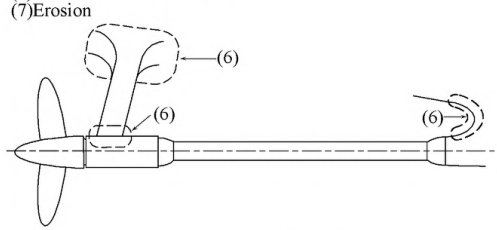
Figure 2 Potential problem areas

Damage to look for:
(1)Fractures and loose coupling bolts
(2)Loose nut
(3)Wear(excessive bearing clearance)
(4)Fractures in way of pintle cutout
(5)Fractures in way of removable access plate
(6)Fractures
(7)Erosion

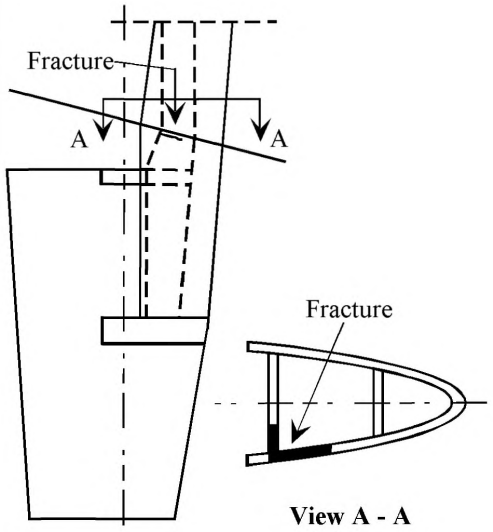
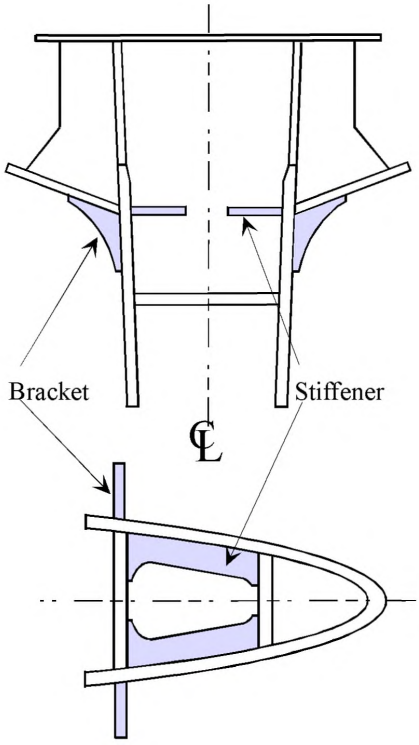
BULK CARRIERS	Guidelines for Surveys, Assessment and Repair of Hull Structure	
Part 2	Fore and aft end regions	Example No.
Area 3	Stern frame, rudder arrangement and propeller shaft support	1
Detail of damage	Fractures in rudder horn along bottom shell plating

1. Insufficient strength due to poor design.

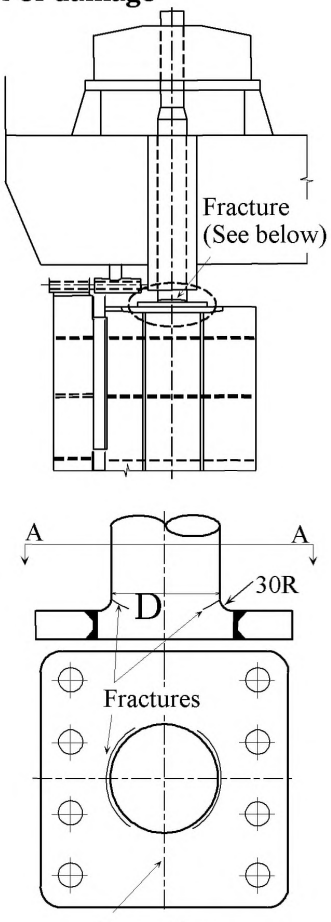
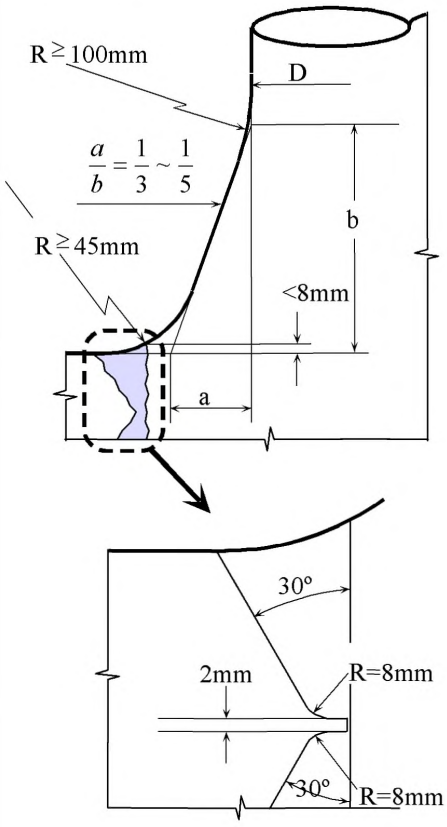
1. Inadequate design for stress concentration in rudder stock.

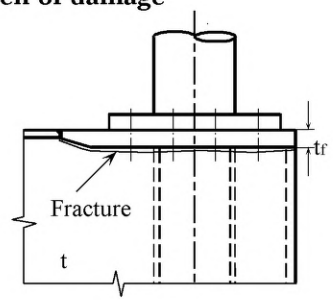
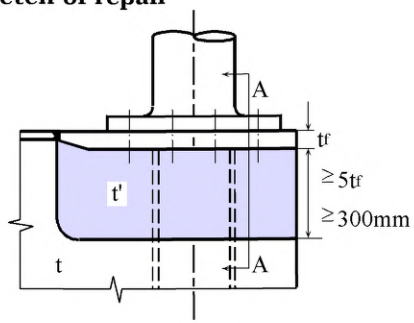
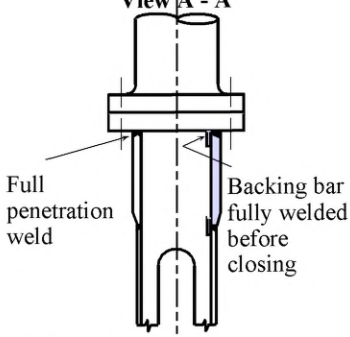
BULK CARRIERS	Guidelines for Surveys, Assessment and Repair of Hull Structure	
Part 2	**Fore and aft end regions**	**Example No.**
Area 3	**Stern frame, rudder arrangement and propeller shaft support**	**3**
Detail of damage	Fractures in connection of palm plate to rudder blade

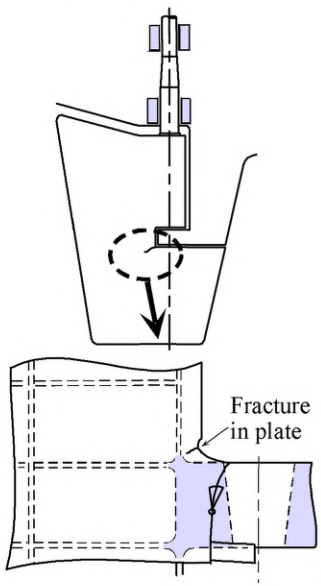
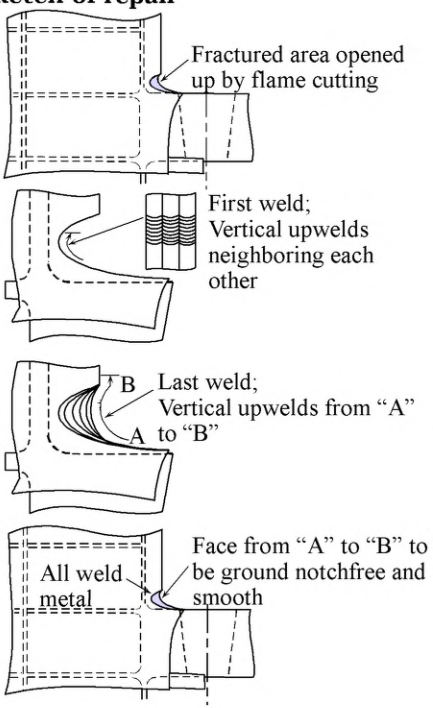
BULK CARRIERS	Guidelines for Surveys, Assessment and Repair of Hull Structure	
Part 2	Fore and aft end regions	Example No.
Area 3	Stern frame, rudder arrangement and propeller shaft support	4
Detail of damage	Fractures in rudder plating of semi-spade rudder (short fracture with end located forward of the vertical web)

1. Stress concentration due to inadequate local design and/or fabrication notches in way of the butt weld between cast piece and plating.

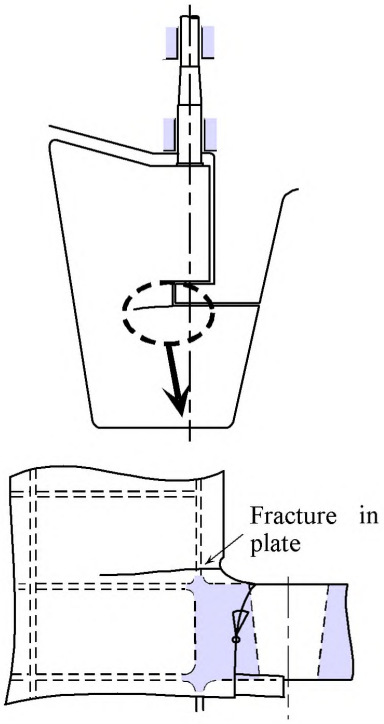
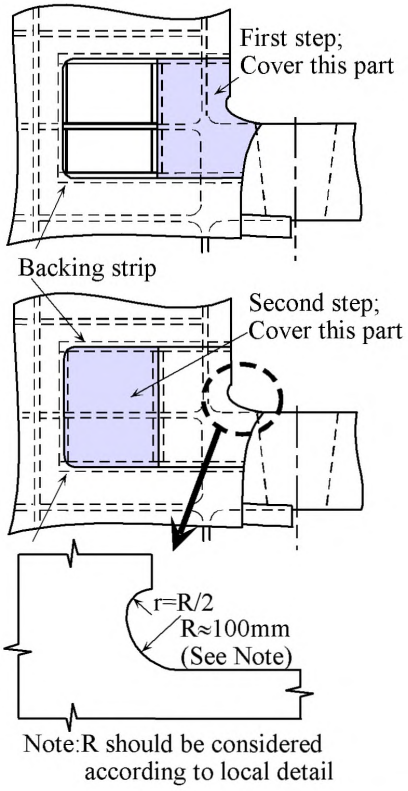
1. Stress concentration due to inadequate local design and/or fabrication notches in way of the butt weld between cast piece and plating.

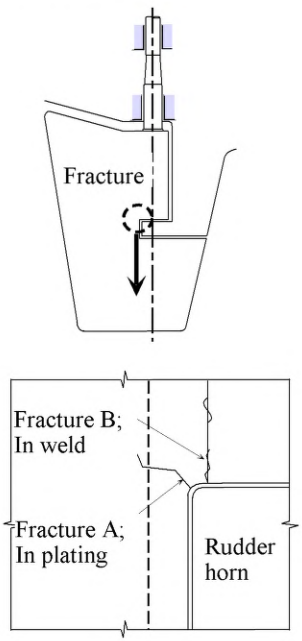
Sketch of damage

BULK CARRIERS	Guidelines for Surveys, Assessment and Repair of Hull Structure	
Part 2	**Fore and aft end regions**	**Example No.**
Area 3	**Stern frame, rudder arrangement and propeller shaft support**	**6**
Detail of damage	Fractures in rudder plating of semi-spade rudder in way of pintle cutout

1. Inadequate design for stress concentration in way of pintle bearing (**Fracture A**).
2. Imperfection in welding seam (**Fracture B**).

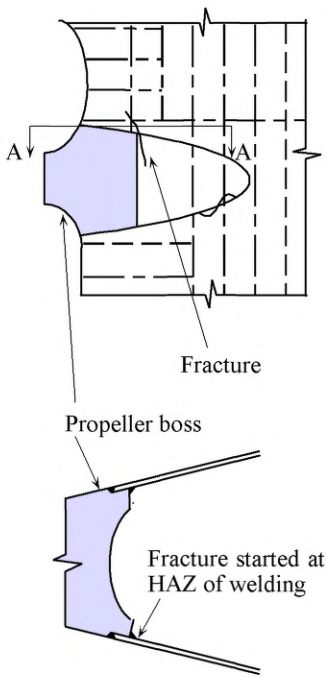
Sketch of damage

BULK CARRIERS	Guidelines for Surveys, Assessment and Repair of Hull Structure	
Part 2	Fore and aft end regions	Example No.
Area 3	Stern frame, rudder arrangement and propeller shaft support	7
Detail of damage	Fractures in side shell plating at the connection to propeller boss

1. Fatigue fracture due to vibration.

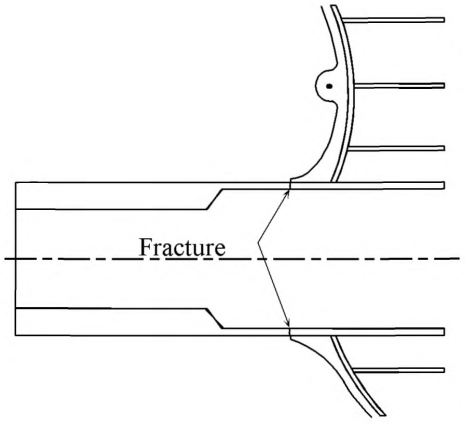
Sketch of damage

BULK CARRIERS	Guidelines for Surveys, Assessment and Repair of Hull Structure	
Part 2	Fore and aft end regions	Example No.
Area 3	Stern frame, rudder arrangement and propeller shaft support	8
Detail of damage	Fractures in stern tube at the connection to stern frame

1. Fatigue fracture due to vibration.

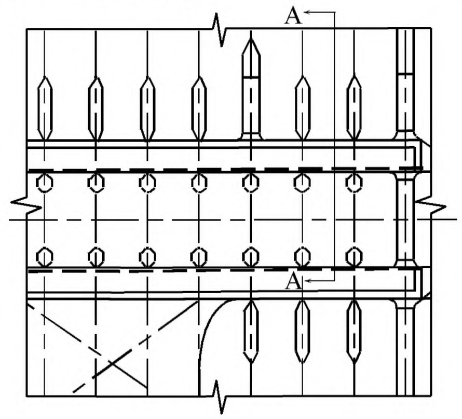
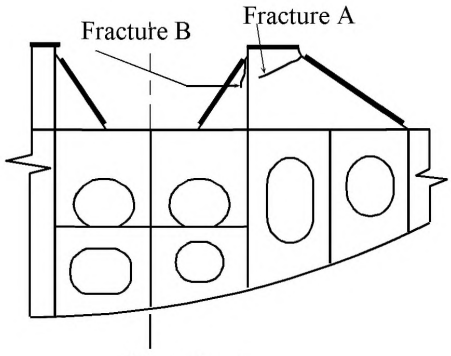
Sketch of damage

BILK CARRIERS	Guidelines for Surveys, Assessment and Repair of Hull Structure	
Part 3	Machinery and accommodation spaces	Example No.
Area 1	Engine room structure	1
Detail of damage	Fractures in brackets at main engine foundation

1. Vibration of main engine.
2. Insufficient strength of brackets at main engine foundation.
3. Insufficient pre-load bolts.

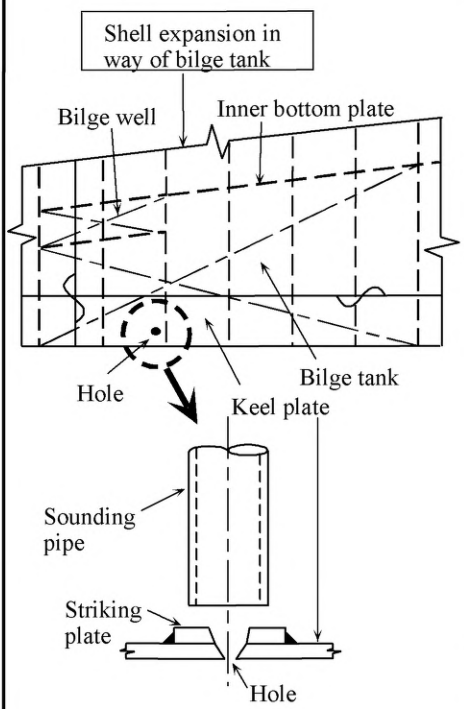
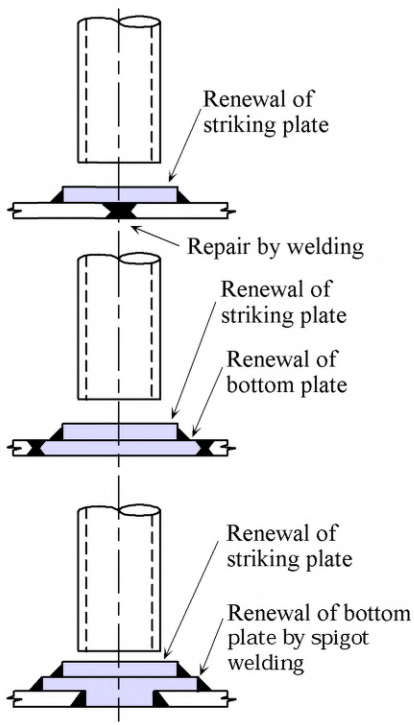
1. Heavy corrosion of bottom plating under sounding pipe.

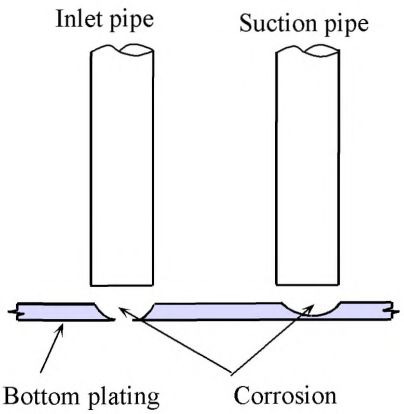
Sketch of damage

BULK CARRIERS	Guidelines for Surveys, Assessment and Repair of Hull Structure	
Part 3	Machinery and accommodation spaces	Example No.
Area 1	Engine room structure	3
Detail of damage	Corrosion in bottom plating under inlet/suction/pipe in way of bilge tank in engine room

1. Heavy corrosion of bottom plating under the inlet/suction pipe.
