No. 96 (April 2007) **Double Hull Oil Tankers -** Guidelines for Surveys, Assessment and Repair of Hull Structures

DOUBLE HULL OIL TANKERS

Guidelines for Surveys, Assessment and Repair of Hull Structures

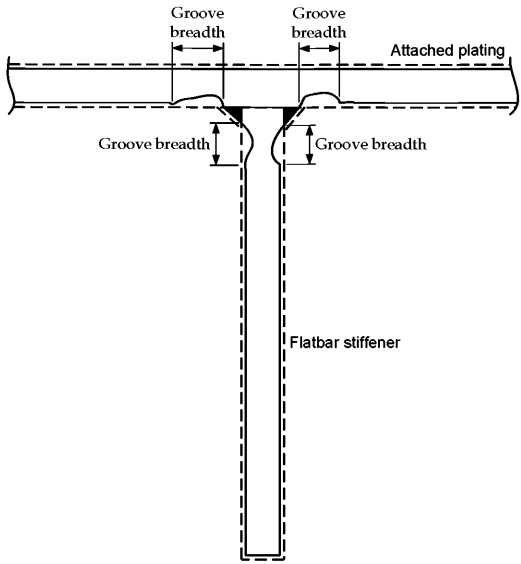
Figure 8 Grooving Corrosion

Grooving corrosion is often found in or beside welds, especially in the heat affected zone. This corrosion is sometimes referred to as 'inline pitting attack' and can also occur on vertical members and flush sides of bulkheads in way of flexing. The corrosion is caused by the galvanic current generated from the difference of the metallographic structure between the heat affected zone and base metal. Coating of the welds is generally less effective compared to other areas due to roughness of the surface, which exacerbates the corrosion. Grooving corrosion may lead to stress concentrations and further accelerate the corrosion process. Grooving corrosion may be found in the base material where coating has been scratched or the metal itself has been mechanically damaged. An example of grooving corrosion is shown in Figure 8.

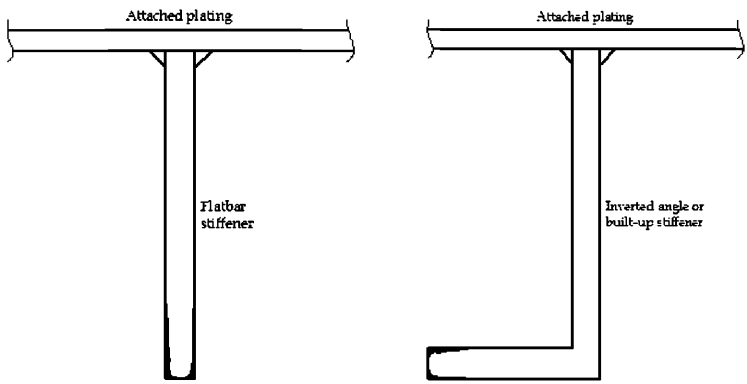
Figure 9 Edge Corrosion

Edge corrosion is defined as local corrosion at the free edges of plates, stiffeners, primary support members and around openings. An example of edge corrosion is shown in Figure 9.

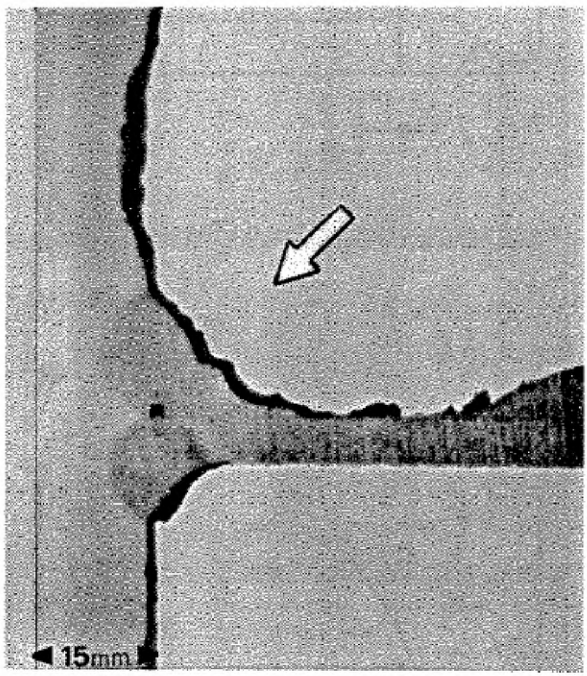
- Necking occurs at the junction of the longitudinal bulkhead plating and longitudinals. The deflection of the bulkhead plating and longitudinals due to reverse, cyclic loading from cargo oil and water ballast plus the accumulated mixtures of water, mud and scale at their junctures accelerates the corrosion rate. As the steel thins and weakens, the flexing consequently increases and hence corrosion accelerates (see Figure 10). The similar necking effect could also occur in the transverse bulkhead plating and stiffeners, or in the inner bottom plating and longitudinals inside the double bottom space. In the coated water ballast tanks, the plating is the principally affected area due to local corrosion in way of coating failure.

Figure 10 Detail of Necking Effect

One of the best methods of preventing corrosion within these spaces is that protective coatings be applied to the underdeck and inner bottom plating areas. In addition to

protecting the steel structure in these areas, this measure would also enable easier and more effective surveys and surveys to be carried out 'in service'.

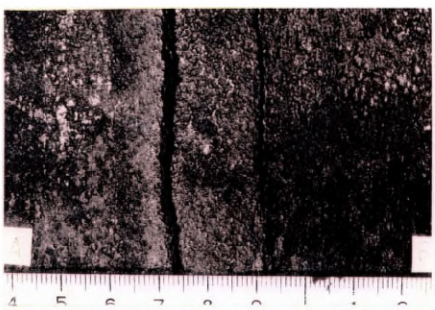
4.1.2 Severe grooving along welding of bottom plating is often found (See **Photographs 1** and **2**). This grooving can be accelerated by poor maintenance of the protective coating and/or sacrificial anodes fitted to the bottom plating.

Photograph 1
Grooving corrosion of welding of bottom plating

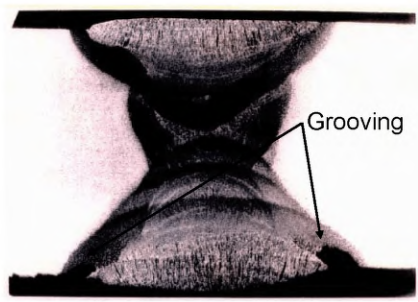
Photograph 2
Section of the grooving shown in Photograph 1

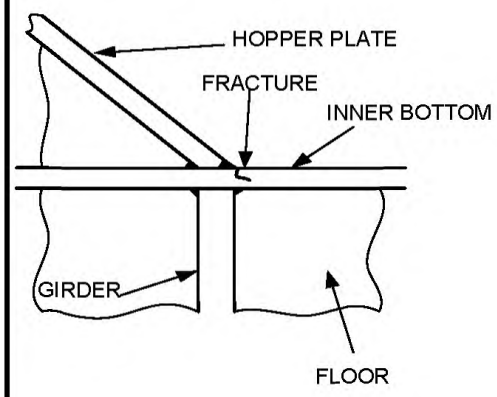
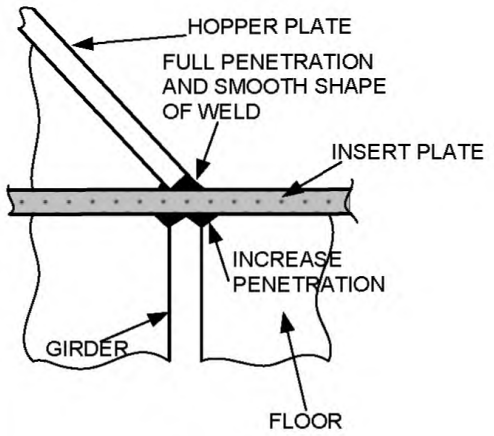
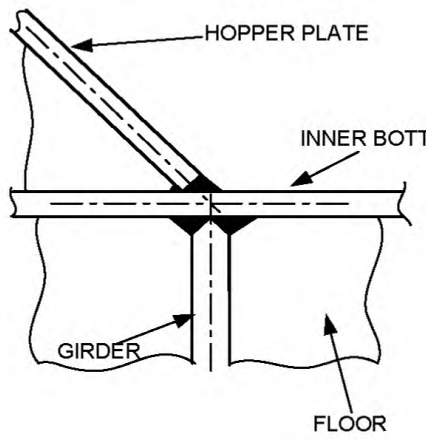
OIL Tankers	Guidelines for Surveys, Assessment and Repair of Hull Structure	
Group 1	Cargo area	Example No.
	Hopper and double bottom ballast tank	1
Detail of damage	Fracture on the inner bottom plating at the connection of hopper plate to inner bottom

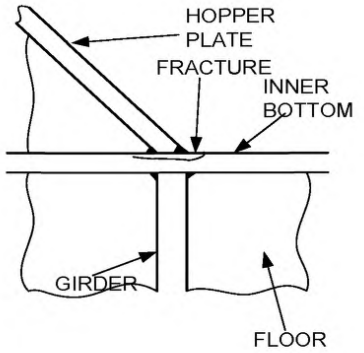
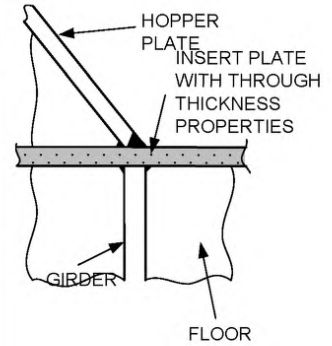
OIL Tankers	Guidelines for Surveys, Assessment and Repair of Hull Structure	
Group 1	Cargo area	Example No.
	Hopper and double bottom ballast tank	2
Detail of damage	Fracture at connection of bilge hopper plate and inner bottom

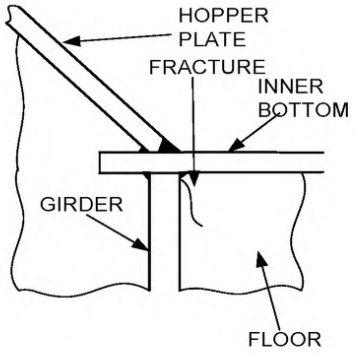
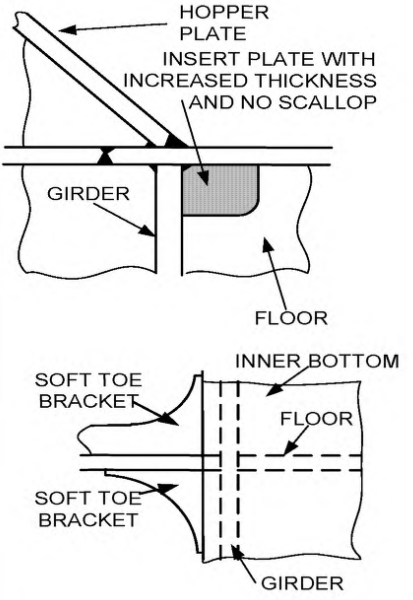
OIL Tankers	Guidelines for Surveys, Assessment and Repair of Hull Structure	
Group 1	Cargo area	Example No.
	Hopper and double bottom ballast tank	3
Detail of damage	Fracture at connection of bilge hopper plate and inner bottom

Factors which may have caused damage	Notes on repairs
1. Stress concentration at the knuckle.	See Sketch.

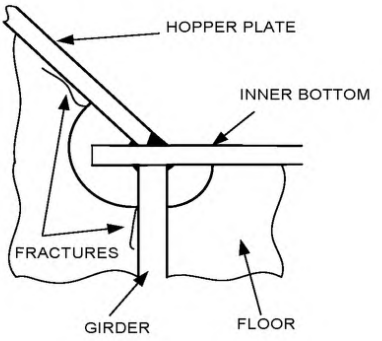
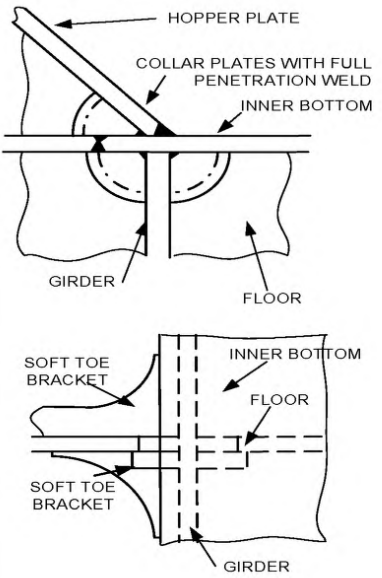
OIL Tankers	Guidelines for Surveys, Assessment and Repair of Hull Structure	
Group 1	Cargo area	Example No.
	Hopper and double bottom ballast tank	4
Detail of damage	Fracture at connection of bilge hopper plate and inner bottom

Factors which may have caused damage	**Notes on repairs**
1. Stress concentration at the knuckle.	See Sketch.

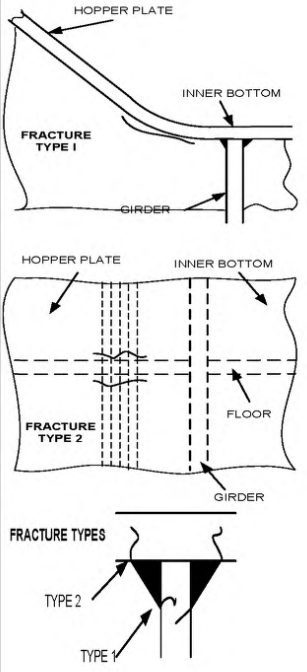
OIL Tankers	Guidelines for Surveys, Assessment and Repair of Hull Structure	
Group 1	Cargo area	Example No.
	Hopper and double bottom ballast tank	5
Detail of damage	Fractured floor and inner bottom plate in way of juncture of inner bottom to hopper plate

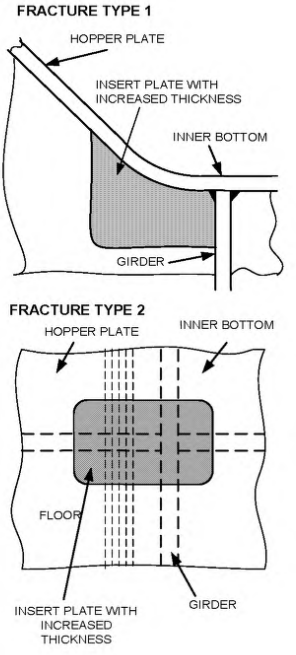
1. Misalignment. The three mid-lines do not cross at the same joint. This misalignment produces an out-of-plane deformation of inner bottom plate in way of knuckle line.
2. Stress concentration at connection between floor and inner bottom plate.
3. Static and dynamic load of ballast water.

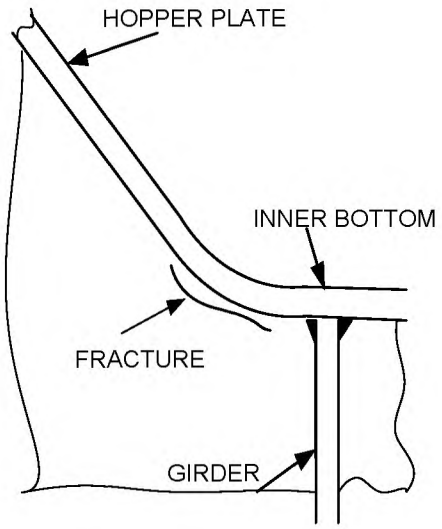
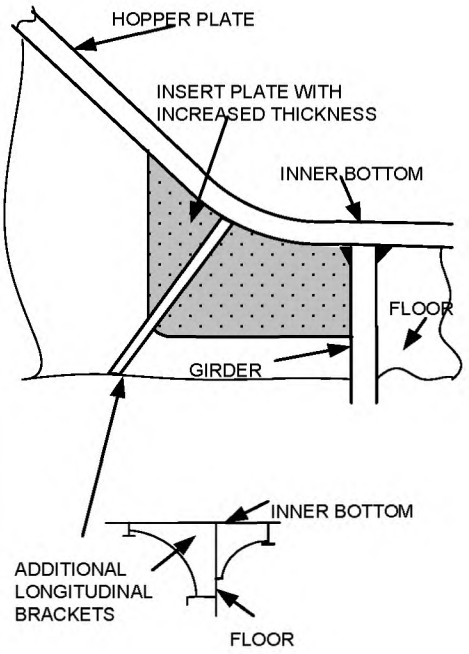
OIL Tankers	Guidelines for Surveys, Assessment and Repair of Hull Structure	
Group 1	Cargo area	Example No.
	Hopper and double bottom ballast tank	6
Detail of damage	Fracture at connection of bilge hopper plate and web frame

1. Stress concentration due to reduction of effective flange area at curved plate.

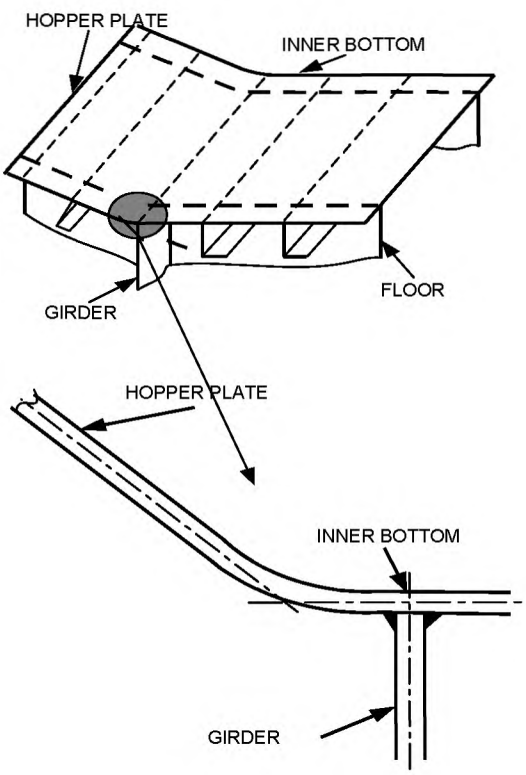
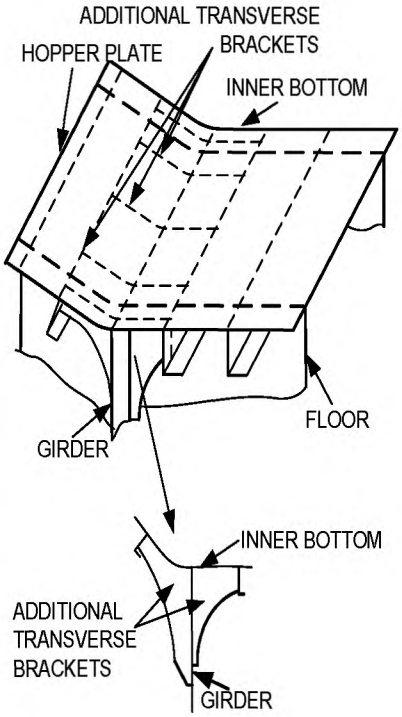
OIL Tankers	Guidelines for Surveys, Assessment and Repair of Hull Structure	
Group 1	Cargo area	Example No.
	Hopper and double bottom ballast tank	7
Detail of damage	Rounded hopper plate deformation in way of the floor

1. Misalignment. The three midlines do not cross at the same joint. This misalignment produces an out-of-plane deformation in knuckled plate in the vicinity of floor.
2. Insufficient stiffening between floors.

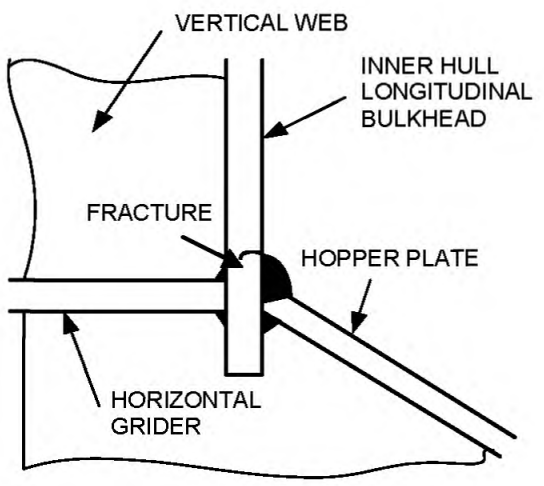
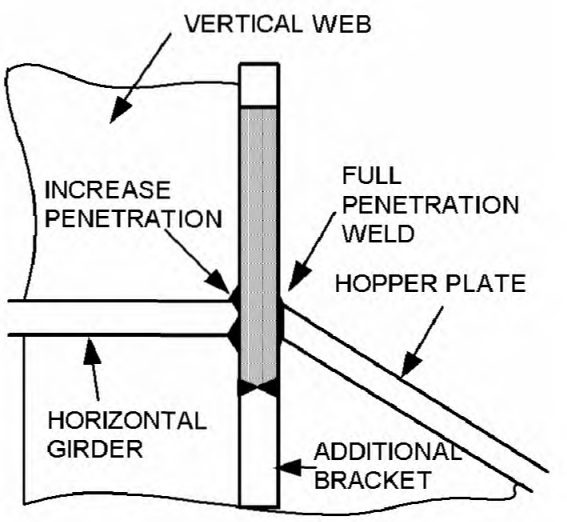
OIL Tankers	Guidelines for Surveys, Assessment and Repair of Hull Structure	
Group 1	Cargo area	Example No.
	Wing cargo tank	8
Detail of damage	Fracture at the connection of hopper plate to outside longitudinal bulkhead.

1. Stress concentration at junction of hopper plate to outside longitudinal bulkhead.
2. Insufficient welding connection and/or incorrect shape of the weld toe.
3. Misalignment between hopper plate, outside longitudinal bulkhead and side stringer.

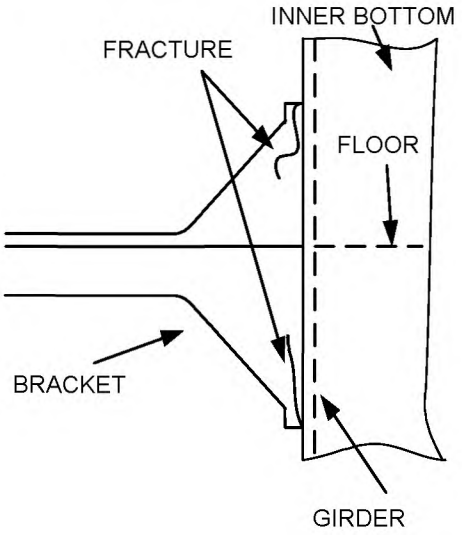
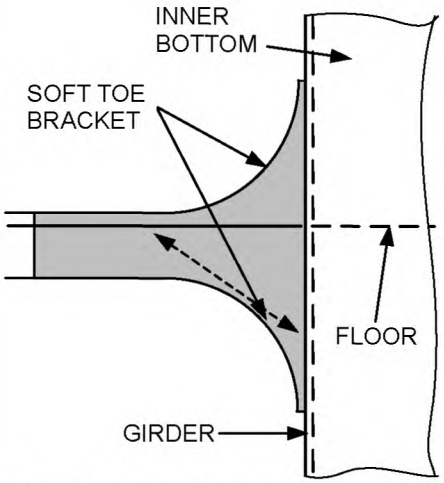
OIL Tankers	Guidelines for Surveys, Assessment and Repair of Hull Structure	
Group 1	Cargo area	Example No.
	Hopper and double bottom ballast tank	9
Detail of damage	Fracture in gusset plate in line with inner bottom

Notes: Bracket radii as large as practicable.
Bracket same thickness as inner bottom stiffener.
Toe height should be small as possible while still allowing return weld (wrapped weld).

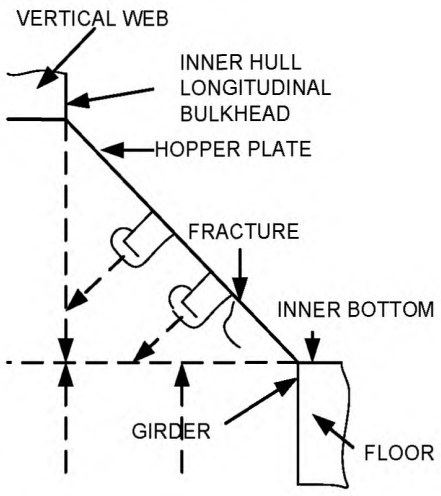
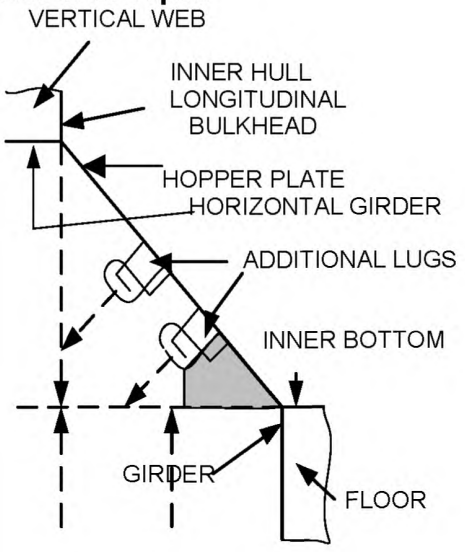
OIL Tankers	Guidelines for Surveys, Assessment and Repair of Hull Structure	
Group 1	Cargo area	Example No.
	Hopper ballast tank	10
Detail of damage	Fracture in way of cut-out in hopper plate

1. Stress concentration due to no collar plate.

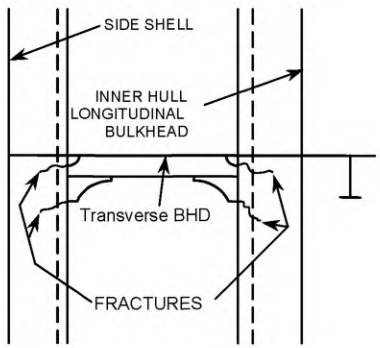
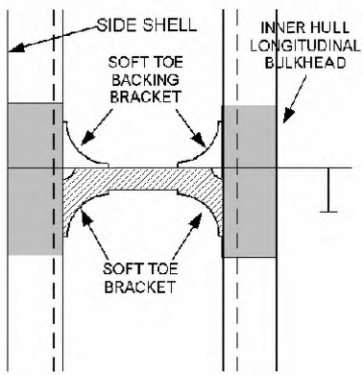
OIL Tankers	Guidelines for Surveys, Assessment and Repair of Hull Structure	
Group 2	Cargo area	Example No.
	Wing ballast tank	1
Detail of damage	Crack in way of connection of longitudinals to transverse bulkhead

1. Asymmetrical connection of bracket without backing bracket.
2. Relative deflection of adjoining transverse web against transverse bulkhead.
3. Additional biaxial bending stresses due to asymmetry of the angle bar longitudinal instead of symmetric T section.
4. Dynamic load in the vicinity of the water line.
5. Large upstand at bracket toe.

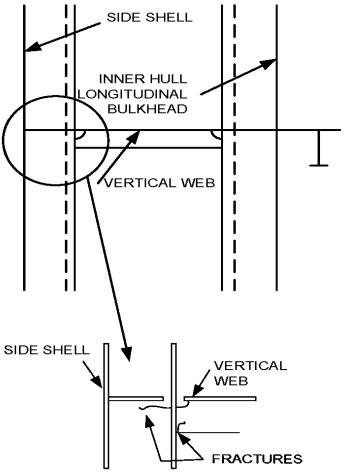
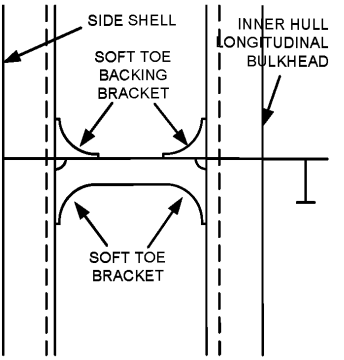
OIL Tankers	Guidelines for Surveys, Assessment and Repair of Hull Structure	
Group 2	Cargo area	Example No.
	Wing ballast tank	2
Detail of damage	Crack in way of connection of longitudinals to transverse webs

1. Asymmetrical connection of flat bar stiffener resulting in high peak stresses at the heel of the stiffener.
2. Insufficient area of connection of longitudinal to web.
3. High bending stresses in the longitudinal.
4. Additional biaxial bending stresses due to asymmetry of the longitudinal (angle bar instead of symmetric T bar).
5. Stress concentration at the square angles at heel and toe of the connections.
6. High shear stress in the transverse web.

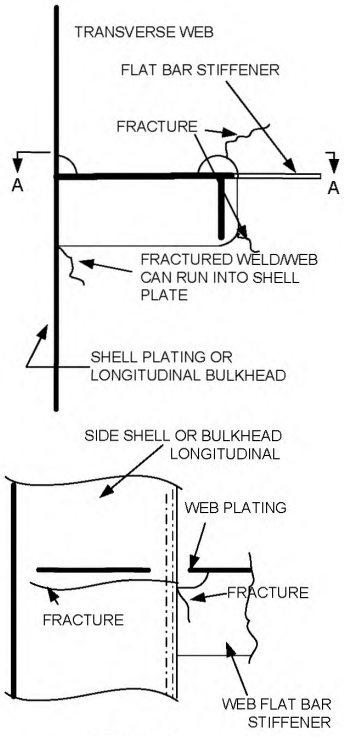
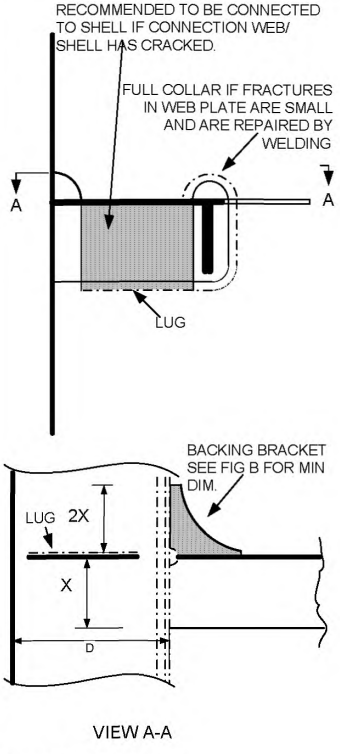
OIL Tankers	Guidelines for Surveys, Assessment and Repair of Hull Structure	
Group 2	Cargo area	Example No.
	Wing ballast tank	3
Detail of damage	Fracture in way of web and flat bar stiffener at cut outs for longitudinal stiffener connections.

Insert longitudinal.

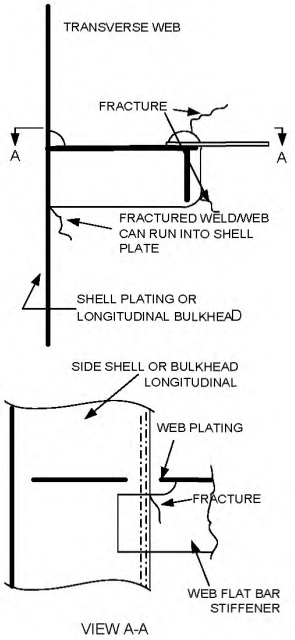
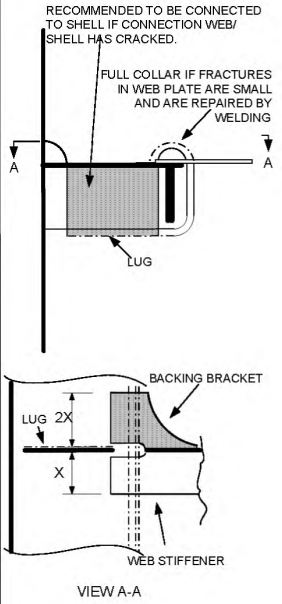
OIL Tankers	Guidelines for Surveys, Assessment and Repair of Hull Structure	
Group 2	Cargo area	Example No.
	Wing ballast tank	4
Detail of damage	Fracture in way of web and flat bar stiffener at cut outs for longitudinal stiffener connections as Example 3 but with faceplate attached to underside of web. Flat bar lap welded.

1. Asymmetrical connection of flat bar stiffener resulting in high peak stress at heel of the stiffener under fatigue loading.
2. Fabricated longitudinal with welding onto exposed edge of the web resulting in poor fatigue strength of the connection of the longitudinal to the flat bar.
3. Insufficient area of connection of longitudinal to web plate.
4. Defective weld at return around the plate thickness.
5. High localized corrosion at areas of stress concentrations such as flat bar stiffener connections, corners of cut out for longitudinal and connection of lug to shell at cut outs.
6. High shear stress in web of the transverse.
7. Dynamic seaway loads/motions.

Insert web plate.

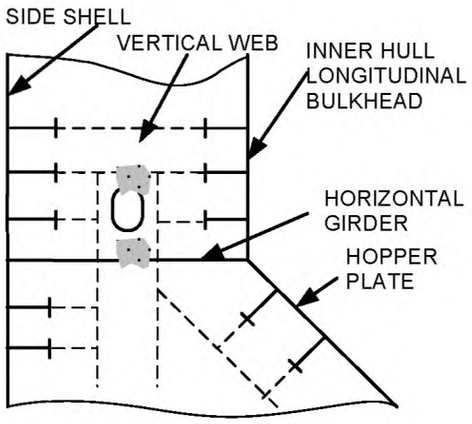
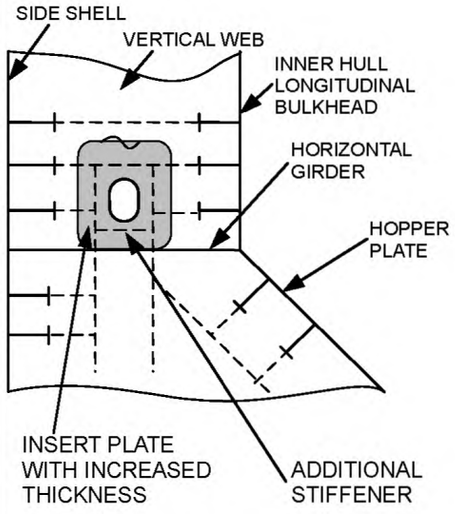
OIL Tankers	Guidelines for Surveys, Assessment and Repair of Hull Structure	
Group 2	Cargo area	Example No.
	Wing ballast tank	5
Detail of damage	Buckling in way of side web panels above hopper horizontal girder

1. High shear stress in the transverse web.
2. Insufficient buckling strength.

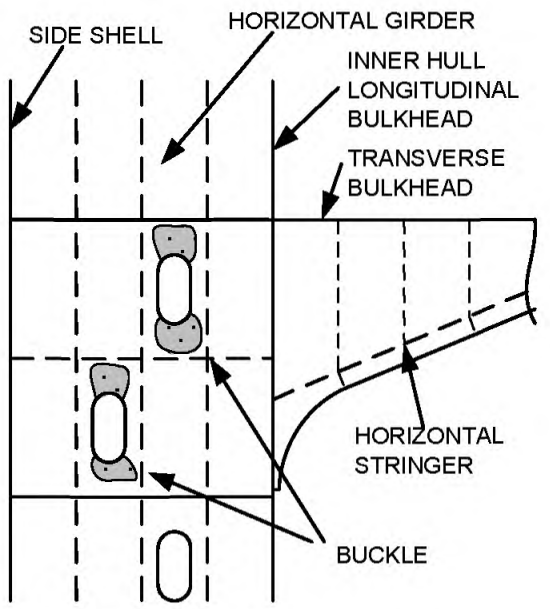
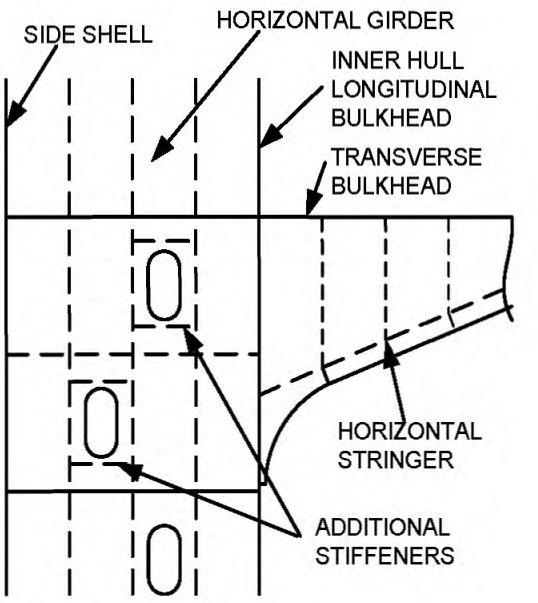
1. High shear or compressive stress in the stringer.
2. Insufficient buckling strength.

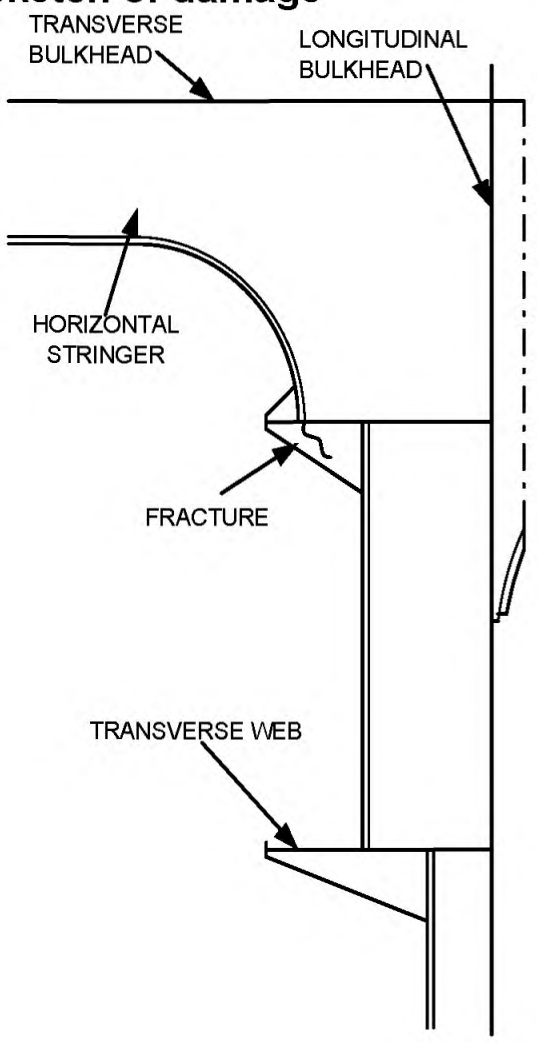
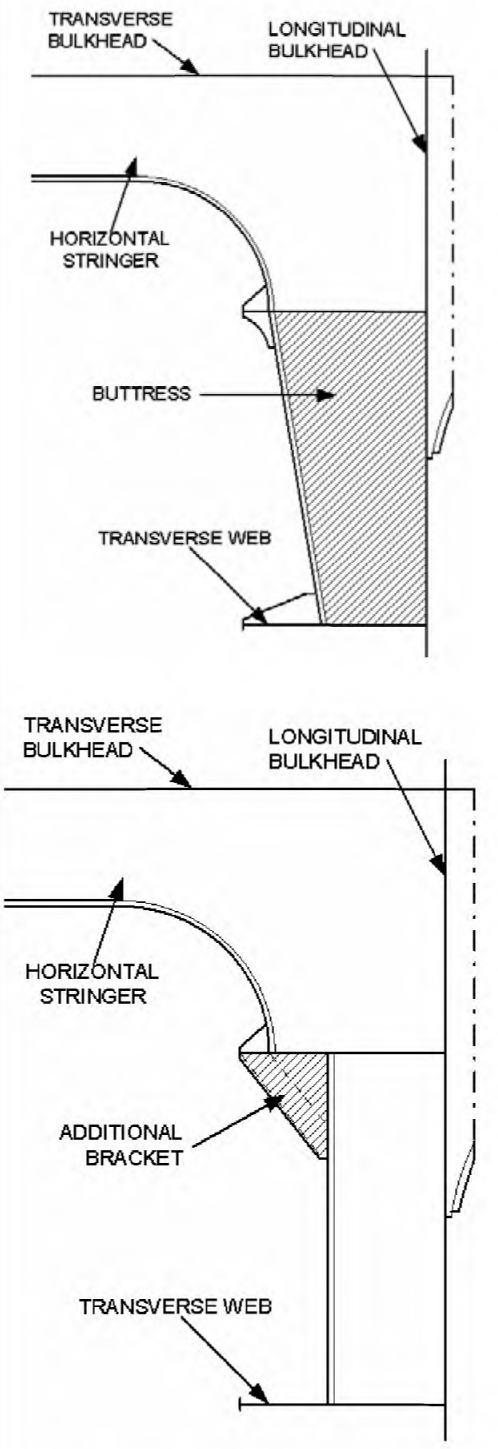
1. Stress concentration due to discontinuous structure.
2. High shear stress in the horizontal stringer.

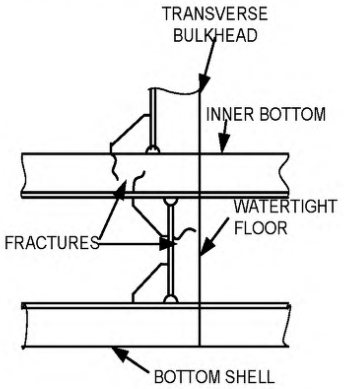
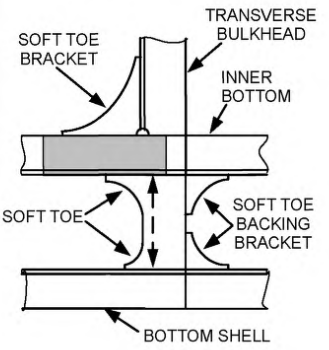
OIL Tankers	Guidelines for Surveys, Assessment and Repair of Hull Structure	
Group 3	Cargo area	Example No.
	Bottom ballast tank	1
Detail of damage	Cracks in way of longitudinals connected to watertight floors

1. Asymmetrical connection of bracket in association with a backing bracket, which is too small.
2. Relative deflection between adjacent floor and transverse bulkhead.
3. Inadequate shape of the brackets.
4. High stresses in the inner bottom longitudinal and the floor stiffener.

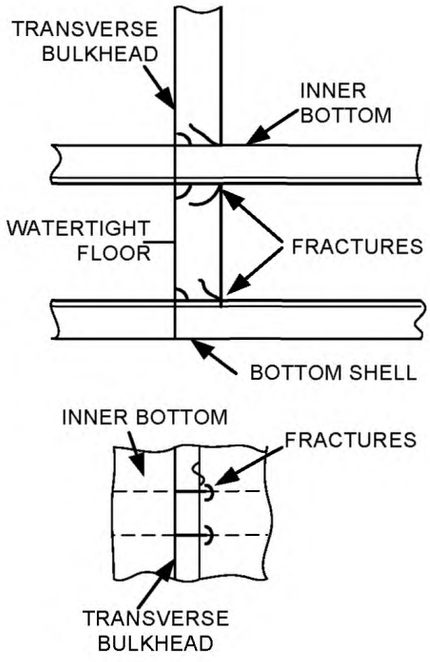
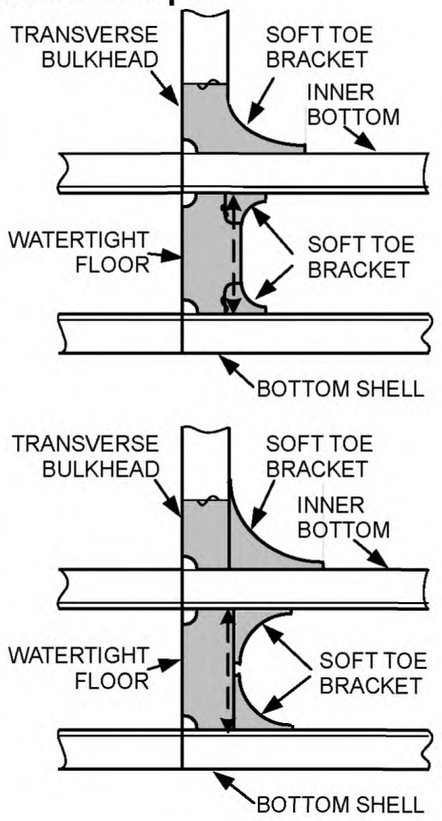
1. Misalignment between bulkhead stiffener and inner bottom longitudinal.
2. High stress concentration.

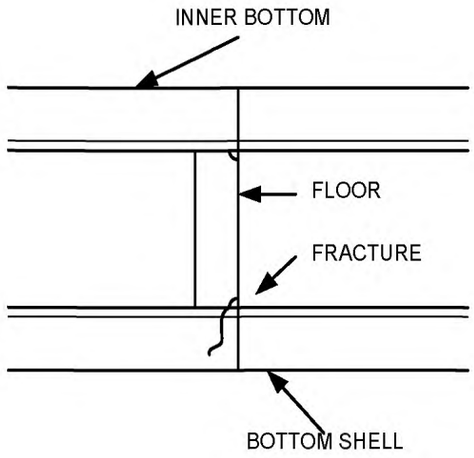
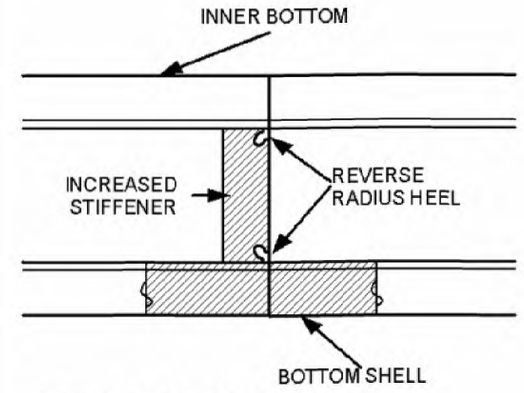
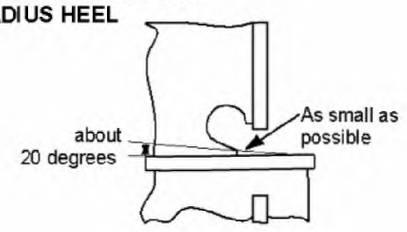
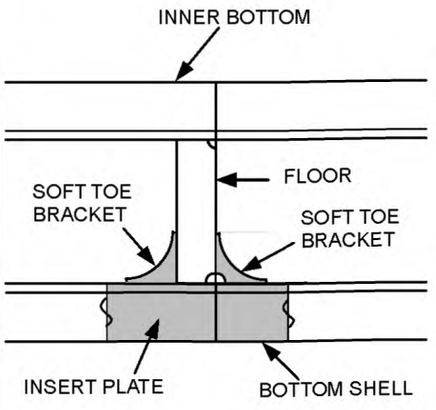
OIL Tankers	Guidelines for Surveys, Assessment and Repair of Hull Structure	
Group 3	Cargo area	Example No.
	Bottom ballast tank	3
Detail of damage	Connection of longitudinals to ordinary floors.

1. Asymmetrical connection.
2. Relative deflection of adjacent floor to transverse bulkhead.

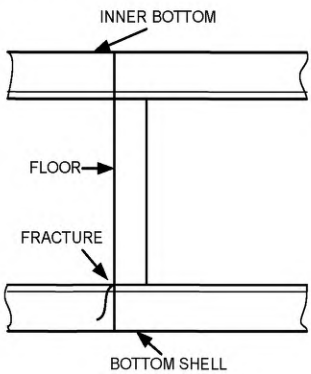
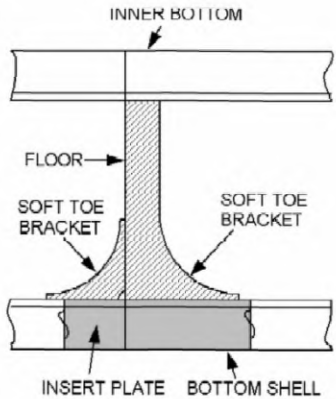
OIL Tankers	Guidelines for Surveys, Assessment and Repair of Hull Structure	
Group 3	Cargo area	Example No.
	Bottom ballast tank	4
Detail of damage	Connection of longitudinals to ordinary floors

1. Stress concentration at the connection of bottom longitudinal and stiffener on floor.

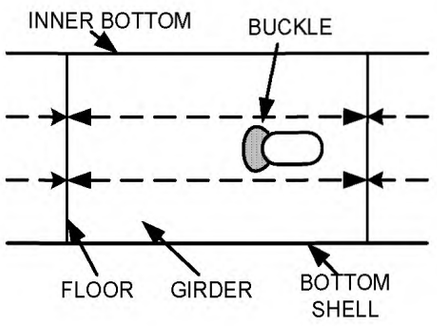
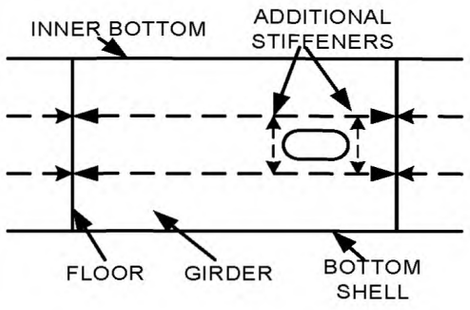
OIL Tankers	Guidelines for Surveys, Assessment and Repair of Hull Structure	
Group 3	Cargo area	Example No.
	Bottom ballast tank	5
Detail of damage	Panels of bottom girders in way of openings.

1. High shear or compressive stress in the side girder.
2. Insufficient buckling strength.

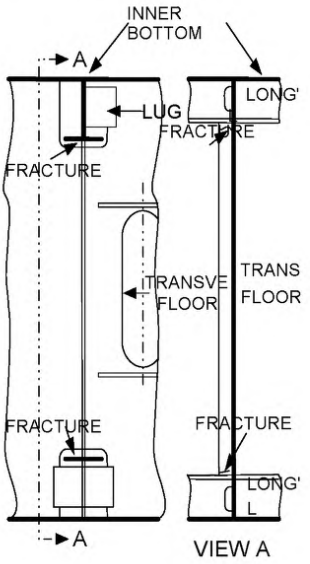
OIL Tankers	Guidelines for Surveys, Assessment and Repair of Hull Structure	
Group 3	Cargo area	Example No.
	Bottom ballast tank	7
Detail of damage	Fractured stiffener connection to bottom and inner bottom longitudinals.

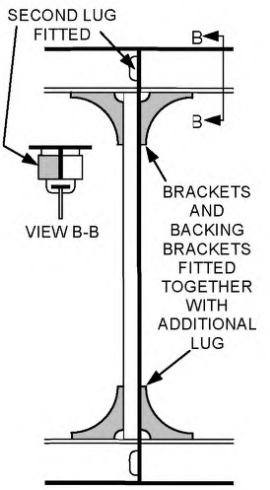
Sketch of repair

1. Asymmetric connection leading to high local stresses at the connection of vertical stiffeners of the transverse floors to the inner and outer bottom longitudinals.
2. Wide slot for longitudinal leads to inefficient lug connection.
3. Sharp corners or flame-cut edges producing a notch effect.
4. Incomplete/defective weld at stiffener connection to the longitudinals.
5. Dynamic sea way loads/ship motions.

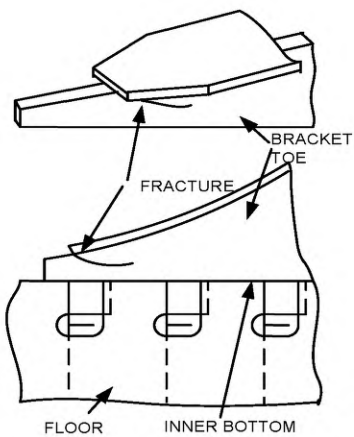
Sketch of damage

OIL Tankers	Guidelines for Surveys, Assessment and Repair of Hull Structure	
Group 4	Cargo area	Example No.
	Web Frame in cargo tank	1
Detail of damage	Fracture at toe of web frame bracket connection to inner bottom.

1. Inadequate tapering the toe end.
2. Insufficient tapering of flange.
3. Lateral flexing of the bracket.

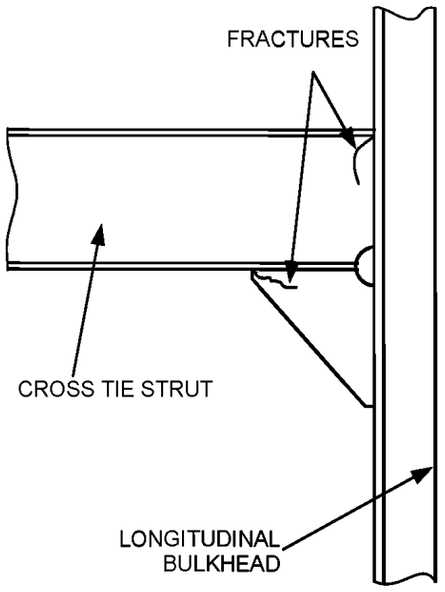
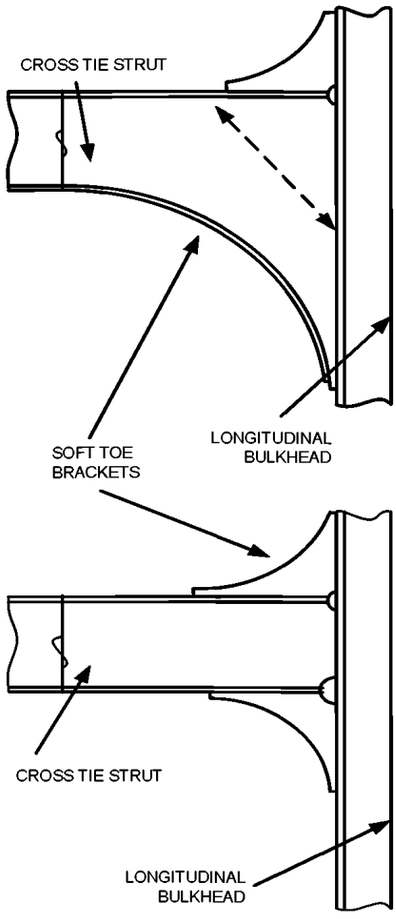
1. Stress concentration due to unsuitable bracket shape at juncture of cross tie to longitudinal.
2. Inadequate panel stiffening of web plate of cross-tie.

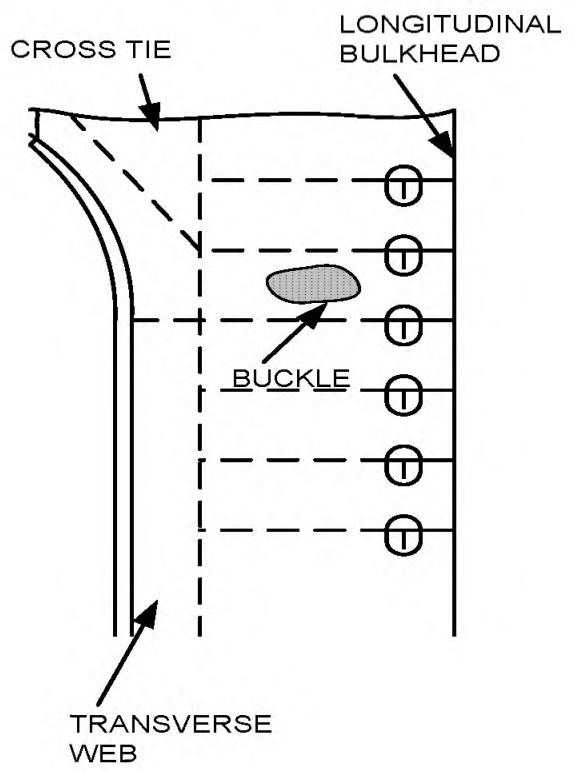
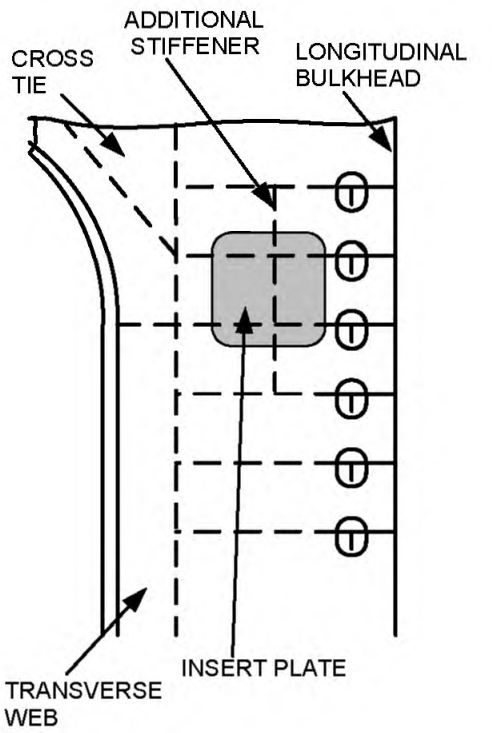
1. Insufficient panel stiffening on transverse web.

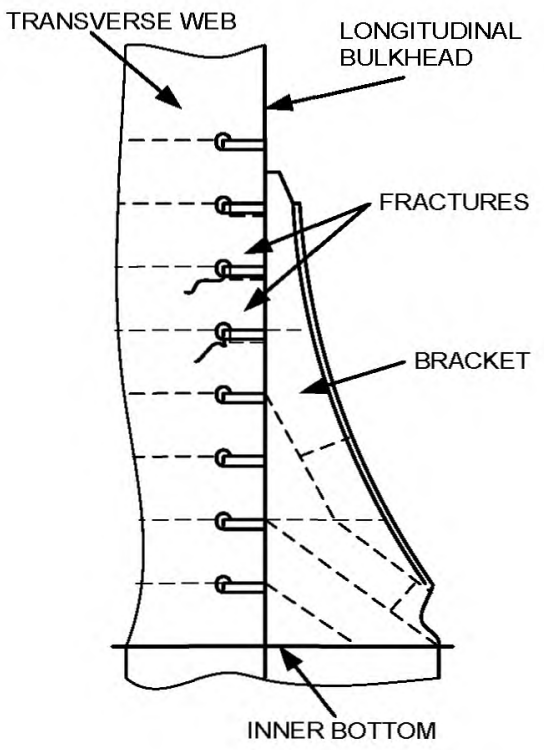
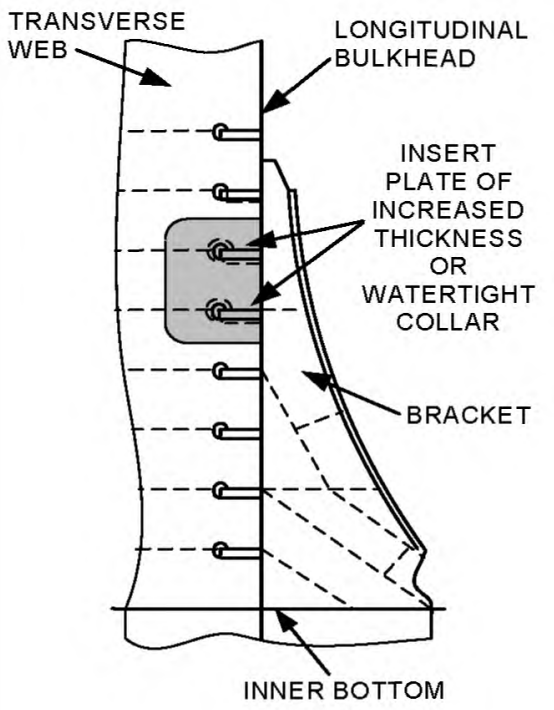
1. High stresses at toe of bottom transverse end bracket.
2. Sharp corner at cut-out.

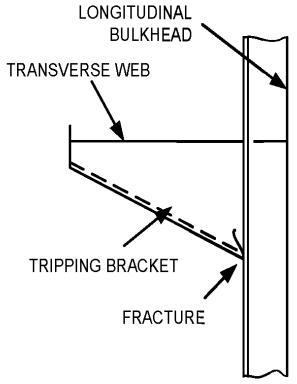
Sketch of damage

OIL Tankers	Guidelines for Surveys, Assessment and Repair of Hull Structure	
Group 4	Cargo area	Example No.
	Web Frame in cargo tank	5
Detail of damage	Fracture in way of connection of transverse web tripping brackets to longitudinal

1. Hard spot at the toe of bracket.
2. Vibration.

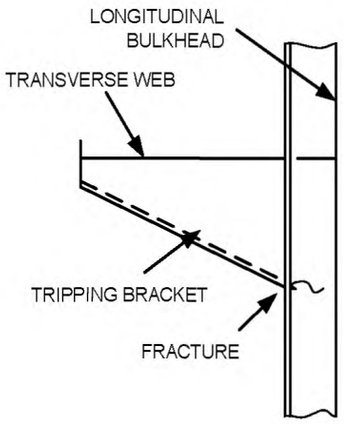
Sketch of damage

OIL Tankers	Guidelines for Surveys, Assessment and Repair of Hull Structure	
Group 4	Cargo area	Example No.
	Web Frame in cargo tank	6
Detail of damage	Tripping brackets modification of the bracket toe.

1. Stress concentrations at toe of bracket.
2. High stress in longitudinal.

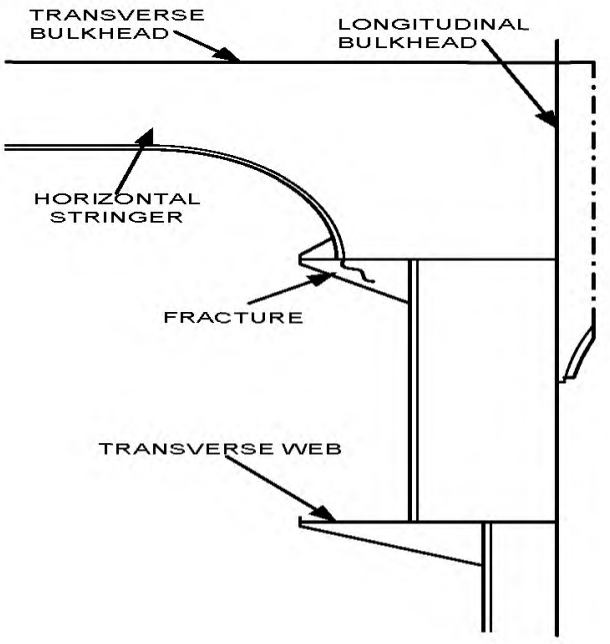
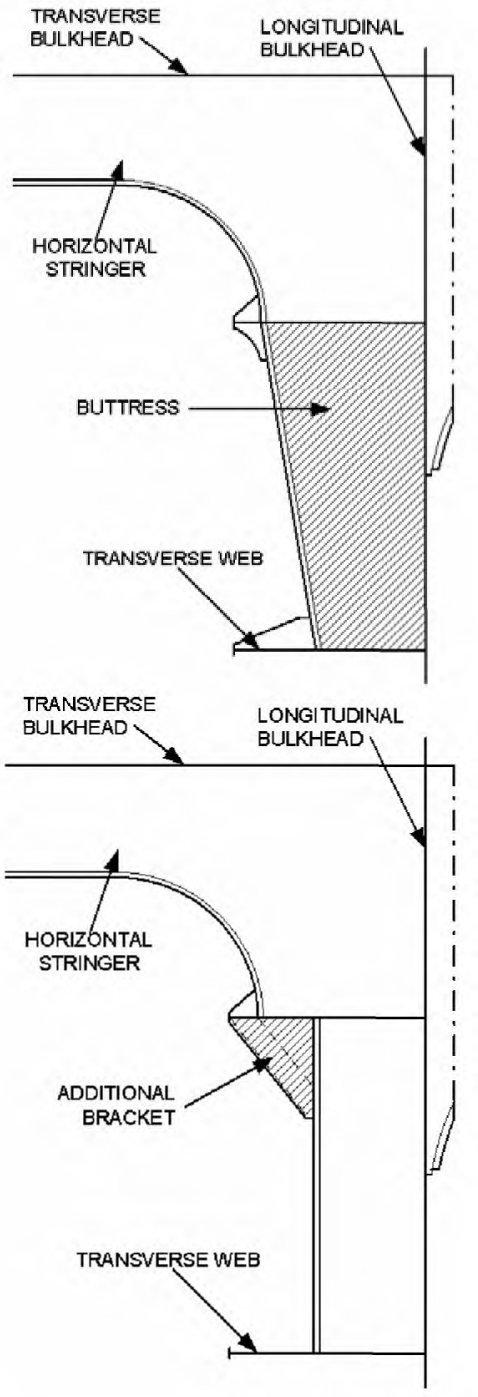
1. Stress concentration due to discontinuous structure.
2. High shear stress in the horizontal stringer.

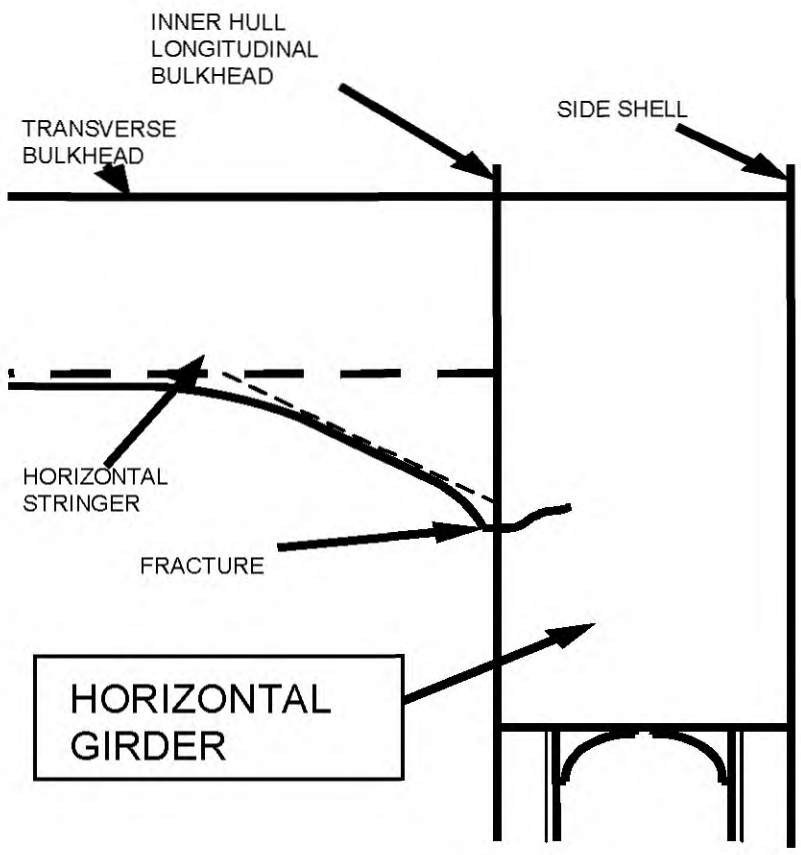
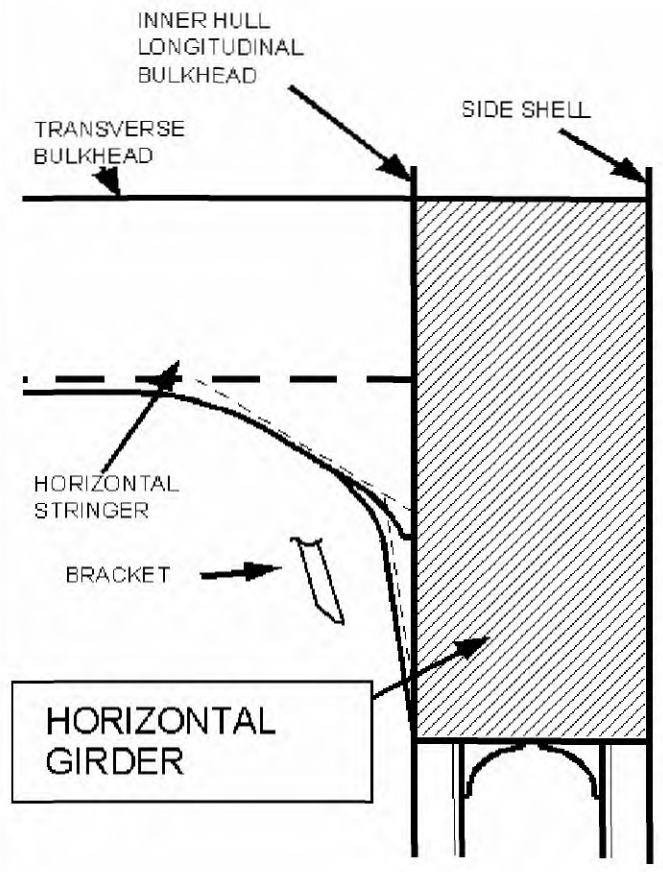
Factors which may have caused damage	Notes on repairs
1. Misalignment between bracket end and side girder in wing tank.	See Sketch.

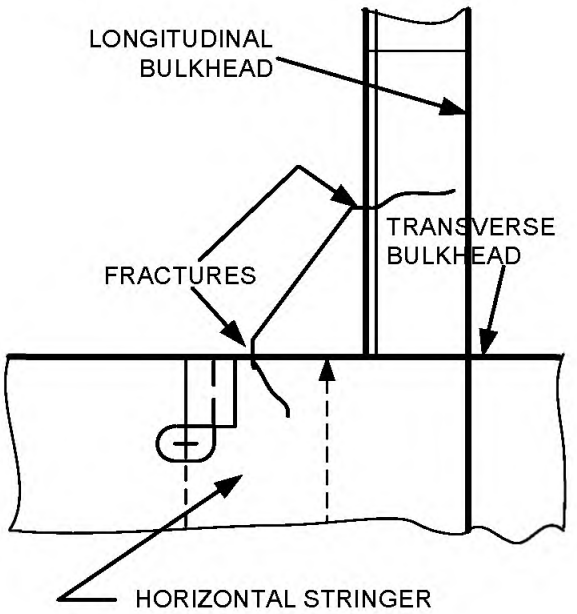
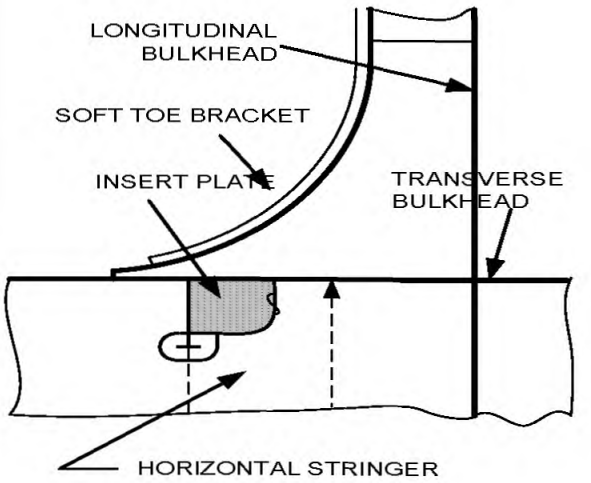
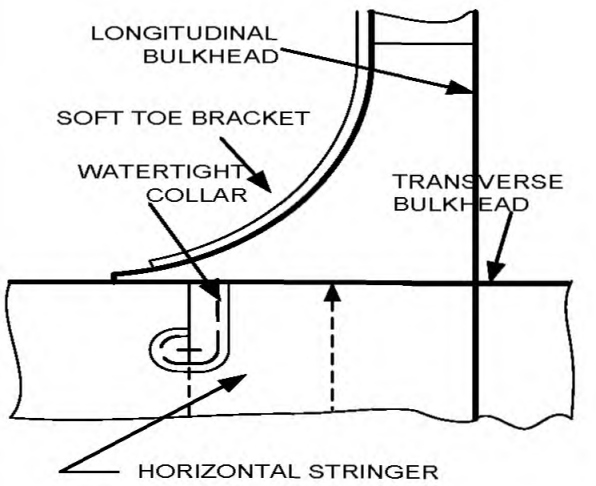
OIL Tankers	Guidelines for Surveys, Assessment and Repair of Hull Structure	
Group 5	Cargo area	Example No.
	Transverse Bulkhead in cargo tank	3
Detail of damage	Connection of longitudinals to horizontal stringers.

1. Stress concentration due to inadequate shape of the bracket.
2. Relative deflection of adjoining transverse web against transverse bulkhead.

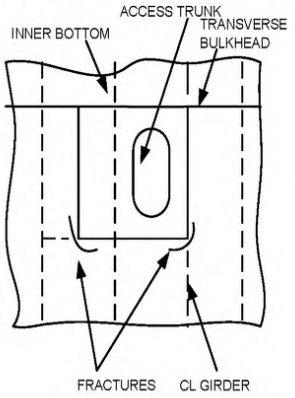
Sketch of damage

OIL Tankers	Guidelines for Surveys, Assessment and Repair of Hull Structure	
Group 5	Cargo area	Example No.
	Transverse Bulkhead in cargo tank	4
Detail of damage	Fractured inner bottom plate at the connection to access trunk wall

1. Stress concentration at the connection of trunk wall to inner bottom plate.
2. Relative deformation between horizontal stringer fitted on transverse bulkhead and inner bottom plate.
3. Static and dynamic load of cargo liquid.
