No. 96 (April 2007) **Double Hull Oil Tankers -** Guidelines for Surveys, Assessment and Repair of Hull Structures

DOUBLE HULL OIL TANKERS

Guidelines for Surveys, Assessment and Repair of Hull Structures

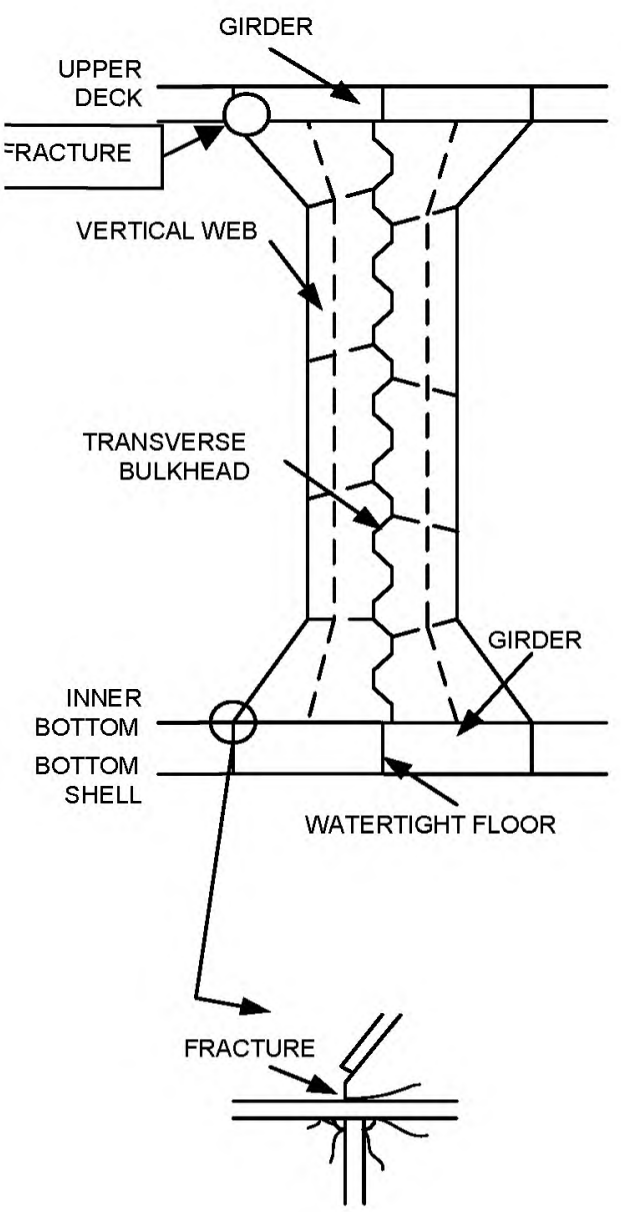
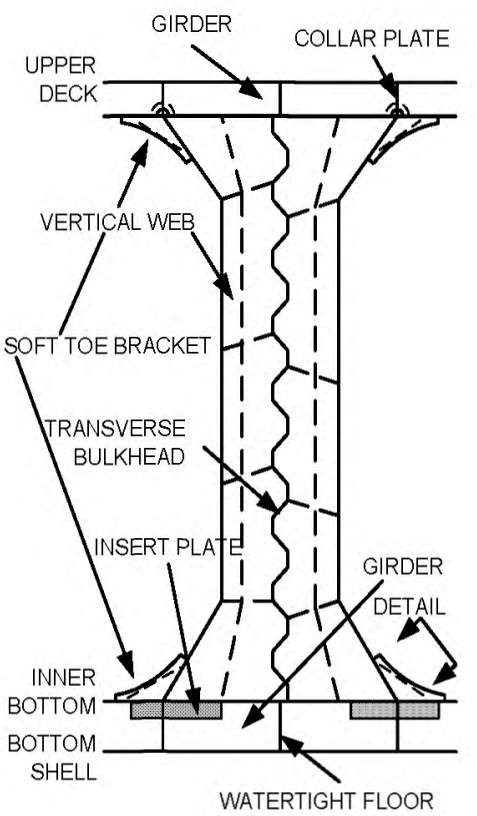
1. Stress concentration at toe of bracket due to sniped face plate and scallop in way.

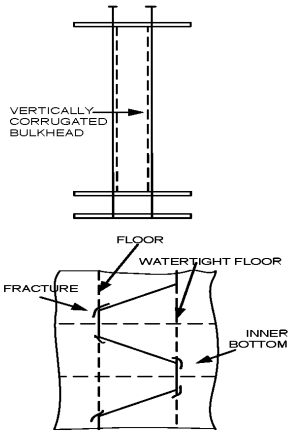
Sketch of damage

OIL Tankers	Guidelines for Surveys, Assessment and Repair of Hull Structure	
Group 5	Cargo area	Example No.
	Transverse Bulkhead in cargo tank	6
Detail of damage	Vertically corrugated bulkhead without stool, connection to deck and inner bottom

1. Stress concentration due to unsupported corrugation web.
2. High through thickness stress, lamellar tearing.
3. Weld details and dimensions.
4. Misalignment between face of corrugation and floor underneath.
5. Cut-outs and scallops or air holes increasing the stress in the floor.
6. Insufficient through thickness properties of inner bottom plate.

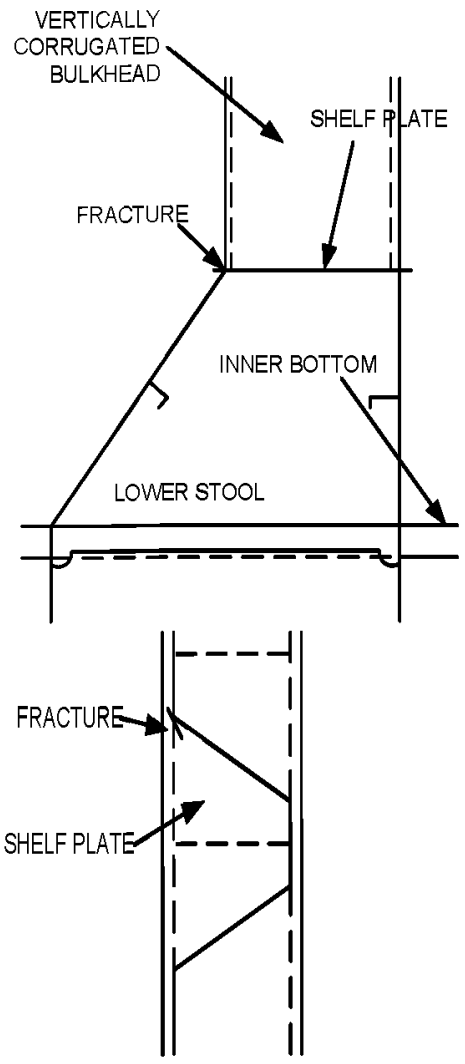
Sketch of damage

OIL Tankers	Guidelines for Surveys, Assessment and Repair of Hull Structure	
Group 5	Cargo area	Example No.
	Transverse Bulkhead in cargo tank	7
Detail of damage	Fracture at connection of vertically corrugated transverse bulkhead with stool to shelf plate and lower stool plate.

1. Stress concentration due to unsupported corrugation web.
2. High through thickness stress, lamellar tearing.
3. Weld details and dimensions.
4. Misalignment.
5. Insufficient thickness of stool side plating in relation to corrugation flange thickness.

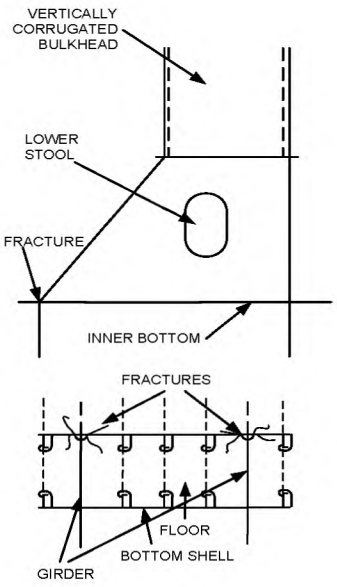
Sketch of damage

OIL Tankers	Guidelines for Surveys, Assessment and Repair of Hull Structure	
Group 5	Cargo area	Example No.
	Transverse Bulkhead in cargo tank	8
Detail of damage	Fracture at connection of lower stool plate to inner bottom tank. Lower stool plate connected to vertically corrugated transverse bulkhead.

1. Misalignment between stool side plating and floor and/or stool webs and girders of double bottom.
2. Insufficient thickness of floor compared to stool thickness.
3. Scallops, cut-outs, air hole reducing the connecting area too much.
4. Weld details and dimensions.
5. Lamellar tearing of inner bottom plating.

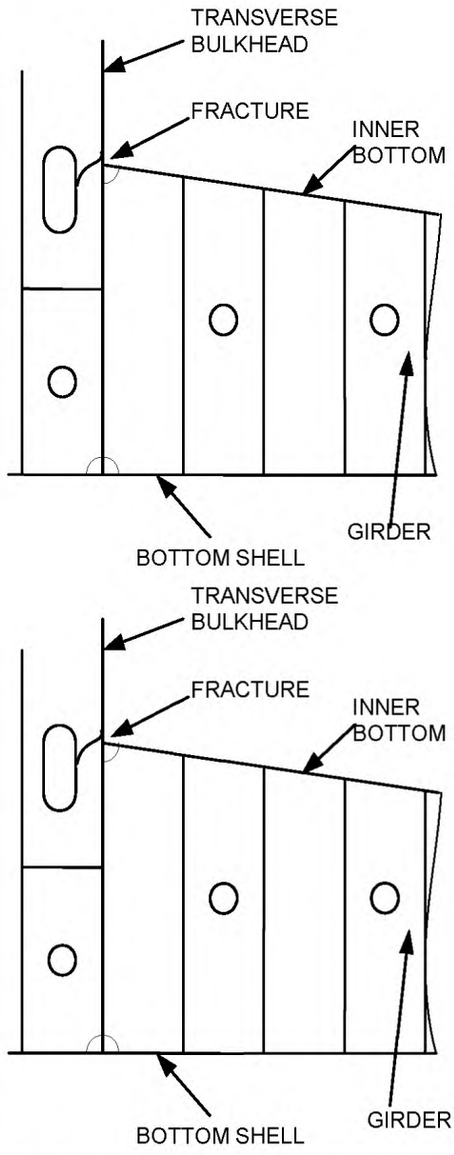
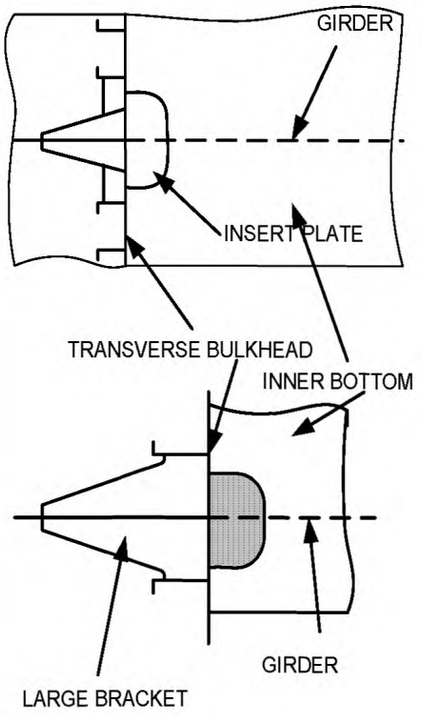
1. High stress concentration.
2. Discontinuity of structural members at knuckle joint.

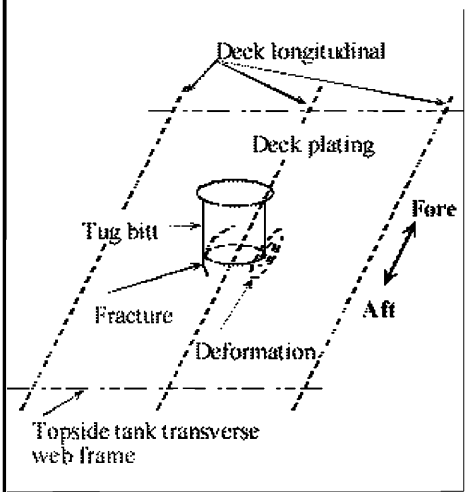
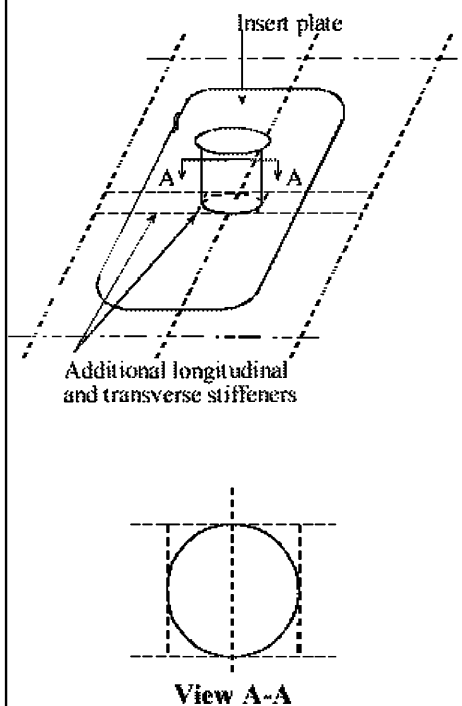
1. Insufficient strength

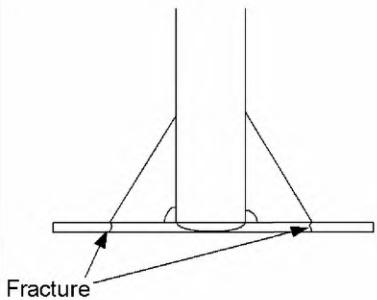
Sketch of damage

OIL Tankers	Guidelines for Surveys, Assessment and Repair of Hull Structure	
Group 6	Deck Structure	Example No.
		5
Detail of damage	Fractured deck plating in way of deck pipe support stanchions (midships)

1. Stanchions experience more severe relative displacements from hull girder bending.

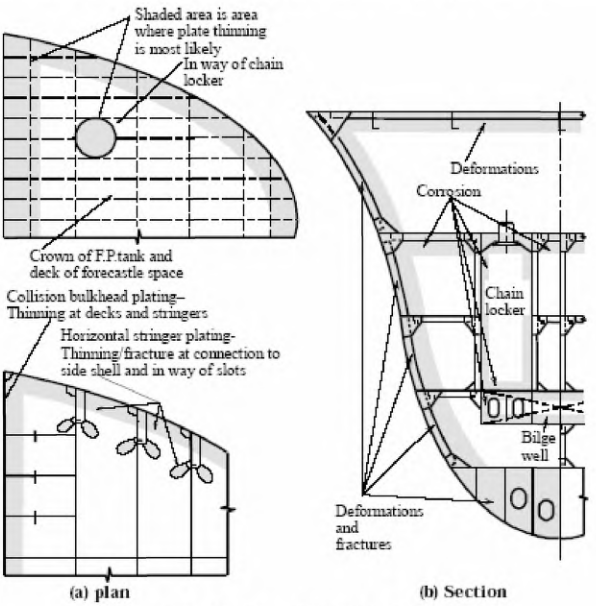
Fig 1 Fore end structure - Potential problem areas

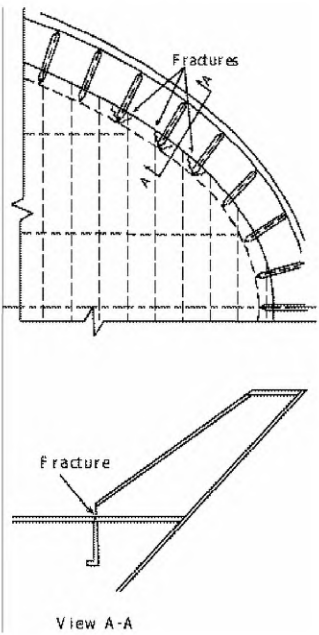
Sketch of damage

OIL Tankers	Guidelines for Surveys, Assessment and Repair of Hull Structure	
Group 7	Fore region	Example No.
Area 1	Forecastle	1
Detail of damage	Fracture in forecastle deck plating at bulwark

1. Bow Flare effect in heavy weather.
2. Stress concentration due to poor design.

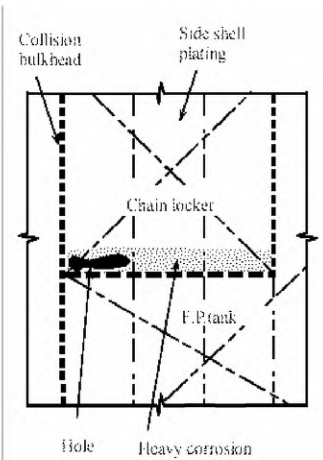
Sketch of damage

OIL Tankers	Guidelines for Surveys, Assessment and Repair of Hull Structure	
Group 7	Fore region	Example No.
Area 1	Chain locker	2
Detail of damage	Fractures in side shell plating in way of chain locker

1. Heavy corrosion in region where mud is accumulated.

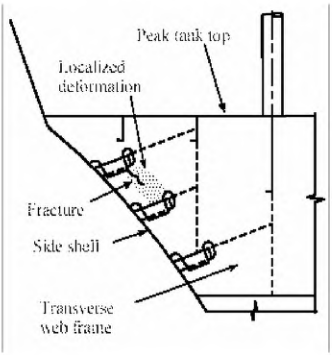
Sketch of damage

OIL Tankers	Guidelines for Surveys, Assessment and Repair of Hull Structure	
Group 7	Fore region	Example No.
Area 1	Forepeak ballast tank	3
Detail of damage	Fractures and deformation of bow transverse webs in way of cut-outs for side longitudinals

1. Localized material wastage in way of coating failure at cut-outs and sharp edges due to working of the structure.
2. Dynamic seaway loading in way of bow flare.

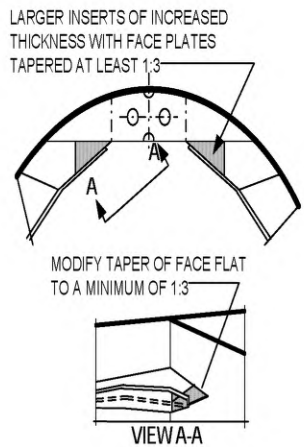
Sketch of repair

1. Inadequate brackets forming the longitudinal endings at bow structure.
2. Localised thinning in way of coating failure at longitudinal endings due to flexing of the structure.
3. Dynamic seaway loadings at bow causing flexing at longitudinal endings.

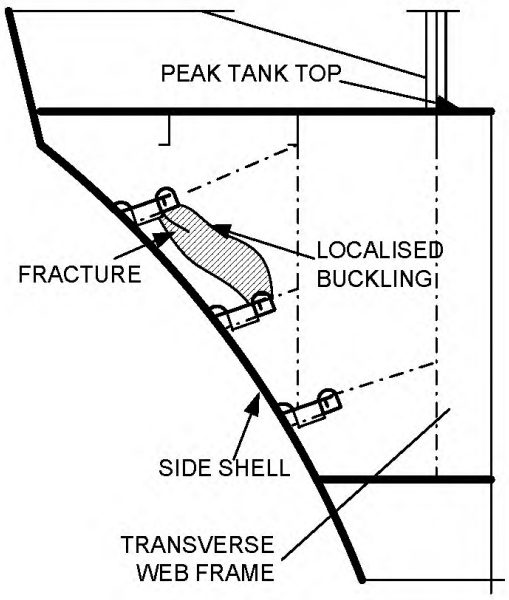
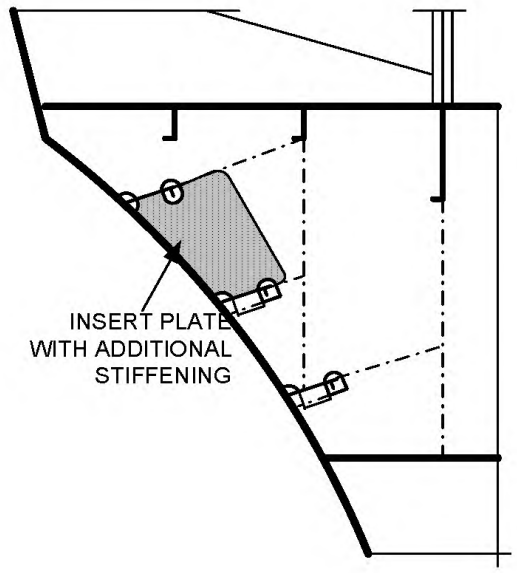
1. Localised thinning in way of coating failure at cut-outs and sharp edges due to working of the structure.
2. Dynamic seaway loadings in way of bow flare.

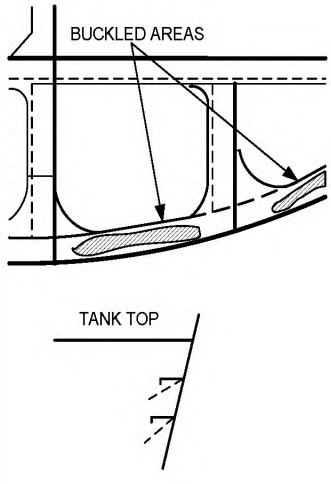
Sketch of damage

OIL Tankers	Guidelines for Surveys, Assessment and Repair of Hull Structure	
Group 7	Fore region	Example No.
Area 1	Fore peak ballast tank	8
Detail of damage	Buckled and tripped breasthooks

1. Bow impact load.
2. Low buckling resistance.

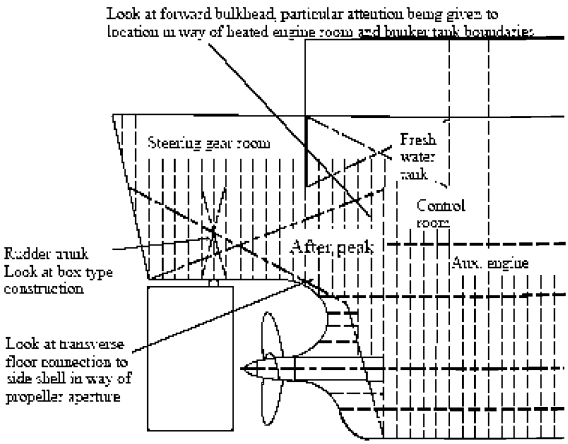
Figure 1 Aft end structure - Potential problem areas

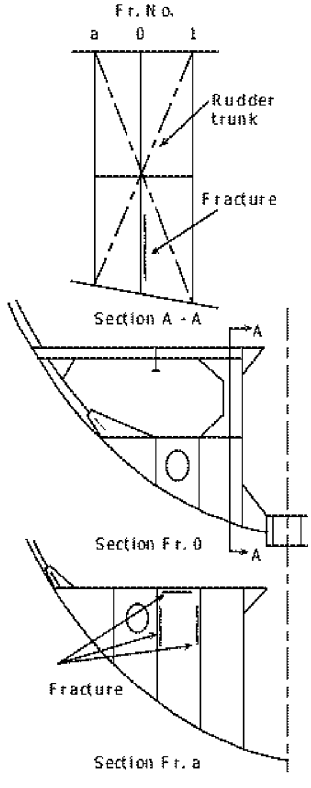
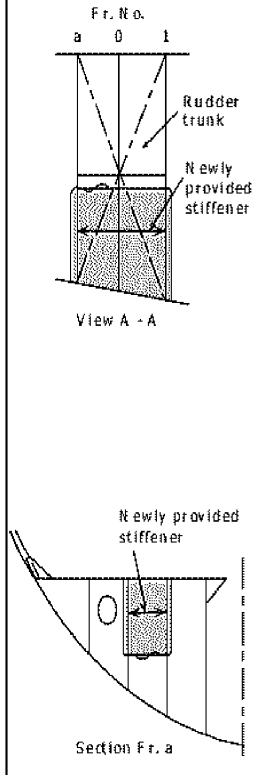
1. Vibration.

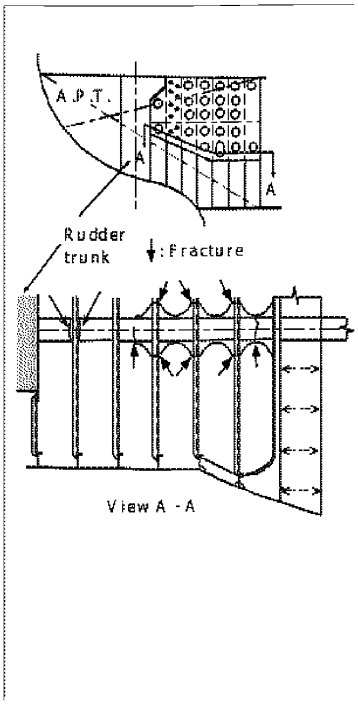
Sketch of damage

OIL Tankers	Guidelines for Surveys, Assessment and Repair of Hull Structure	
Group 7	Aft region	Example No.
Area 2	Aft peak ballast tank	10
Detail of damage	Fractures at the connection of floors and girders/side brackets

1. Vibration.

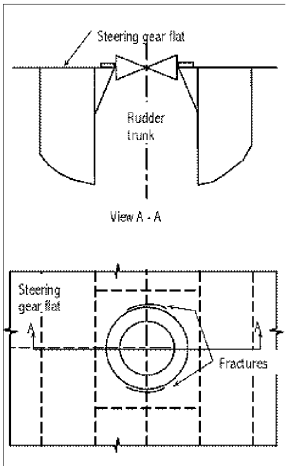
Sketch of damage

OIL Tankers	Guidelines for Surveys, Assessment and Repair of Hull Structure	
Group 7	Aft region	Example No.
Area 2	Machinery space outside Engine room	11
Detail of damage	Fractures in flat where rudder carrier is installed in steering gear room

1. Inadequate design.

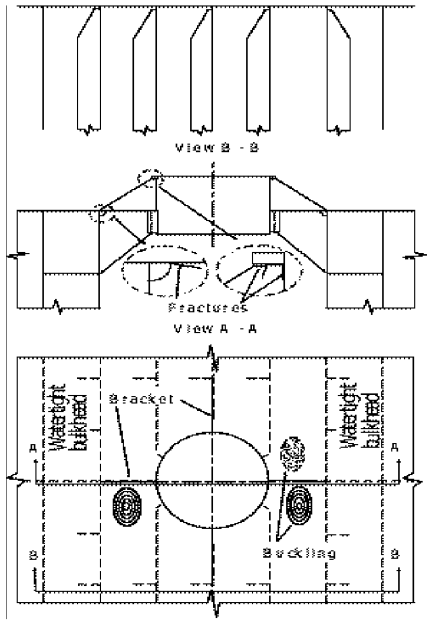
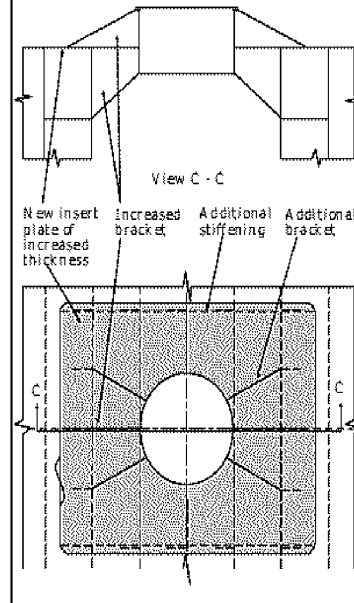
1. Insufficient deck strengthening (missing base plate).
2. Insufficient strengthening of steering gear foundation.
3. Bolts of steering gear were not sufficiently pre-loaded.

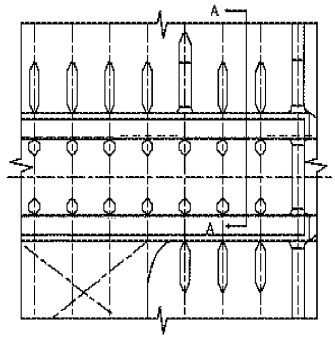
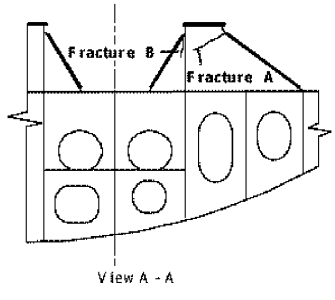
Sketch of damage

OIL Tankers	Guidelines for Surveys, Assessment and Repair of Hull Structure	
Group 8	Machinery and accommodation spaces	Example No.
Area 1	Engine room	1
Detail of damage	Fractures in brackets at main engine foundation

1. Vibration of main engine.
2. Insufficient strength of brackets at main engine foundation.
3. Insufficient pre-load of the bolts.

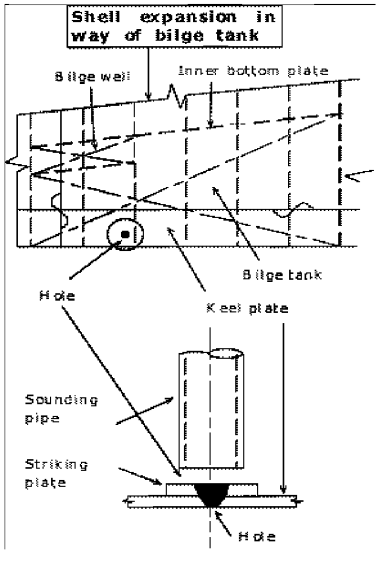
Sketch of damage

OIL Tankers	Guidelines for Surveys, Assessment and Repair of Hull Structure	
Group 8	Machinery and accommodation spaces	Example No.
Area 1	Engine room	2
Detail of damage	Corrosion in bottom plating under sounding pipe in way of bilge storage tank in engine room

1. Heavy corrosion of bottom plating under sounding pipe.
