No.76 IACS Guidelines for Surveys, Assessment and Repair of Hull Structure – Bulk Carriers

BULK CARRIERS

Guidelines for Surveys, Assessment and Repair of Hull Structure

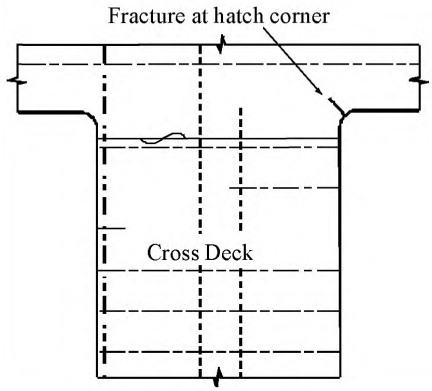
Sketch of damage

BULK CARRIERS	Guidelines for Surveys, Assessment and Repair of Hull Structure	
Part 1	**Cargo hold region**	**Example No.**
Area 1	**Deck structure**	**1**
Detail of damage	Fractures at main cargo hatch corner

1. Stress concentration at hatch corners, i.e. radius of corner.
2. Welded attachment of shedder plate close to edge of hatch corner.
3. Wire rope groove.

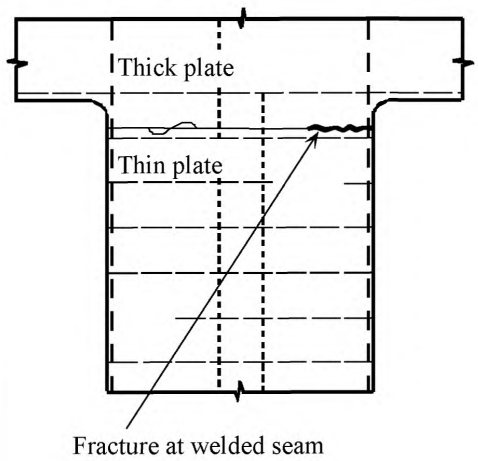
Sketch of damage

BULK CARRIERS	Guidelines for Surveys, Assessment and Repair of Hull Structure	
Part 1	**Cargo hold region**	**Example No.**
Area 1	**Deck structure**	**2-a**
Detail of damage	Fractures of welded seam between thick plate and thin plate at cross deck

1. Stress concentration created by abrupt change in deck plating thickness.
2. In-plane bending in cross deck strip due to torsional (longitudinal) movements of ship sides.
3. Welded seam not clear of tangent point of hatch corner.

Copyright
© **IACS - the International Association of Classification Societies and the International Association of Classification Societies Limited.**

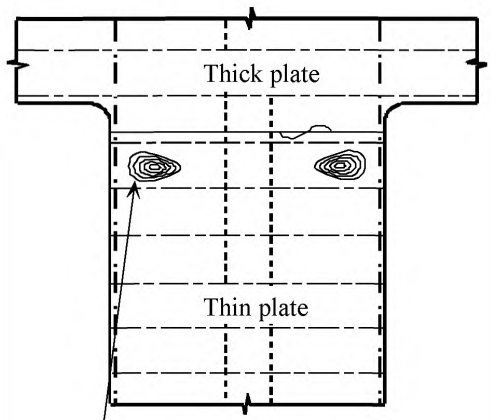
Sketch of damage

BULK CARRIERS	Guidelines for Surveys, Assessment and Repair of Hull Structure	
Part 1	**Cargo hold region**	**Example No.**
Area 1	**Deck structure**	**2-b**
Detail of damage	Plate buckling in thin plate near thick plate at cross deck

Buckling of cross deck plating (Buckling of hatch end structure should be examined. Refer to **Example 7-a**.)

Except as permitted under current English legislation no part of this work may be photocopied, stored in a retrieval system, published, performed in public, adapted, broadcast, transmitted, recorded or reproduced in any form or by means, without prior permission of the copyright owner.

Additional transverse stiffening and/or insertion of plate with suitable intermediate thickness

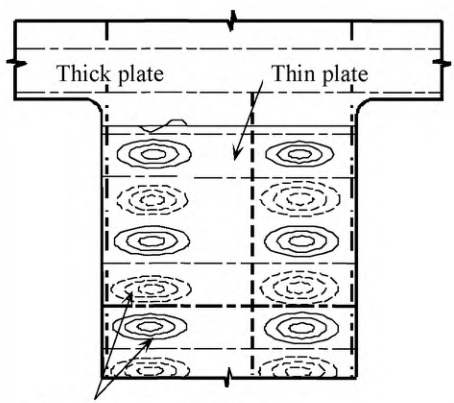
Sketch of damage

BULK CARRIERS	Guidelines for Surveys, Assessment and Repair of Hull Structure	
Part 1	**Cargo hold region**	**Example No.**
Area 1	**Deck structure**	**2-c**
Detail of damage	Overall buckling of cross deck plating

Buckling of cross deck plating (Buckling of hatch end structure should be examined. Refer to **Example 7-a.**)

1. Transverse compression of deck due to sea load.
2. Transverse compression of deck due to excessive loading in two adjacent holds.
3. Insufficient plate thickness and/or transverse stiffening.

Enquiries should be addressed to the Permanent Secretary:

International Association of Classification Societies Ltd,
36 Broadway,
London, SW1H 0BH
Telephone: 020 7976 0660
Fax: 020 7808 1100
Email: gost.e-ecolog.ru

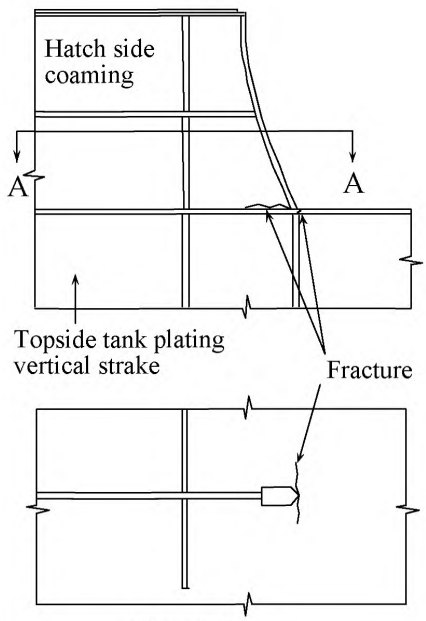
Sketch of damage

BULK CARRIERS	Guidelines for Surveys, Assessment and Repair of Hull Structure	
Part 1	Cargo hold region	Example No.
Area 1	Deck structure	3-a
Detail of damage	Fractures in the web or in the deck at the toes of the longitudinal hatch coaming termination bracket

Terms and Conditions
The International Association of Classification Societies (IACS), its Member Societies and IACS Ltd. and their directors, officers, members, employees and agents (on behalf of whom this notice is issued) shall be under no liability or responsibility in contract or negligence or otherwise howsoever to any person in respect of any information or advice expressly or impliedly given in this document, or in respect of any inaccuracy herein or omission herefrom or in respect of any act or omission which has caused or contributed to this document being issued with the information or advice it contains (if any).
Without derogating from the generality of the foregoing, neither the International Association of Classification Societies (IACS) nor IACS Ltd. nor its Member Societies nor their directors, officers, members, employees or agents shall be liable in contract or negligence or otherwise howsoever for any direct, indirect or consequential loss to any person caused by or arising from any information, advice, inaccuracy or omission given or contained herein or any act or omission causing or contributing to any such information, advice, inaccuracy or omission given or contained herein.

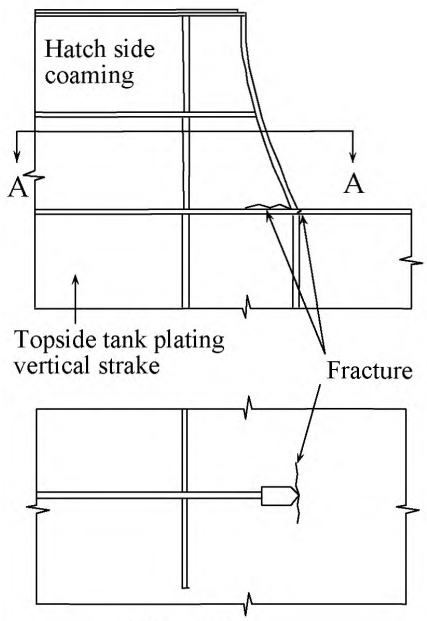
Sketch of damage

BULK CARRIERS	Guidelines for Surveys, Assessment and Repair of Hull Structure	
Part 1	Cargo hold region	Example No.
Area 1	Deck structure	3-b
Detail of damage	Fractures in the web or in the deck at the toes of the longitudinal hatch coaming termination bracket

1. This damage is caused by stress concentrations attributed to the design of the bracket.

Contents

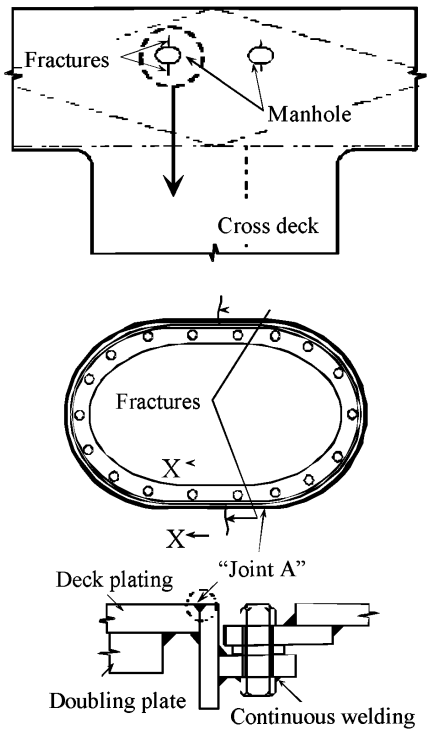
Sketch of damage

BULK CARRIERS	Guidelines for Surveys, Assessment and Repair of Hull Structure	
Part 1	**Cargo hold region**	**Example No.**
Area 1	**Deck structure**	**4**
Detail of damage	Fractures in deck plating initiated from weld of access manhole

1. Heavy weather.
2. Improper welding of joint "A".

2 Class survey requirements
2.1 General
2.2 Annual Surveys
2.3 Intermediate Surveys
2.4 Special Surveys
2.5 Bottom surveys
2.6 Damage and repair surveys

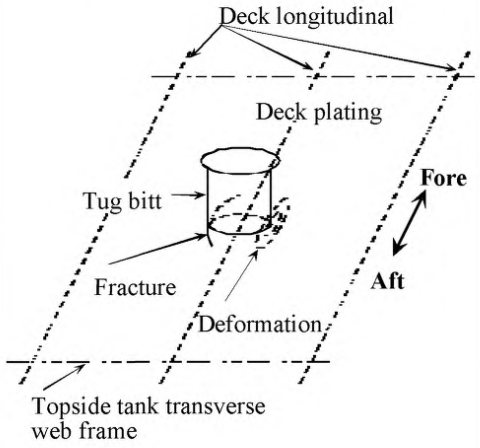
Sketch of damage

BULK CARRIERS	Guidelines for Surveys, Assessment and Repair of Hull Structure	
Part 1	Cargo hold region	Example No.
Area 1	Deck structure	5
Detail of damage	Deformed and fractured deck plating around tug bitt

4 Survey planning, preparation and execution
4.1 General
4.2 Survey Programme
4.3 Principles for Planning Document
4.4 Conditions for survey
4.5 Access arrangement and safety
4.6 Personal equipment
4.7 Thickness measurement and fracture detection
4.8 Survey at sea or at anchorage
4.9 Documentation on board

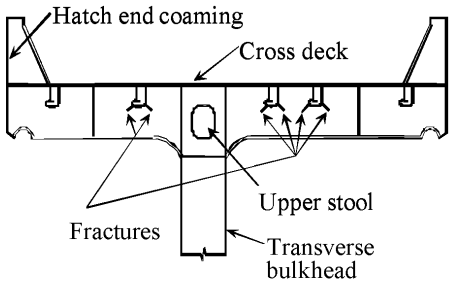
Sketch of damage

BULK CARRIERS	Guidelines for Surveys, Assessment and Repair of Hull Structure	
Part 1	**Cargo hold region**	**Example No.**
Area 1	**Deck structure**	**6**
Detail of damage	Fractures around cut-outs in cross deck girder

1. Stress concentration at the cut-outs in cross deck girder.

Part 2 Fore and aft end regions
- Area 1 Fore end structure
- Area 2 Aft end structure
- Area 3 Stern frame, rudder arrangement and propeller shaft support

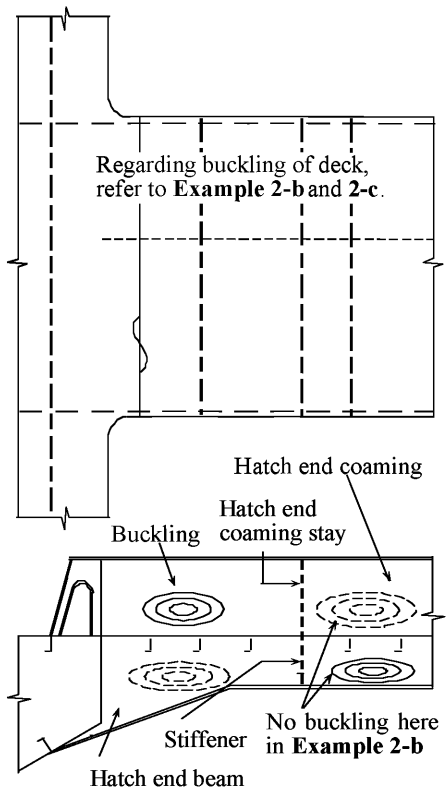
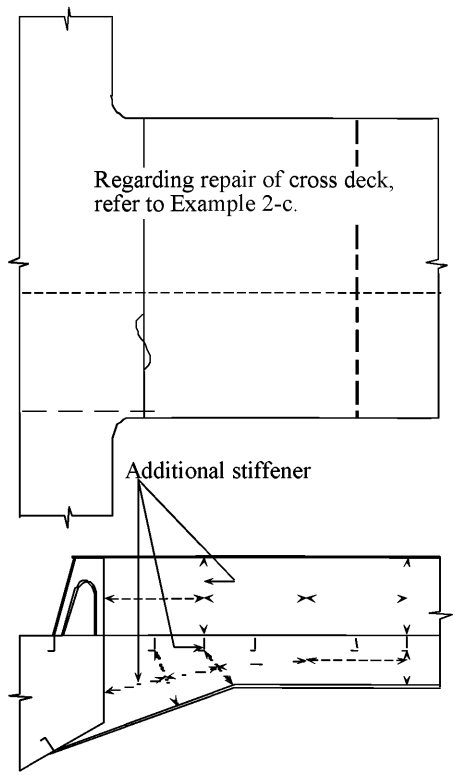
BULK CARRIERS	Guidelines for Surveys, Assessment and Repair of Hull Structure	
Part 1	**Cargo hold region**	**Example No.**
Area 1	**Deck structure**	**7-a**
Detail of damage	Buckling of hatch coaming and hatch end beam

1. Additional transverse forces due to heavy seas, and torsional loading.
2. Inadvertent overloading of cargo spaces.

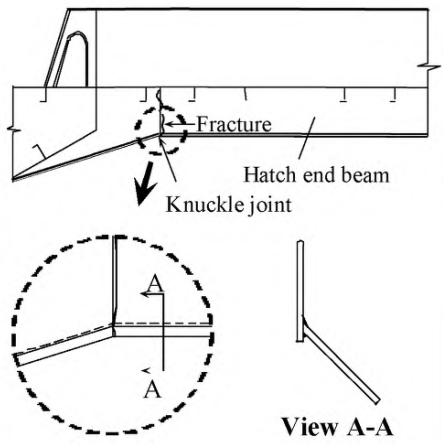
Sketch of damage

BULK CARRIERS	Guidelines for Surveys, Assessment and Repair of Hull Structure	
Part 1	**Cargo hold region**	**Example No.**
Area 1	**Deck structure**	**7-b**
Detail of damage	Fractures in hatch end beam at knuckle joint

1. Stress concentration at knuckle joint.

This manual gives guidelines for a bulk carrier type ship which is constructed with a single deck, single skin, double bottom, hopper side tanks and topside tanks in cargo spaces, and is intended primarily to carry dry cargo, including ore, in bulk. **Figure 1** shows the general view of a typical single skin bulk carrier with 9 cargo holds.

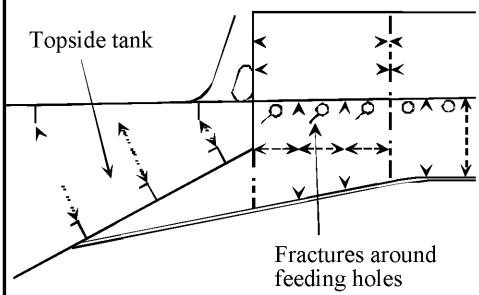
Sketch of damage

BULK CARRIERS	Guidelines for Surveys, Assessment and Repair of Hull Structure	
Part 1	**Cargo hold region**	**Example No.**
Area 1	**Deck structure**	**9**
Detail of damage	Fractures in hatch end beam around feeding holes

The manual includes a review of survey preparation guidelines, which cover the safety aspects related to the performance of the survey, the necessary access facilities, and the preparation necessary before the surveys can be carried out.

The survey guidelines encompass the different main structural areas of the hull where damages have been recorded, focusing on the main features of the structural items of each area.

Reinforcement of feeding holes by doubling plate or insert of pipe. See "Detail" below.

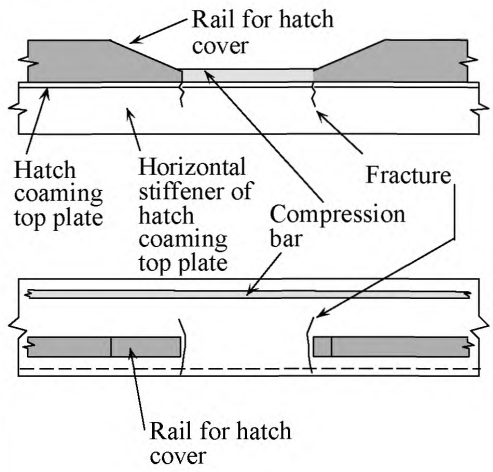
Sketch of damage

BULK CARRIERS	Guidelines for Surveys, Assessment and Repair of Hull Structure	
Part 1	**Cargo hold region**	**Example No.**
Area 1	**Deck structure**	**10-a**
Detail of damage	Fractures in hatch coaming top plate at the termination of rail for hatch cover

1. Stress concentration at the termination of the rail for hatch cover due to poor design.

The "IACS Early Warning Scheme (EWS)", with the emphasis on the proper reporting of significant hull damages by the respective Classification Societies, will enable the analysis of problems as they arise, including revisions of these Guidelines.

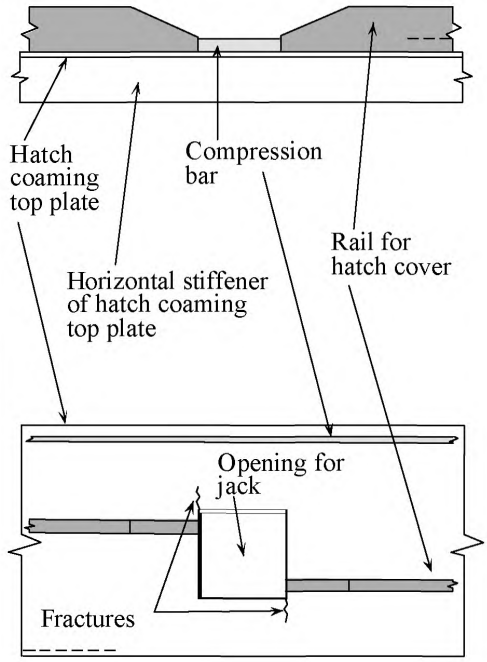
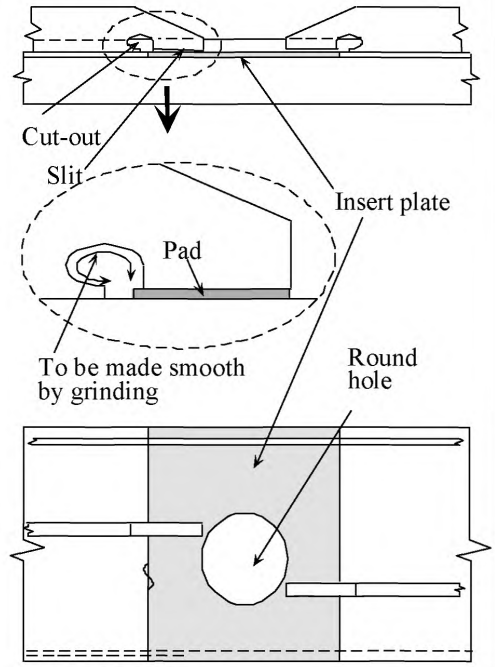
BULK CARRIERS	Guidelines for Surveys, Assessment and Repair of Hull Structure	
Part 1	**Cargo hold region**	**Example No.**
Area 1	**Deck structure**	**10-b**
Detail of damage	Fractures in hatch coaming top plate at the termination of rail for hatch cover

1. Stress concentration at the termination of the rail for hatch cover due to poor design of opening.

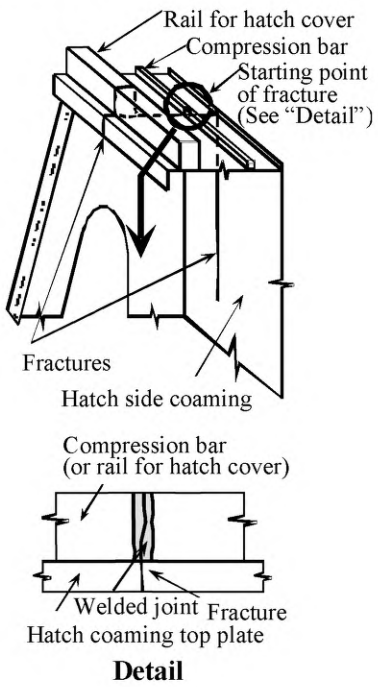
Sketch of damage

BULK CARRIERS	Guidelines for Surveys, Assessment and Repair of Hull Structure	
Part 1	**Cargo hold region**	**Example No.**
Area 1	**Deck structure**	**11**
Detail of damage	Fractures in hatch coaming top plate initiated from butt weld of compression bar

1. Heavy weather
2. Insufficient preparation of weld of compression bar and/or rail (Although the compression bar and rail are not longitudinal strength members, they subject same longitudinal stress as longitudinal members)
3. Crack may initiate from insufficient penetration of weld of rail for hatch cover.

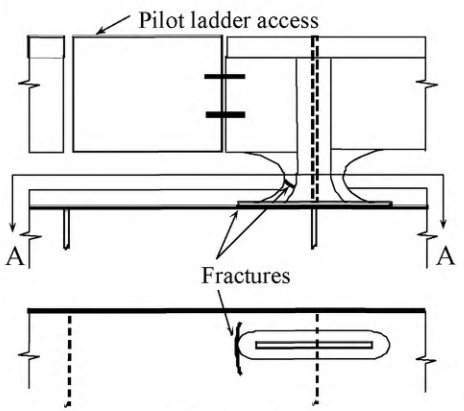
Sketch of damage

BULK CARRIERS	Guidelines for Surveys, Assessment and Repair of Hull Structure	
Part 1	**Cargo hold region**	**Example No.**
Area 1	**Deck structure**	**12**
Detail of damage	Fractures in deck plating at the pilot ladder access of bulwarks

2 Class survey requirements

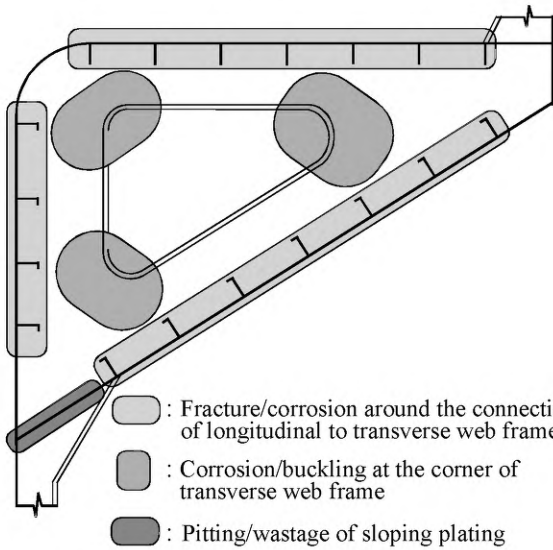
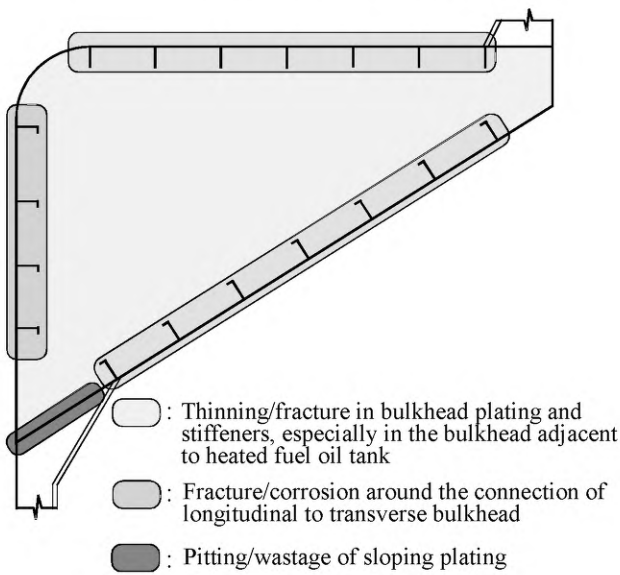
Figure 1 Topside tank - Potential problem areas

(c) Areas susceptible to coating breakdown
Back side of face plate of longitudinal
Welded joint
Edge of access opening

(d) Areas subjected to poor drainage
Web of side and sloping longitudinals

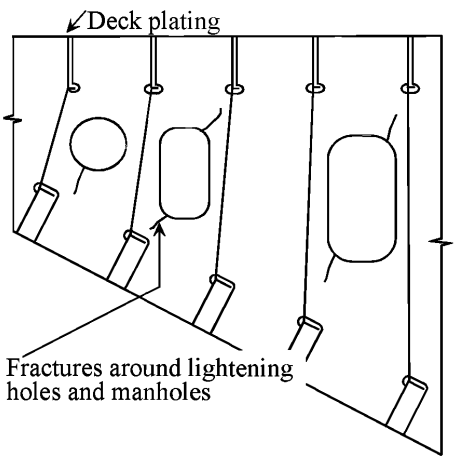
Sketch of damage

BULK CARRIERS	Guidelines for Surveys, Assessment and Repair of Hull Structure	
Part 1	Cargo hold region	Example No.
Area 2	Topside tank structure	1
Detail of damage	Fractures around unstiffened lightening holes and manholes in wash bulkhead

1. General levels of corrosion and presence of stress concentration.

2.1.3 The International Maritime Organization (IMO), in 1997 SOLAS Conference, adopted structural survivability standards for new and existing bulk carriers carrying the high density cargoes. All new single side skin bulk carriers, defined as ships built on or after 1st July 1999, are required to have sufficient strength to withstand the flooding of any one cargo hold taking dynamic effects into account. All existing single side skin bulk carriers, defined as ships built before 1 July 1999, must comply with the relevant IACS criteria for assessing the vertically corrugated transverse watertight bulkhead between the first two cargo holds and the double bottom in way of the first cargo hold with the first cargo hold assumed flooded. The relevant IMO adopted standards, IACS UR S19 and S22 for existing ships, and recommended standards, IACS UR S17, S18 and S20 for new ships, and the extent of possible repairs and/or reinforcements of vertically corrugated transverse watertight bulkheads on existing bulk carriers are freely available at IACS web site

gost.e-ecolog.ru

2.1.4 From 1 July 2001, bulk carriers of 20,000 DWT and above, to which the Enhanced Survey Programme (ESP) requirements apply, starting with the 3rd Special Survey, all Special and Intermediate hull classification surveys are to be carried out by at least two exclusive surveyors. Further, one exclusive surveyor is to be on board while thickness measurements are taken to the extent necessary to control the measurement process.

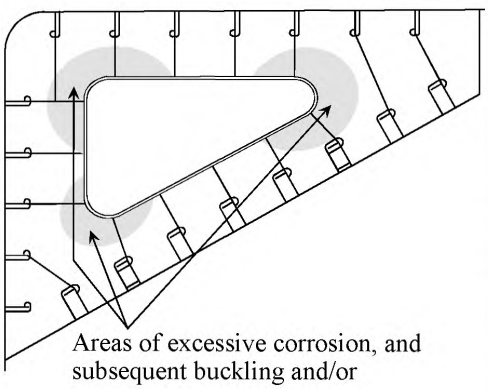
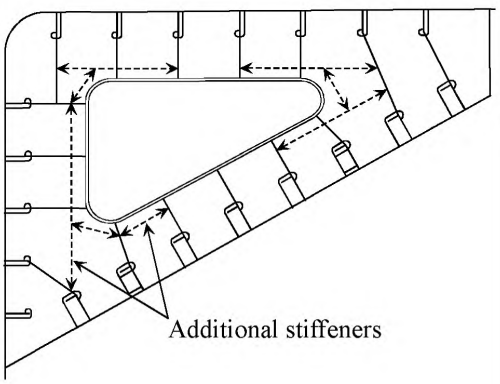
BULK CARRIERS	Guidelines for Surveys, Assessment and Repair of Hull Structure	
Part 1	Cargo hold region	Example No.
Area 2	Topside tank structure	2-a
Detail of damage	Thinning and subsequent buckling of web plating in the vicinity of the radii of the opening

1. Insufficient buckling strength.
2. Corrosion due to stress concentration at corners.

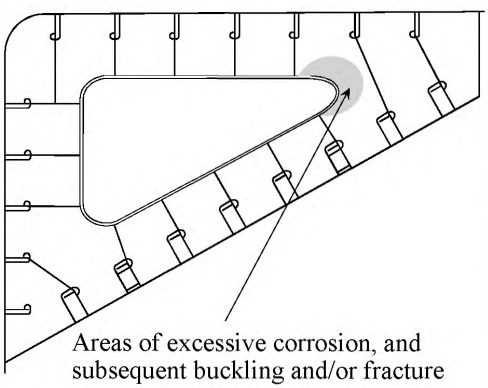
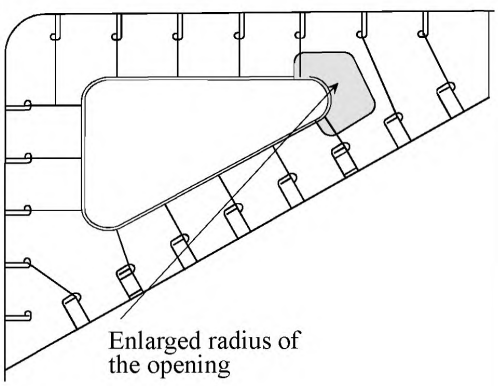
BULK CARRIERS	Guidelines for Surveys, Assessment and Repair of Hull Structure	
Part 1	Cargo hold region	Example No.
Area 2	Topside tank structure	2-b
Detail of damage	Thinning and subsequent buckling of web plating in the vicinity of the radii of the opening

1. Corrosion caused by stress concentration at the corner due to insufficient radius for the opening.

1. Corroded/buckled plating is to be cropped and parts renewed with plating of increased thickness and additional stiffeners are preferable to minimize deflection.
2. An attempt should be made to improve the design of the radius if felt necessary.

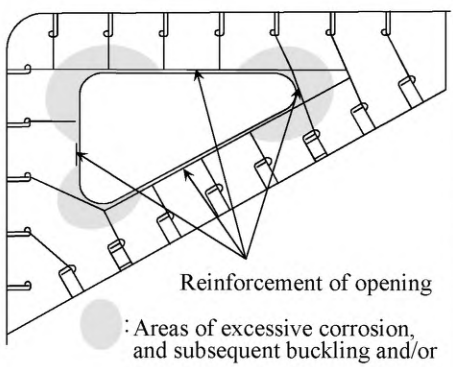
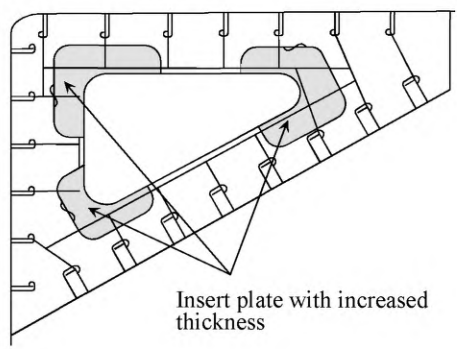
BULK CARRIERS	Guidelines for Surveys, Assessment and Repair of Hull Structure	
Part 1	**Cargo hold region**	**Example No.**
Area 2	**Topside tank structure**	**2-c**
Detail of damage	Thinning and subsequent buckling of web plating in the vicinity of the radii of the opening

1. Additional stresses at the free edge of transverse web. (In **Example 2-a - 2-c** face plate is provided for the reinforcement of the opening.)

1. Corroded/buckled plating is to be cropped and part renewed with plating of increased thickness.

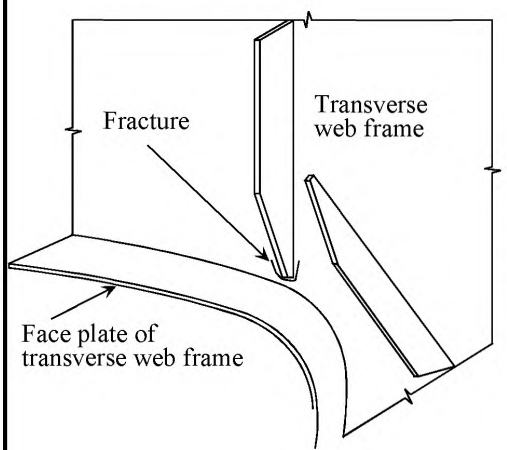
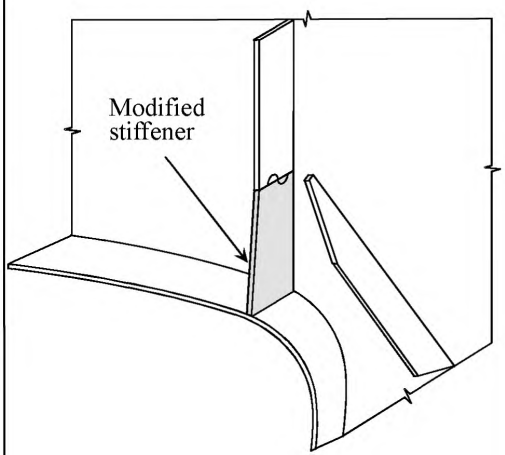
BULK CARRIERS	Guidelines for Surveys, Assessment and Repair of Hull Structure	
Part 1	**Cargo hold region**	**Example No.**
Area 2	**Topside tank structure**	**3**
Detail of damage	Fractures in transverse web at sniped end of stiffener

1. Stress concentration.

1. Fracture can be veed-out and welded provided the plating is not generally corroded. If necessary, fractured plating should be cropped and renewed.
2. Excessive stress concentration at the end of stiffener should be avoided.

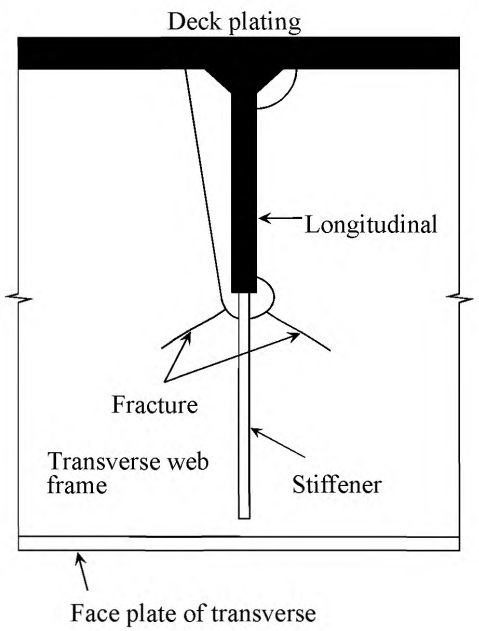
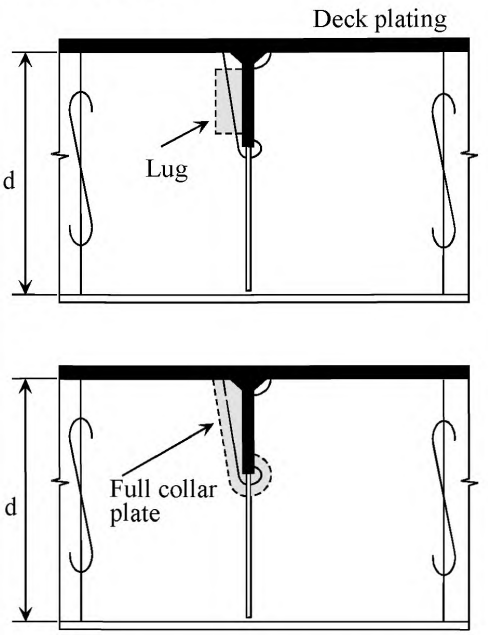
BULK CARRIERS	Guidelines for Surveys, Assessment and Repair of Hull Structure	
Part 1	Cargo hold region	Example No.
Area 2	Topside tank structure	4-a
Detail of damage	Fractures at slots in way of transverse web frame

(Note) Full collar plate where the depth of cut-out is more than 0.4 times the depth of web frame (0.4d) and in an areas of high shear stress

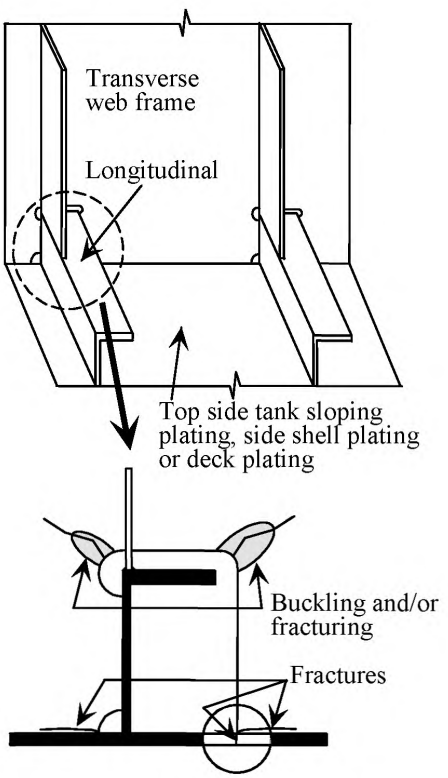
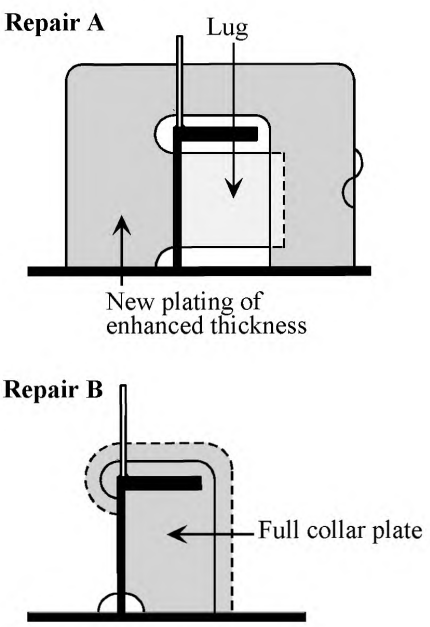
BULK CARRIERS	Guidelines for Surveys, Assessment and Repair of Hull Structure	
Part 1	Cargo hold region	Example No.
Area 2	Topside tank structure	4-b
Detail of damage	Fractures and buckling at slots in way of transverse web frame

1. Damage can be caused by general levels of corrosion and presence of stress concentration associated with the presence of a cut-out.

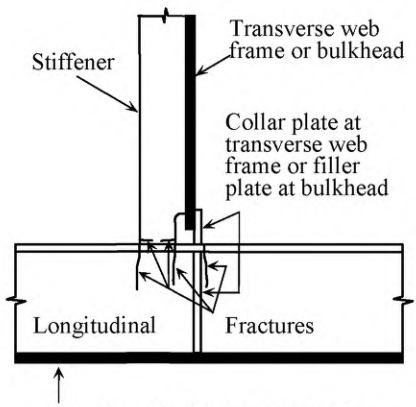
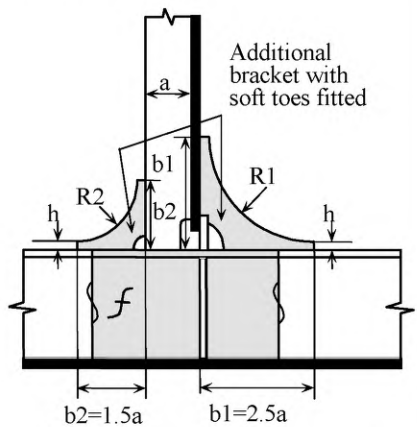
BULK CARRIERS	Guidelines for Surveys, Assessment and Repair of Hull Structure	
Part 1	**Cargo hold region**	**Example No.**
Area 2	**Topside tank structure**	**5**
Detail of damage	Fractures in longitudinal at transverse web frame or bulkhead

1. Damage can be caused by stress concentrations leading to accelerated fatigue in this region.

f: Where required, the longitudinal to be cropped and part renewed

1. For a slope at toes max. 1:3, R1=(b1-h)x 1.6 and R2=(b2-h)x 1.6
2. Soft toe bracket to be welded first to longitudinal
3. Scallop in bracket to be as small as possible, recommended max. 35mm
4. If toes of brackets are ground smooth, full penetration welds in way to be provided
5. Maximum length to thickness ratio =50:1 for unstiffened bracket edge
6. Toe height, h, to be as small as possible (10-15mm)

1. If fracture extends to over one third of the depth of the longitudinal, then crop and part renew. Otherwise the fracture can be veed-out and welded.

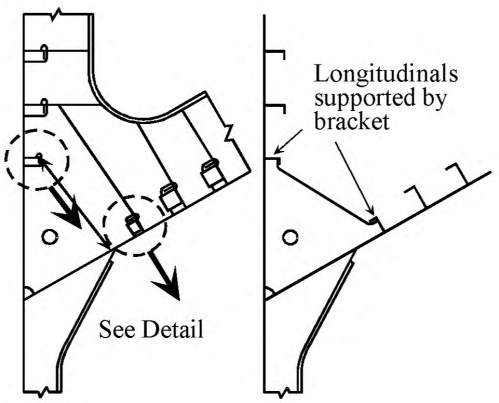
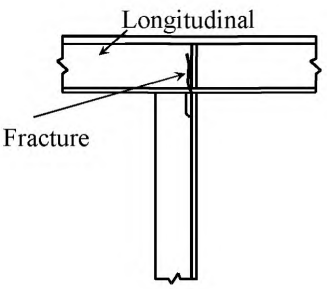
BULK CARRIERS	Guidelines for Surveys, Assessment and Repair of Hull Structure	
Part 1	Cargo hold region	Example No.
Area 2	Topside tank structure	6
Detail of damage	Fractures in the lowest longitudinal at transverse web frame

1. Insufficient scantling for torsional rigidity (The lowest longitudinal is usually supported by bracket(s) as shown in the above and smaller scantling may be adopted. However, the lowest longitudinal undergoes torsion from side shell frame through bracket(s) and may suffer fracture.)

1. Fractured part to be cropped and renewed.
2. Size of bracket should be increased

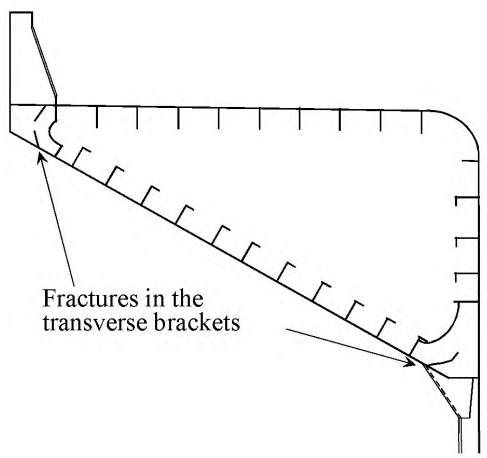
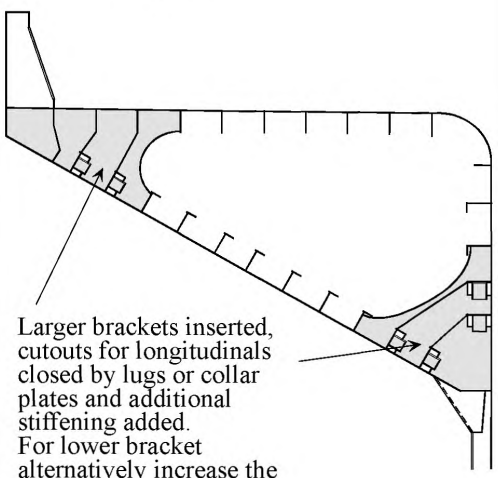
BULK CARRIERS	Guidelines for Surveys, Assessment and Repair of Hull Structure	
Part 1	Cargo hold region	Example No.
Area 2	Topside tank structure	7-a
Detail of damage	Fractures in transverse brackets

1. General levels of corrosion and presence of stress concentrations.
2. Misalignment of the brackets with adjoining structure, e.g. side shell frame brackets and/or coaming brackets.
3. High shear stresses due to insufficient bracket size.
4. Inadvertent overloading.

1. If the damage is caused by misalignment with the side shell frame brackets or the hatch coaming brackets the misalignment is to be rectified and the replacement by larger brackets incorporated only if considered necessary.

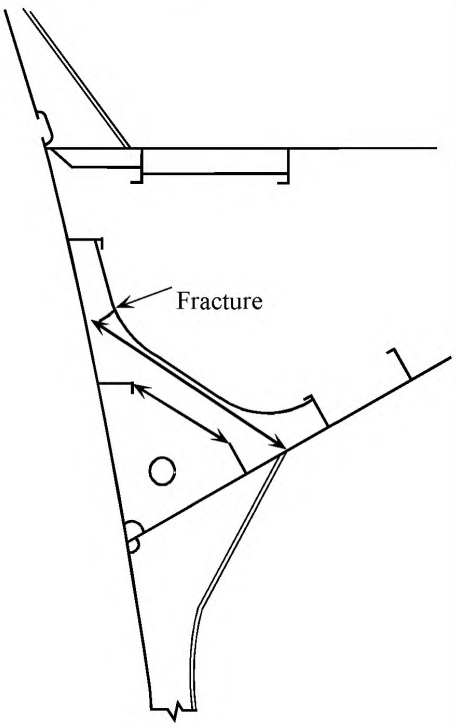
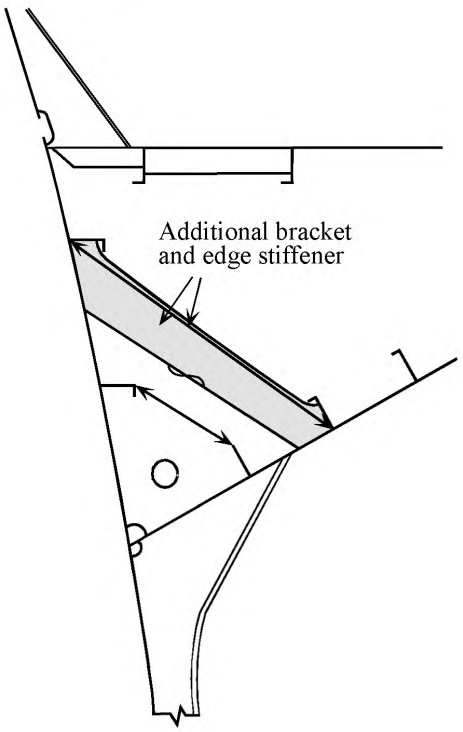
1. Insufficient strength.
2. Corrosion.

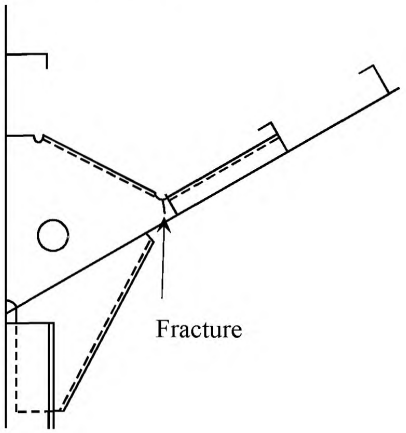
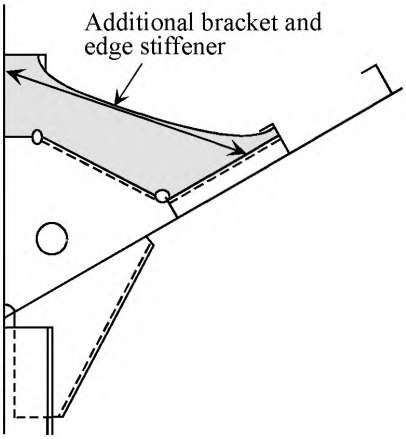
BULK CARRIERS	Guidelines for Surveys, Assessment and Repair of Hull Structure	
Part 1	Cargo hold region	Example No.
Area 2	Topside tank structure	7-c
Detail of damage	Fractures at toes of transverse bracket

1. Stress concentration due to the shape of the bracket.

1. Cracked weld to be veed-out and rewelded.

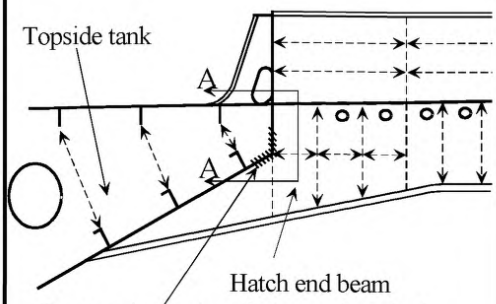
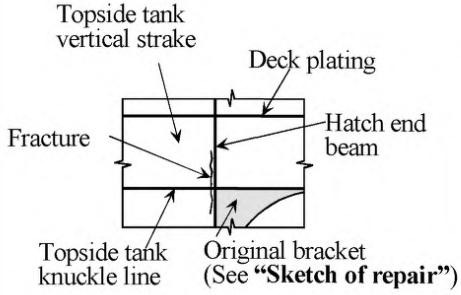
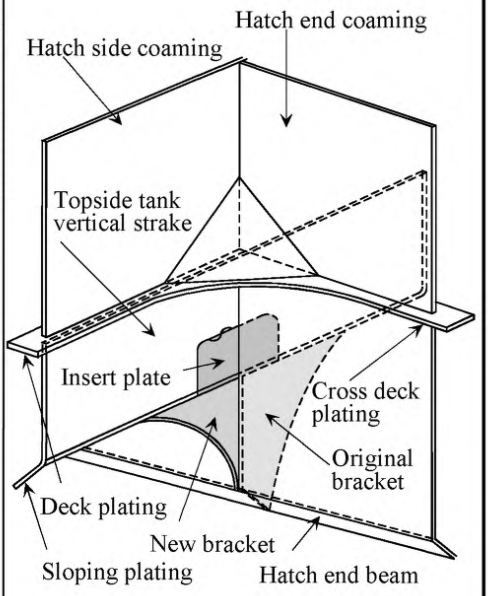
BULK CARRIERS	Guidelines for Surveys, Assessment and Repair of Hull Structure	
Part 1	**Cargo hold region**	**Example No.**
Area 2	**Topside tank structure**	**8**
Detail of damage	Fractures in sloping plating and vertical strake initiated from the connection of topside tank to hatch end beam

1. Stress concentration at the connection of hatch end beam to topside tank.

1. Fractured part to be cropped and renewed with increased thickness.
2. Additional bracket should be considered for reinforcement.

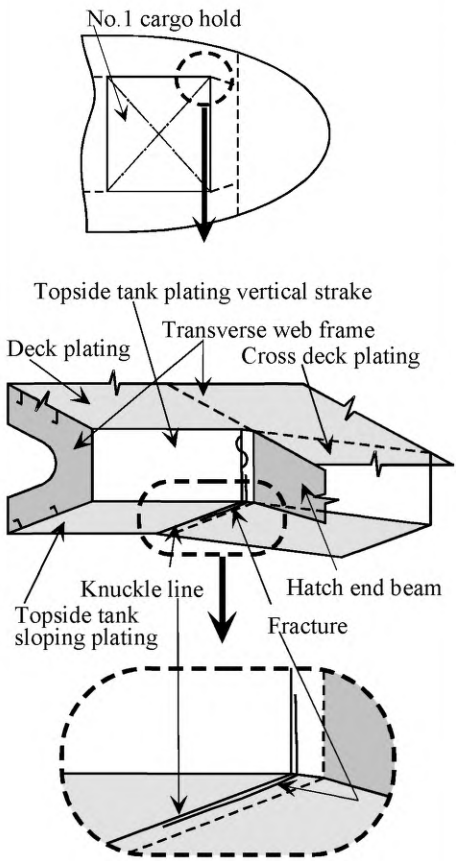
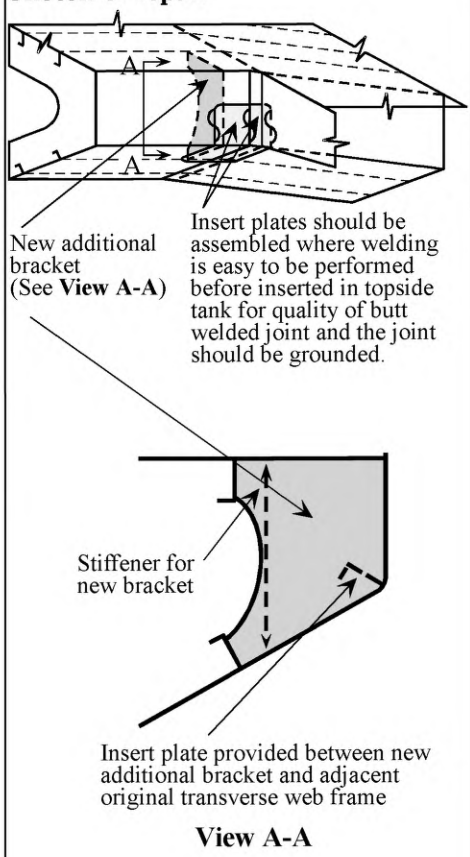
1. Insufficient strength.
2. Additional stress induced by knuckle.

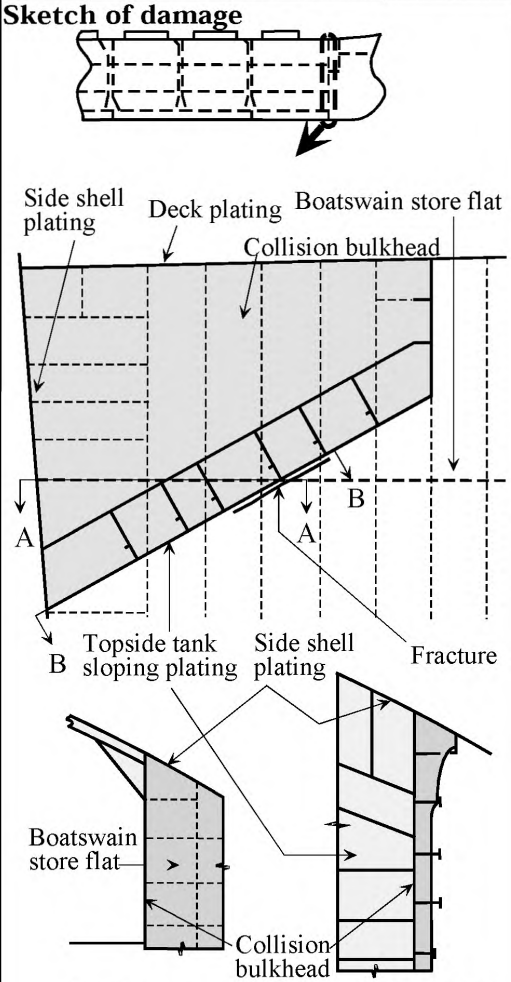
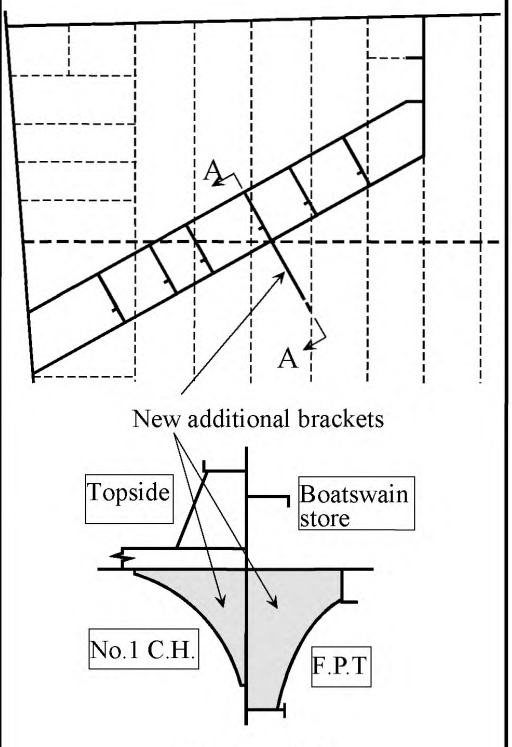
1. Damage caused by hard spot at intersection of the topside tank sloping plating and boatswain's store deck plating (fore peak tank top plating).

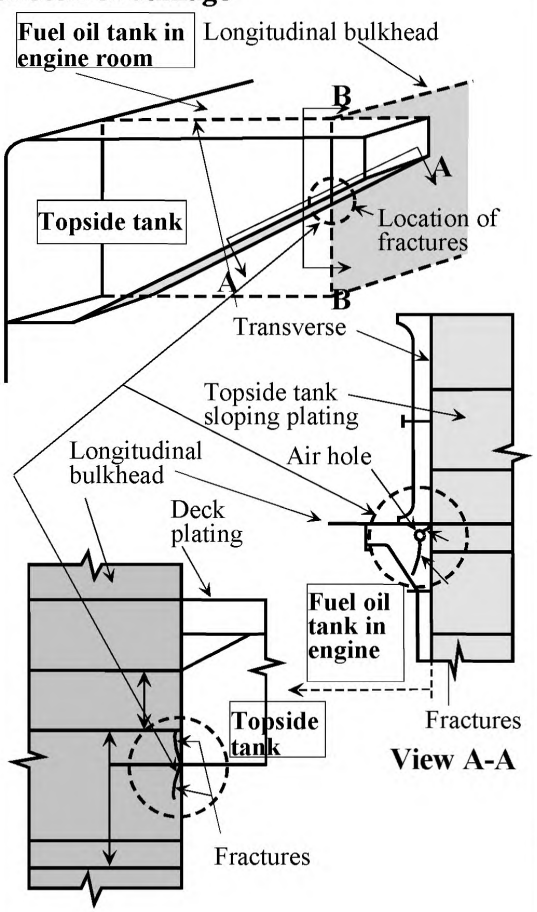
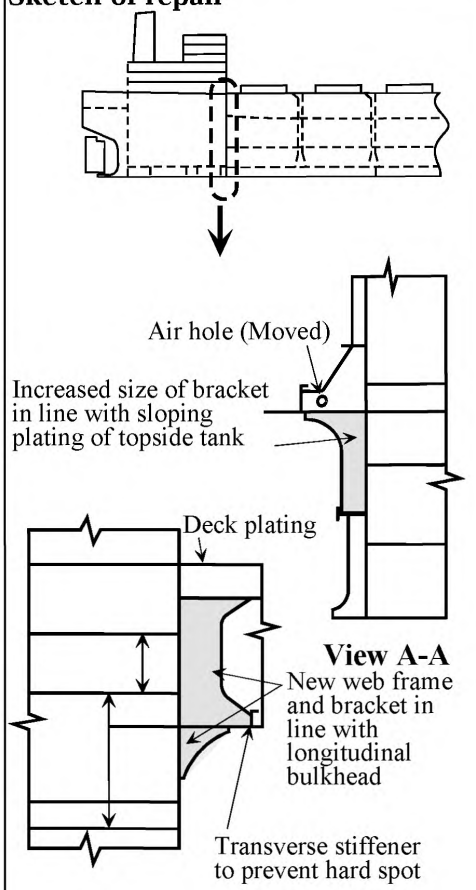
1. Damage caused by hard spot at intersection of the topside tank sloping plating and longitudinal bulkhead of the fuel oil tank in engine room.

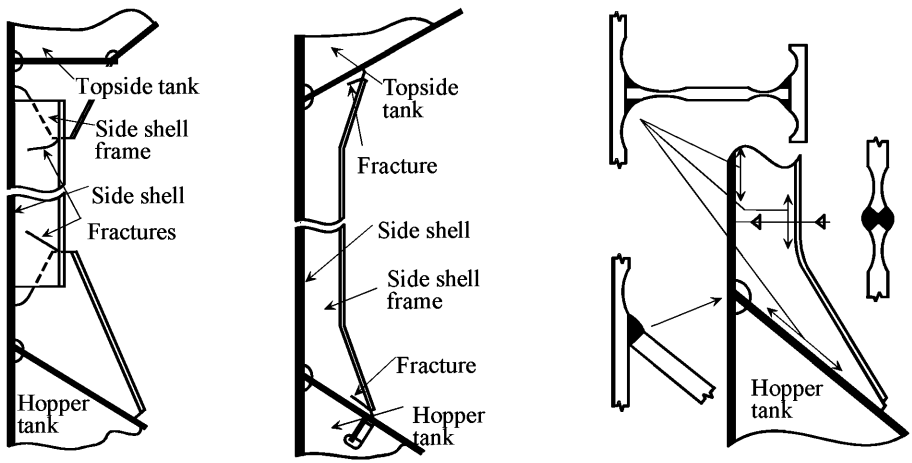
Figure 2 Damages to side shell frame - Potential problem areas

(Note) The type of bracket configuration used will, to a large extent, dictate the location and extent of fracture. Where separate brackets are employed, the fracture location is normally at the bracket toe position on the frames, whereas with integral brackets the location is at the toe position on the hopper and topside tank.

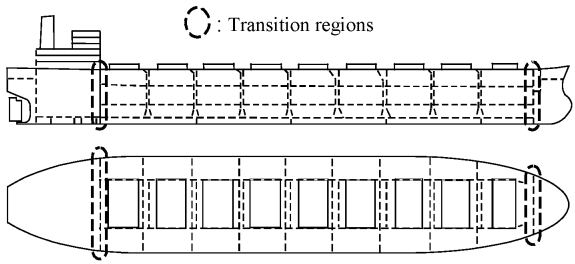
Figure 4 Transition regions - Potential problem area

1.5 The structure at the transition regions at the fore and aft ends of the ship are subject to stress concentrations due to structural discontinuities. The side shell plating at the transition regions is also subject to panting. The lack of continuity of the longitudinal structure, and the increased slenderness and flexibility of the side structure, makes the structure at the transition regions more prone to fracture damages.

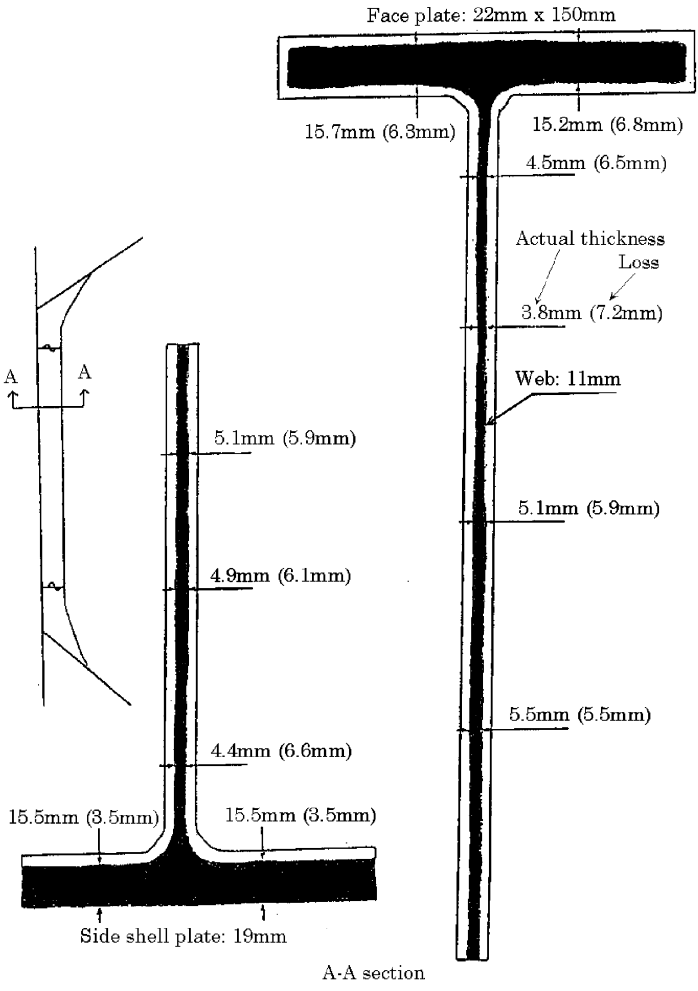
2.1.1 Attention is drawn to the fact that side shell frames may be significantly weakened by loss of thickness although diminution and deformations may not be apparent. Inspection should be made after the removal of any scale or rust deposit. Thickness measurements may be necessary, particularly if the corrosion is smooth and uniform, to determine the condition of the structure (See **Figure 5**).

Figure 5 Uniform corrosion of side shell frame

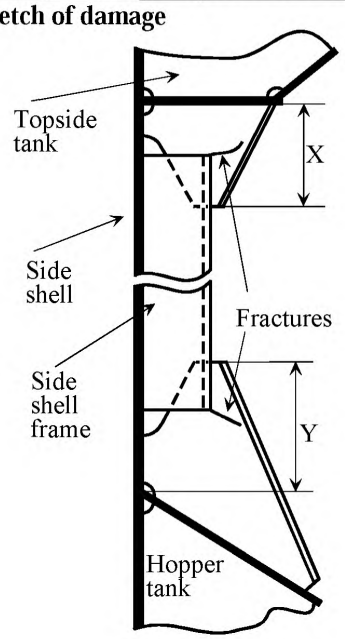
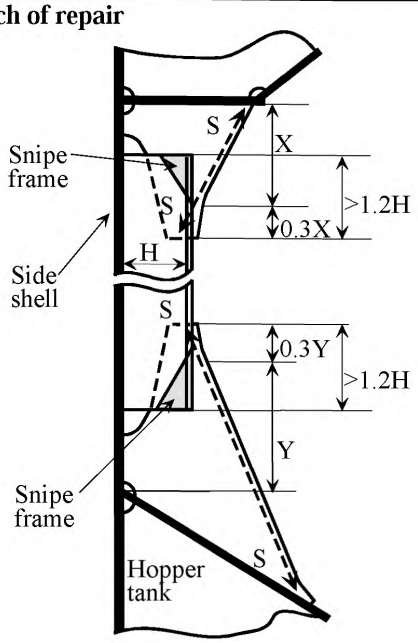
BULK CARRIERS	Guidelines for Surveys, Assessment and Repair of Hull Structure	
Part 1	Cargo hold region	Example No.
Area 3	Cargo hold side structure	1-a
Detail of damage	Fractures in brackets at termination of frame

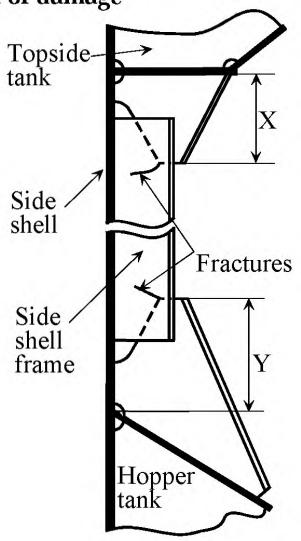
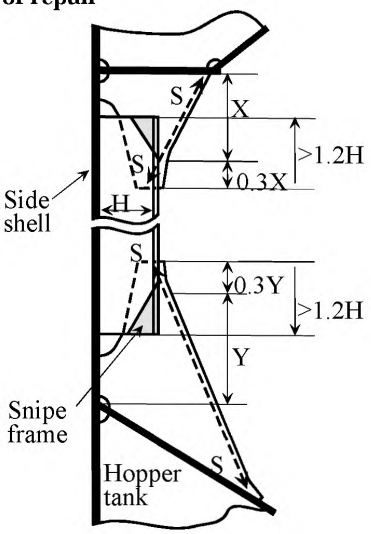
BULK CARRIERS	Guidelines for Surveys, Assessment and Repair of Hull Structure	
Part 1	Cargo hold region	Example No.
Area 3	Cargo hold side structure	1-b
Detail of damage	Fractures in side shell frame at bracket's toe

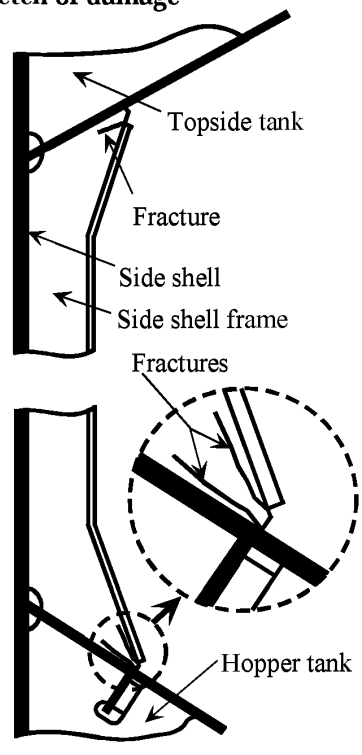
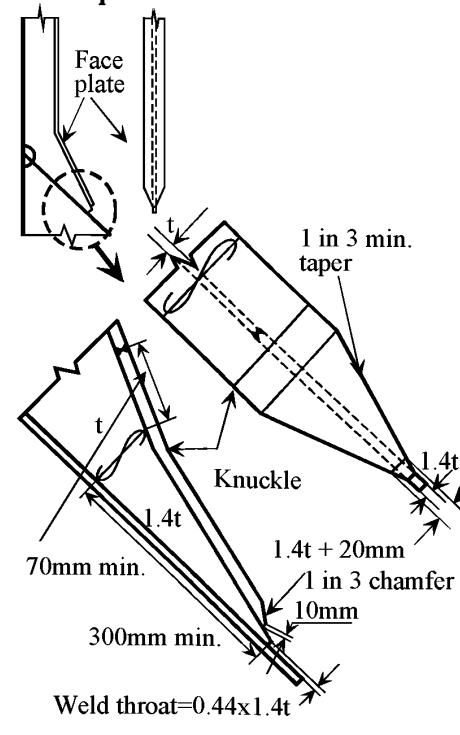
1. This type of damage is caused due to stress concentration.

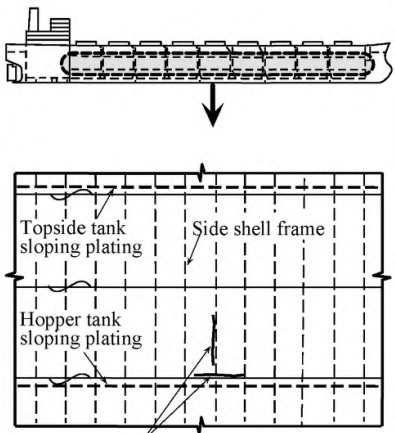
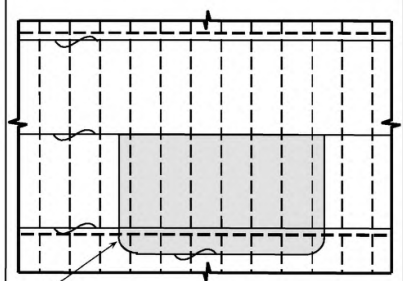
BULK CARRIERS	Guidelines for Surveys, Assessment and Repair of Hull Structure	
Part 1	Cargo hold region	Example No.
Area 3	Cargo hold side structure	3
Detail of damage	Fractures in side shell frame/lower bracket and side shell plating near hopper

1. Heavy corrosion (grooving). Refer to **Figure 2 (c)**.

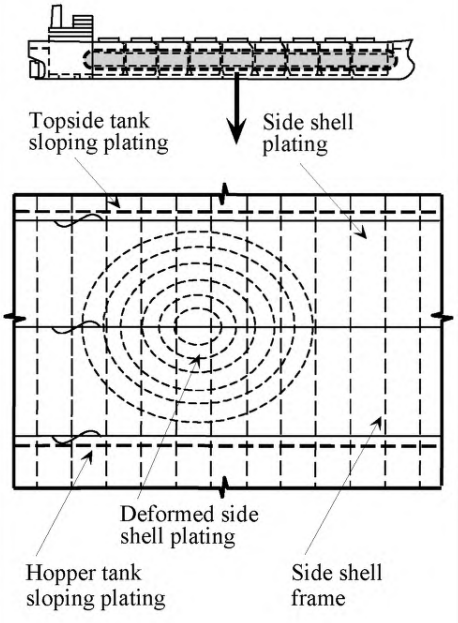
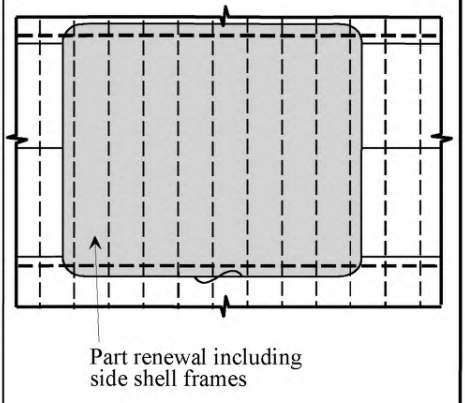
BULK CARRIERS	Guidelines for Surveys, Assessment and Repair of Hull Structure	
Part 1	Cargo hold region	Example No.
Area 3	Cargo hold side structure	4
Detail of damage	Deformation of side shell plating

1. Insufficient stiffness of side shell frames due to buckling and/or detachment of side shell frames due to corrosion.
2. Heavy weather.
