No.76 IACS Guidelines for Surveys, Assessment and Repair of Hull Structure – Bulk Carriers

BULK CARRIERS

Guidelines for Surveys, Assessment and Repair of Hull Structure

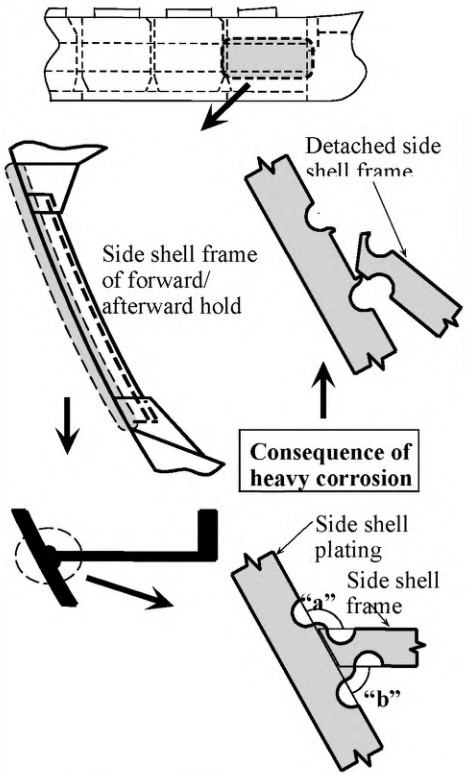
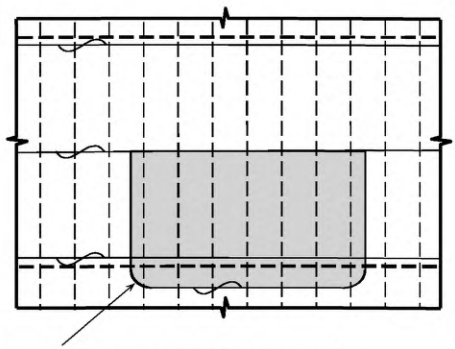
BULK CARRIERS	Guidelines for Surveys, Assessment and Repair of Hull Structure	
Part 1	Cargo hold region	Example No.
Area 3	Cargo hold side structure	5
Detail of damage	Adverse effect of corrosion on the frame of forward/afterward hold

1. Part renewal including side shell frames and hopper plating, as found necessary
2. Deep penetration welding at the connections of side shell frames to side shell plating

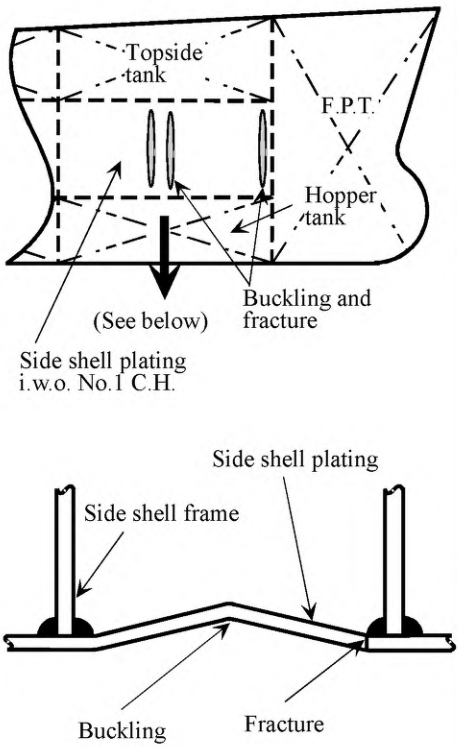
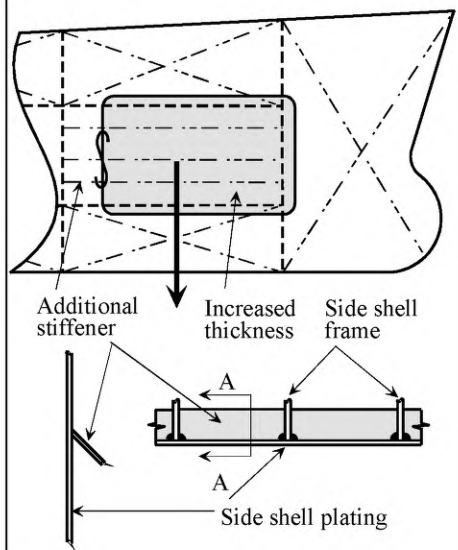
BULK CARRIERS	Guidelines for Surveys, Assessment and Repair of Hull Structure	
Part 1	Cargo hold region	Example No.
Area 3	Cargo hold side structure	6
Detail of damage	Buckling and fractures of side shell plating in foremost cargo hold

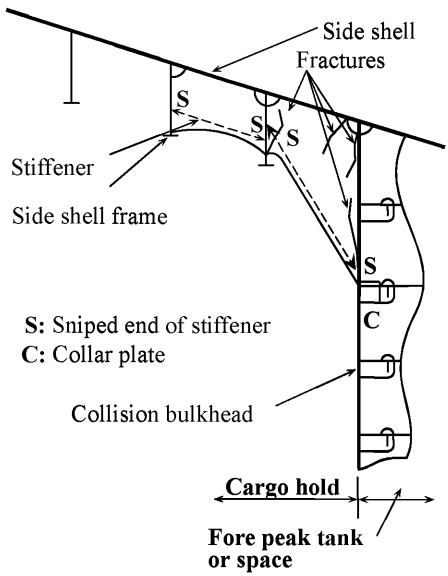
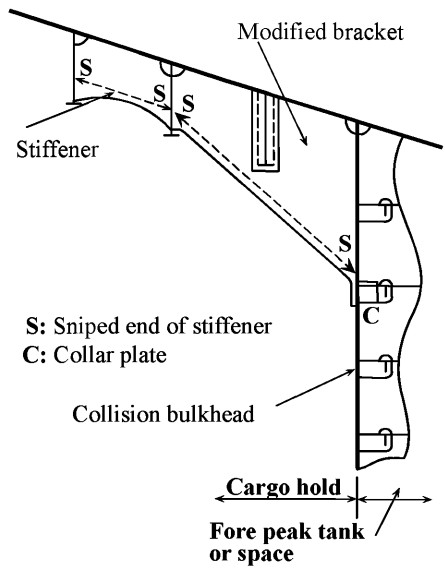
BULK CARRIERS	Guidelines for Surveys, Assessment and Repair of Hull Structure	
Part 1	Cargo hold region	Example No.
Area 3	Cargo hold side structure	7
Detail of damage	Fractures at the supporting brackets in way of the collision bulkhead

1. Insufficient bracket size resulting in high stress due to load cantilevered from side frame.
2. Stress concentration at toe of bracket and misalignment between bracket and stringer in fore peak tank or space.

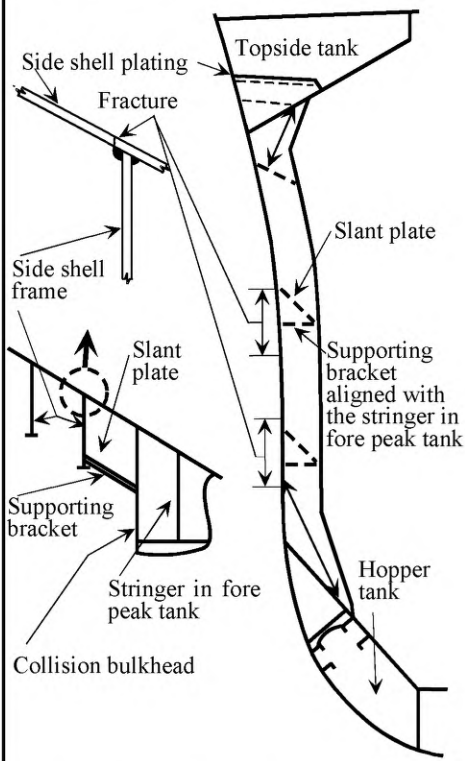
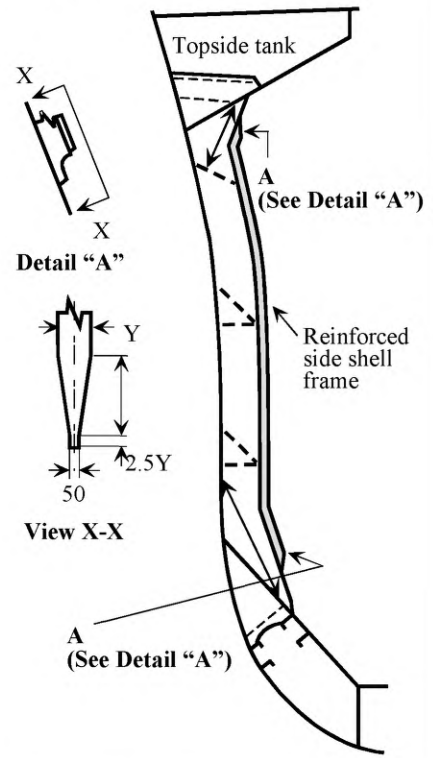
1. Damage caused by stress concentration leading to fatigue fracture in side shell. This has been exacerbated because of the greater flexibility of the hold structure in relation to the structure forward of the collision bulkhead.

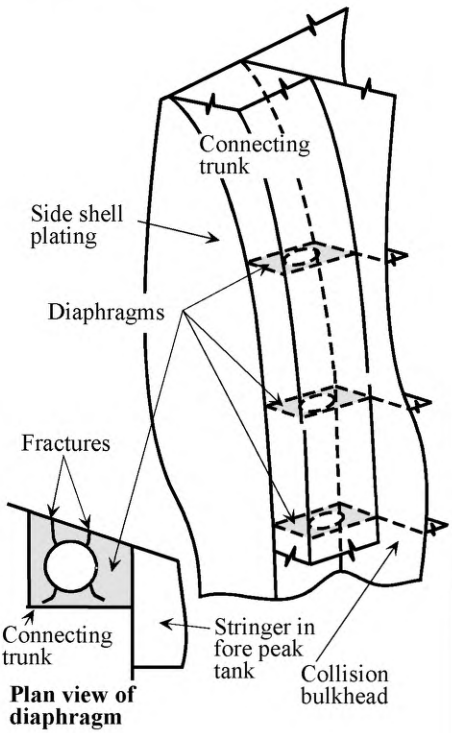
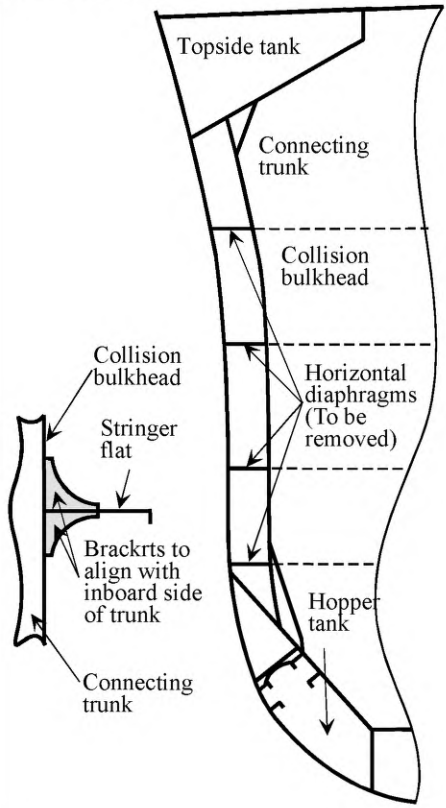
1. Damage caused by stress concentration resulting from the discontinuity created by the trunk and diaphragm structure. This has been exacerbated because of the greater flexibility of the hold structure in relation to the trunk and structure forward of the collision bulkhead.

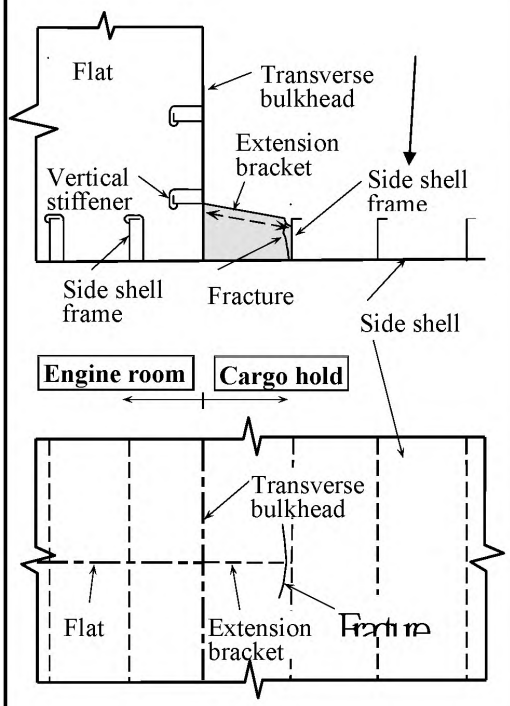
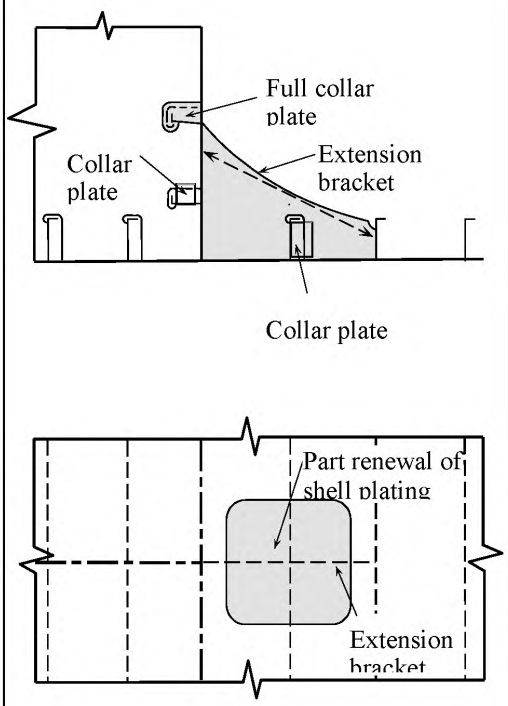
1. Damage caused by stress concentration leading to fatigue fracture on side shell. This will be exacerbated because of the greater flexibility of the hold structure in relation to the engine room structure.

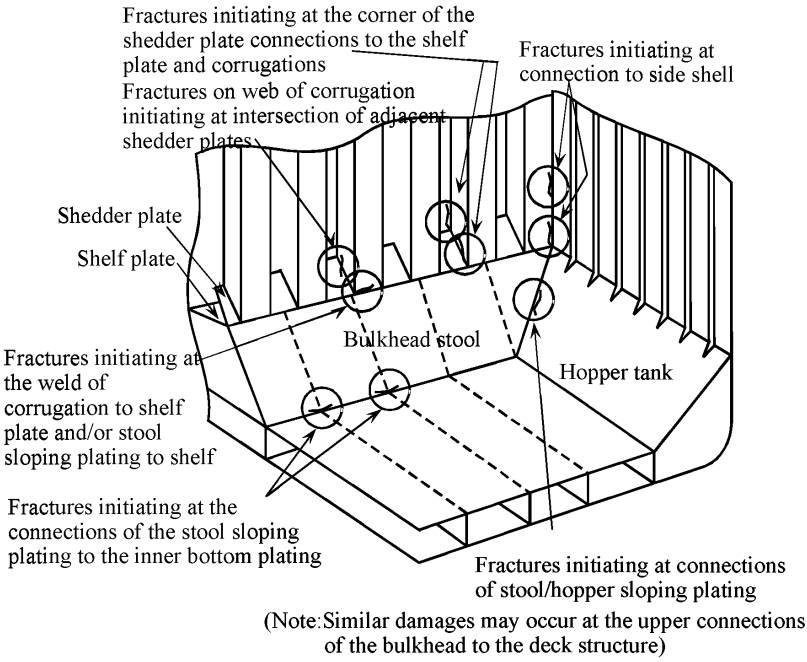
Figure 2 Typical fracturing at the connection of transverse bulkhead structure

2.3.1 Fractures usually occur at the boundaries of corrugations and bulkhead stools particularly in way of shelf plates, shedder plates, deck, inner bottom, etc. (See **Figure 2**).

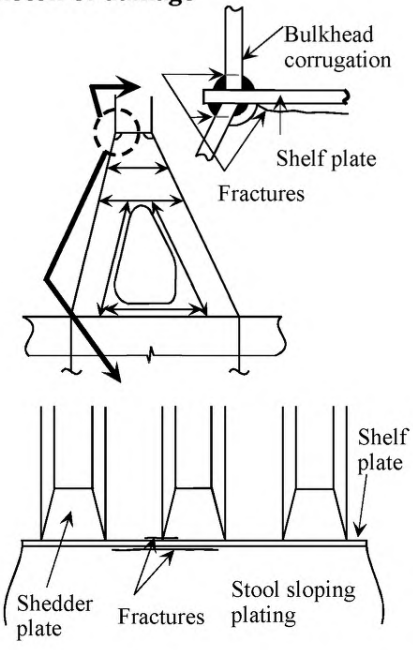
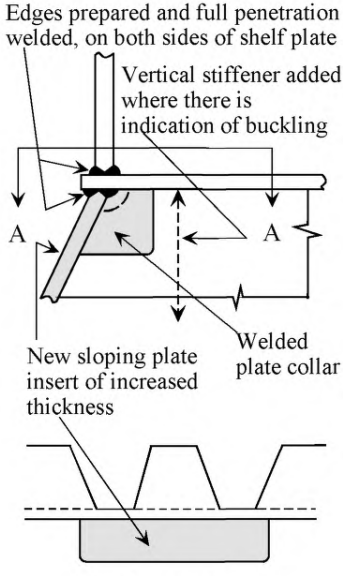
BULK CARRIERS	Guidelines for Surveys, Assessment and Repair of Hull Structure	
Part 1	Cargo hold region	Example No.
Area 4	Transverse bulkhead and associated structure in cargo hold	1-a
Detail of damage	Fractures at weld connections to stool shelf plate

1. Stress concentrations at welds adjacent to the scallops.
2. Inadequate welding area connecting corrugation flange to shelf plate or similarly sloping stool plating to shelf plate.
3. Inadequate thickness of sloping plating in relation to corrugation flange thickness.
4. Stress concentration at knuckle of corrugation where web is not supported by bracket inside the stool.

1. Fractures to be veed-out and rewelded.
2. Reductions in stress concentration by fitting welded plate collars in way of the scallop.
3. Where necessary an insert plate to be arranged in stool plating and/or diaphragm.

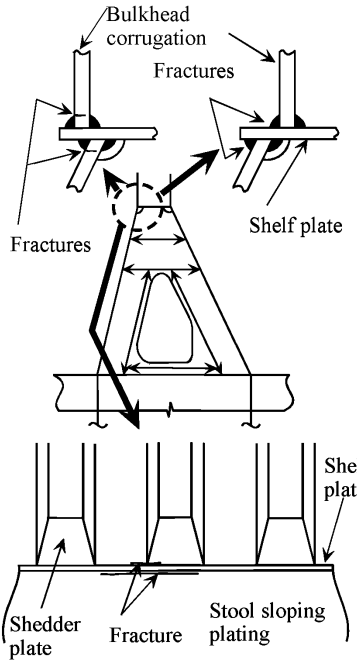
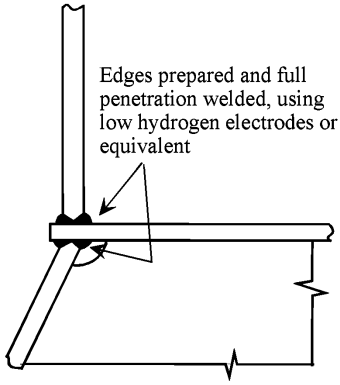
BULK CARRIERS	Guidelines for Surveys, Assessment and Repair of Hull Structure	
Part 1	**Cargo hold region**	**Example No.**
Area 4	**Transverse bulkhead and associated structure in cargo hold**	**1-b**
Detail of damage	Fractures at weld connections to stool shelf plate

1. Misalignment between corrugation flange and sloping stool plating.
2. Inadequate welding area connecting corrugation flange to shelf plate or similarly sloping stool plating to shelf plate.

1. Fractures to be veed-out and rewelded.
2. Structure to be released and misalignment rectified.
3. Edge of the corrugated bulkhead and the stool plating on both sides of shelf plate to have full penetration welds.
4. Where necessary an insert plate to be arranged in stool plating.

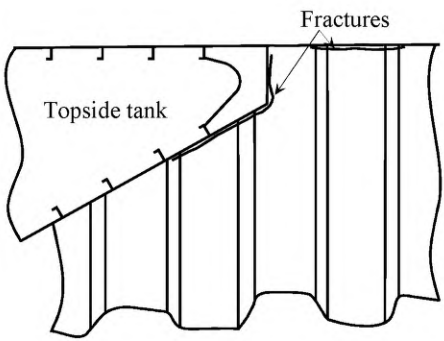
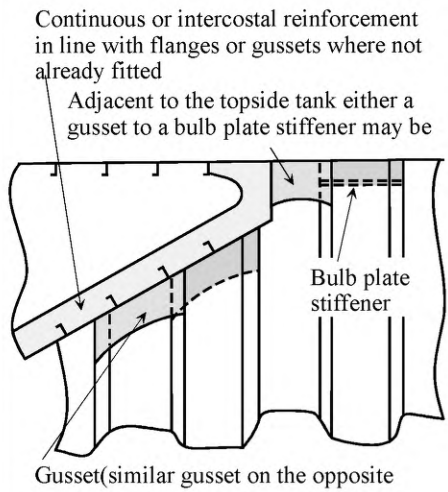
BULK CARRIERS	Guidelines for Surveys, Assessment and Repair of Hull Structure	
Part 1	**Cargo hold region**	**Example No.**
Area 4	**Transverse bulkhead and associated structure in cargo hold**	**2**
Detail of damage	Fractures at the upper boundaries to topside tanks

1. Damage due to poor design and/or defective welds.

1. Fractures may be veed-out and rewelded. If necessary corrugated plating cropped and renewed.
2. It is recommended that reinforcement as shown above be incorporated, giving due consideration to the following criteria:

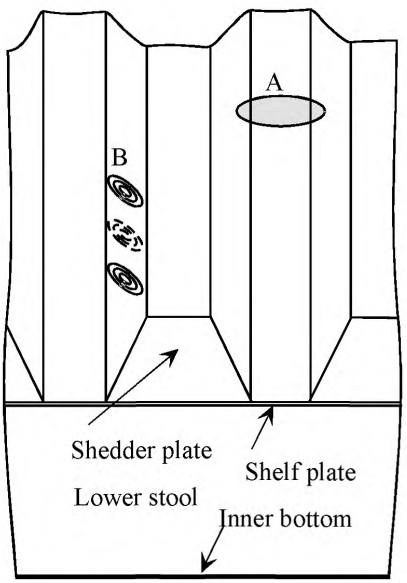
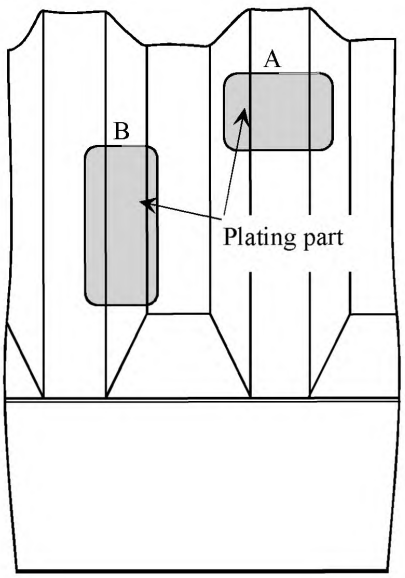
BULK CARRIERS	Guidelines for Surveys, Assessment and Repair of Hull Structure	
Part 1	Cargo hold region	Example No.
Area 4	Transverse bulkhead and associated structure in cargo hold	3
Detail of damage	Indentation and buckling of vertical corrugation

1. Damages by mechanical abuse during cargo handling e.g. grab damage.
2. Damage resulting from thickness reduction by corrosion.
3. Buckling caused by bending or shear, see locations A and B respectively above, with a minimum reduction in thickness could be caused by underdesign or overloading. If this cause is suspected, the Classification Society concerned shall be contacted before proceeding with repairs.

1. Damage by mechanical abuse
   If the indentation/buckling is local and of a minor nature, the plating can be faired in place.
   If the deformation is more pronounced and/or in association with a generalized reduction in thickness the plating is to be cropped and renewed, as shown at locations A and B above.
2. Damage resulting from corrosion
   In this case thickness measurements are to be taken at mid-span and top and bottom of corrugations, and corrugations renewed or part renewed as necessary. Particular attention is to be given to the fit and alignment at corners of flanged corrugations when being partly renewed.

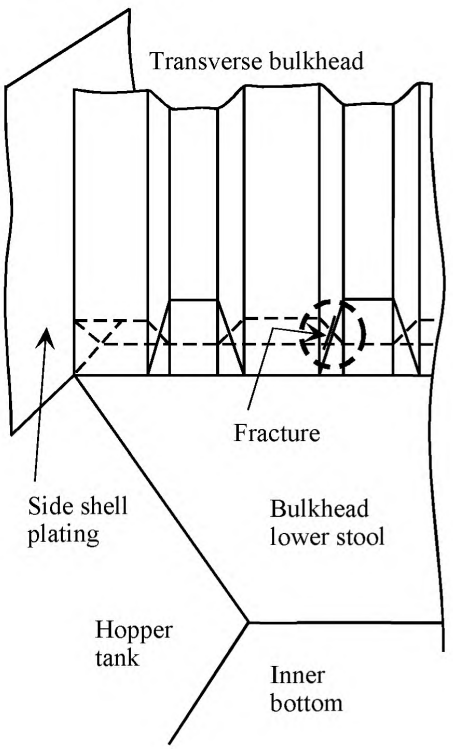
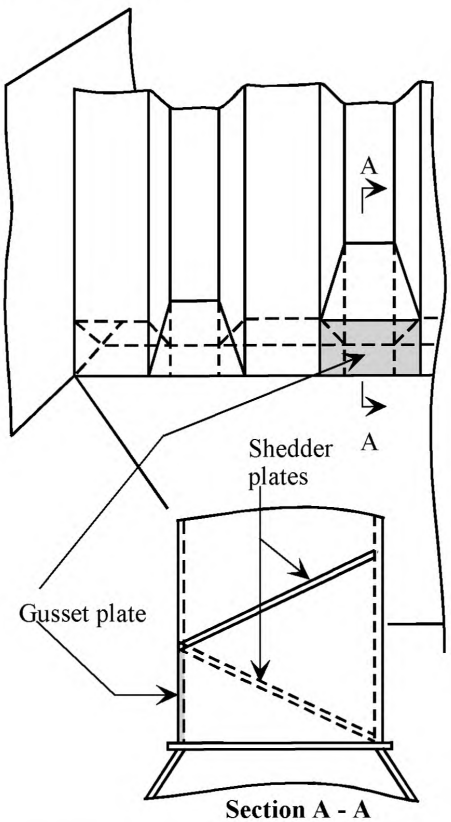
1. Damage due to stress concentrations at intersection of shedder plates. This can be exacerbated by corrosion and reduction in thickness of the corrugation web plating.

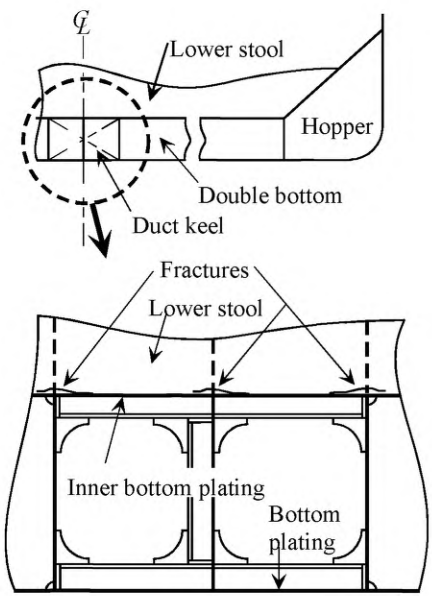
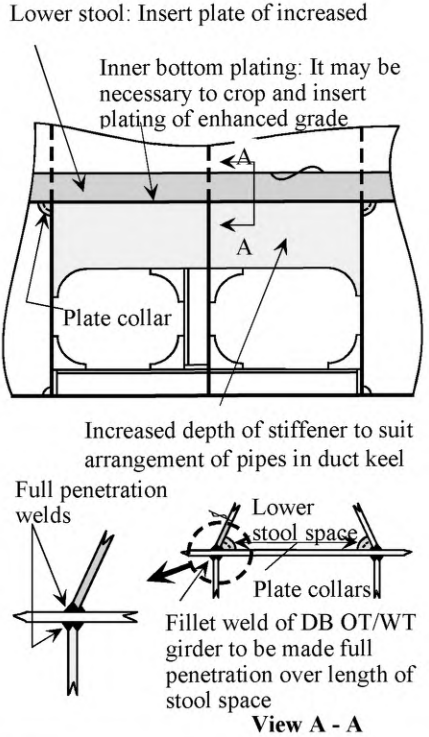
1. This type of failure is more likely to occur at the boundaries of the ballast hold.
2. The fractures arise because of stress concentration in way of cut-outs and exacerbated by the flexibility of the inner bottom structure in way of the duct keel.

1. In order to prevent recurrence of the damage, the additional reinforcement shown should be fitted.

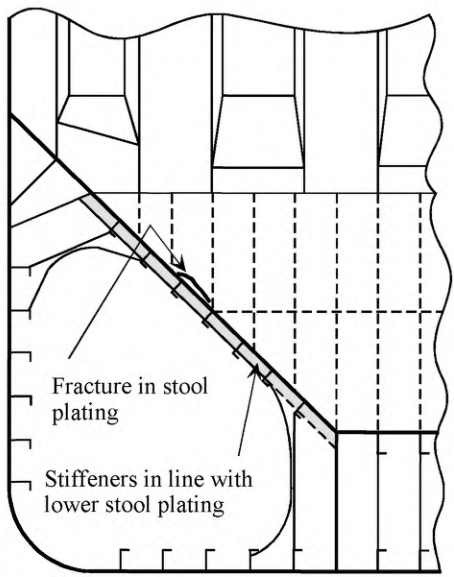
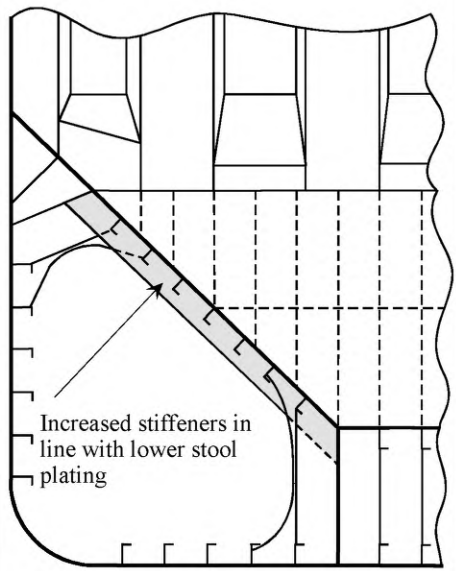
BULK CARRIERS	Guidelines for Surveys, Assessment and Repair of Hull Structure	
Part 1	Cargo hold region	Example No.
Area 4	Transverse bulkhead and associated structure in cargo hold	6
Detail of damage	Fractures at the connection of lower stool to hopper

1. Insufficient strength of the connection
2. Corrosion

1. Fractured stool plating should be partly cropped and renewed (thicker plate) if considered necessary.
2. If the damage occurred due to insufficient strength, stiffeners in line with stool plating should be increased.

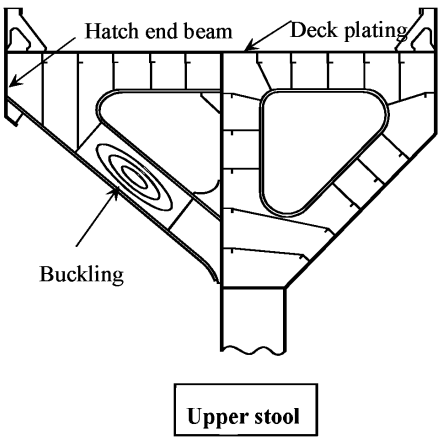
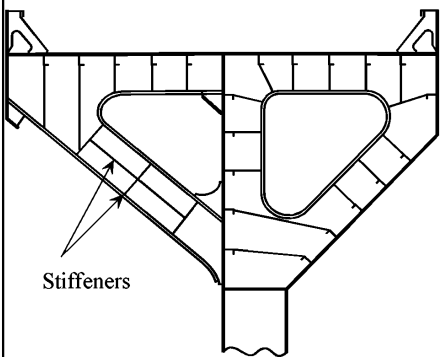
BULK CARRIERS	Guidelines for Surveys, Assessment and Repair of Hull Structure	
Part 1	Cargo hold region	Example No.
Area 4	Transverse bulkhead and associated structure in cargo hold	7
Detail of damage	Buckling of strut supporting hatch end beam

1. Insufficient strength
2. Partial ballast loading in ballast cargo hold (sloshing)
3. Corrosion

1. Deformed part to be cropped and renewed if considered necessary.
2. If the damage occurred due to insufficient strength, appropriate reinforcement is to be considered (thicker plate/additional stiffener(s)).

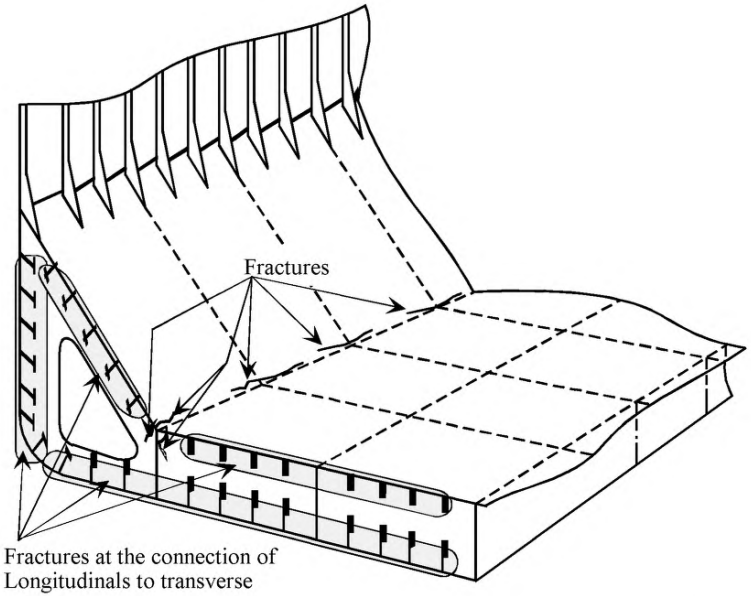
Figure 1 Typical fractures in the connection of hopper sloping plating to inner bottom (tank top) and longitudinals to transverse (or transverse bulkhead)

extend through the thickness of the plating or through the welds may be observed during pressure testing of the double bottom tanks (See **Figure 1** and **2** of **Area 4**).

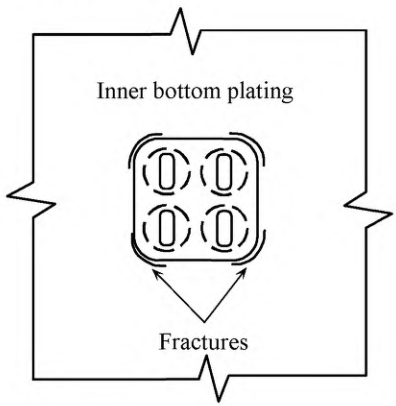
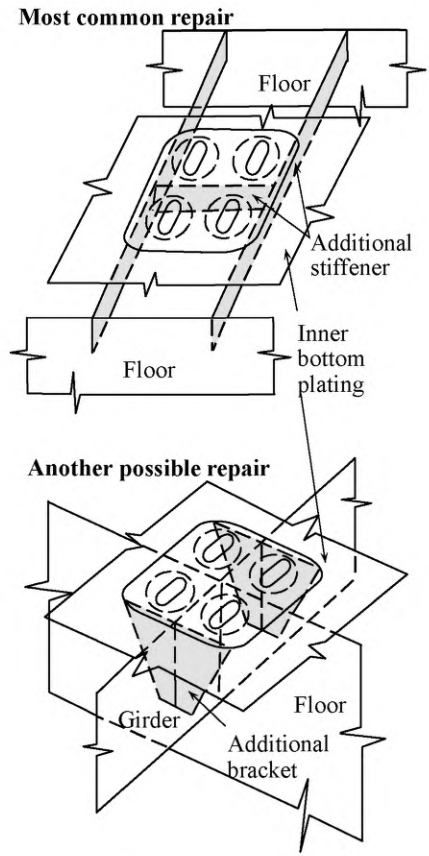
BULK CARRIERS	Guidelines for Surveys, Assessment and Repair of Hull Structure	
Part 1	**Cargo hold region**	**Example No.**
Area 5	**Double bottom structure including hopper**	**1**
Detail of damage	Fractures in inner bottom plating around container bottom pocket

1. Pocket is not supported correctly by floor, longitudinal and/or stiffener.

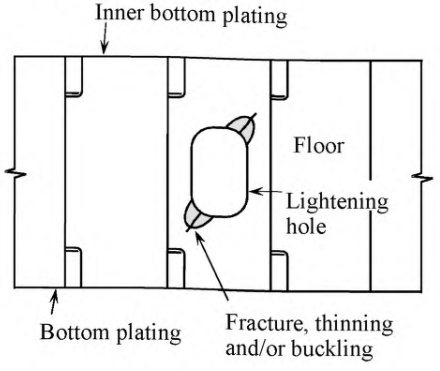
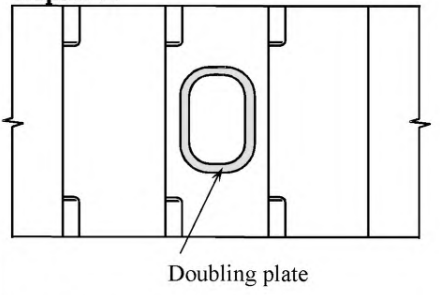
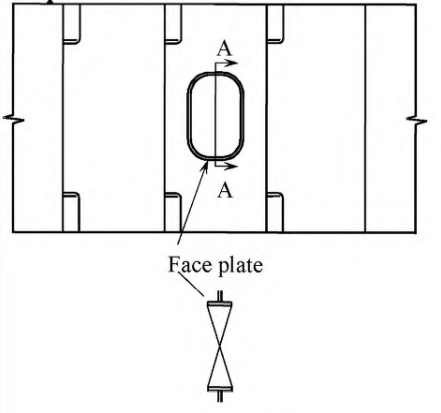
BULK CARRIERS	Guidelines for Surveys, Assessment and Repair of Hull Structure	
Part 1	**Cargo hold region**	**Example No.**
Area 5	**Double bottom structure including hopper**	**2**
Detail of damage	Fractures, corrosion and/or buckling of floor/girder around lightening hole

1. Insufficient strength due to lightening hole.
2. Fracture, corrosion and/or buckling around lightening hole due to high stress.

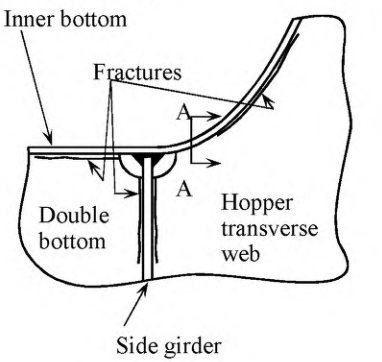
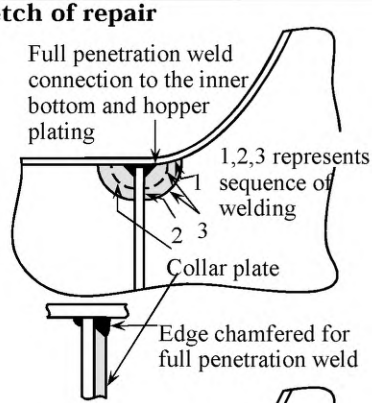
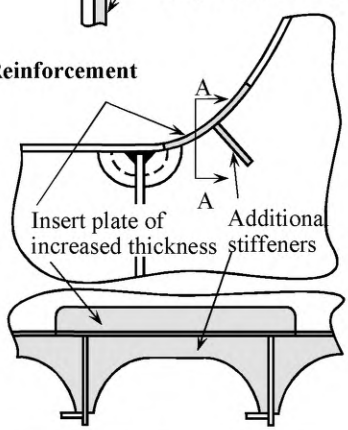
Transverse fractures in hopper web plating into possibly extending into the hopper sloping plating

1. The damage is partly due to stress concentrations at the edges of the weld created by the presence of cut-outs and local stress variations caused by the deflections in the inner bottom/hopper plating.

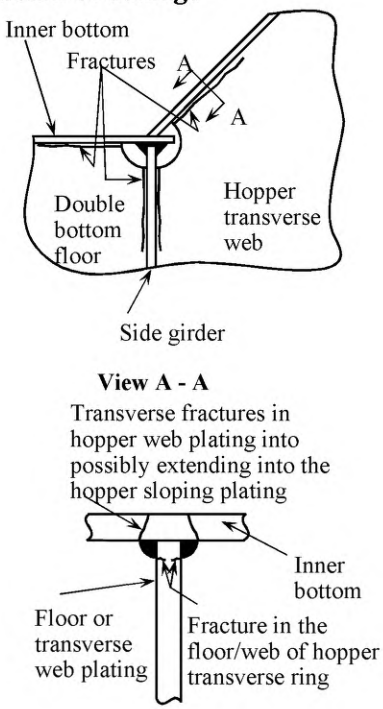
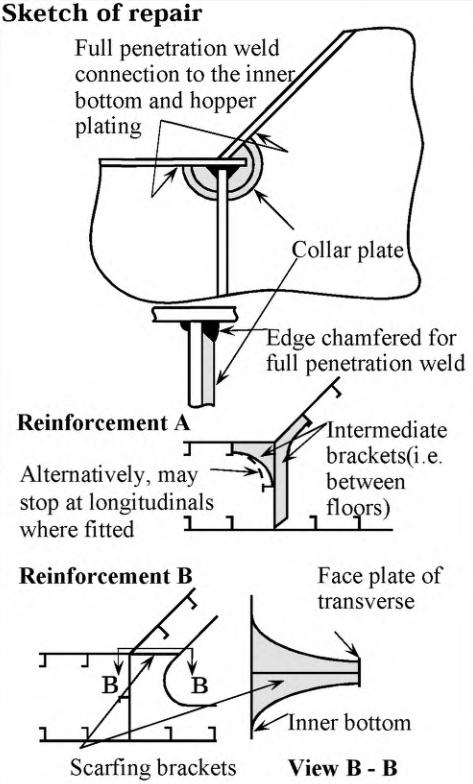
1. The damage is partly due to stress concentration at the edges of the weld .created by the presence of the deflections in the inner bottom/hopper plating.

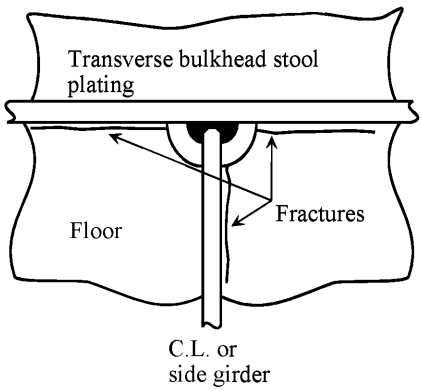
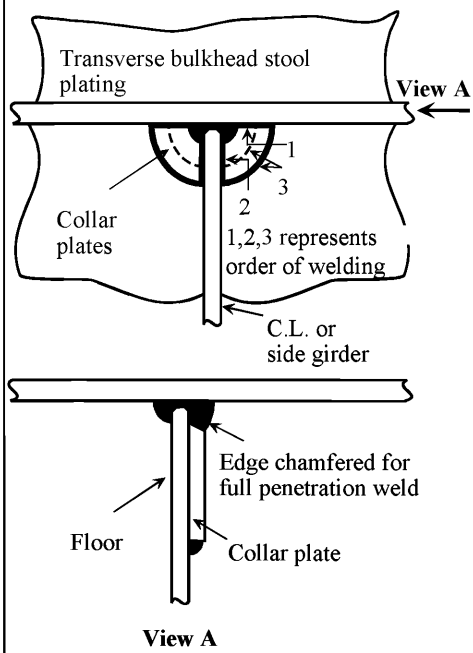
BULK CARRIERS	Guidelines for Surveys, Assessment and Repair of Hull Structure	
Part 1	Cargo hold region	Example No.
Area 5	Double bottom tank structure including hopper	5
Detail of damage	Fractures at weld connections of floors in way of inner bottom and side girders, and plating of bulkhead stool

1. Stress concentration at the welds due to scallops.

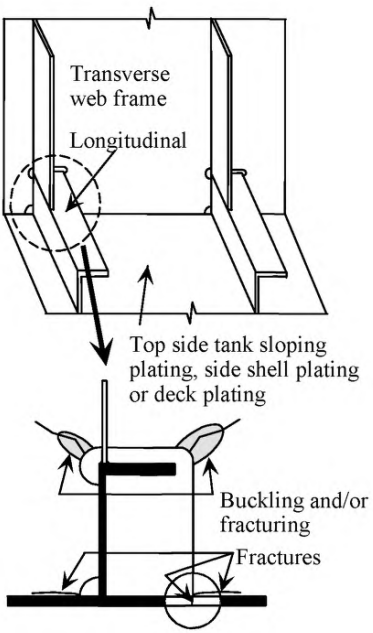
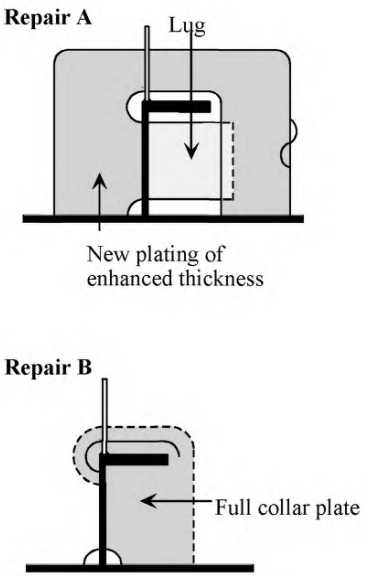
1. Damage can be caused by general levels of corrosion and presence of stress concentration associated with the presence of a cut-out.

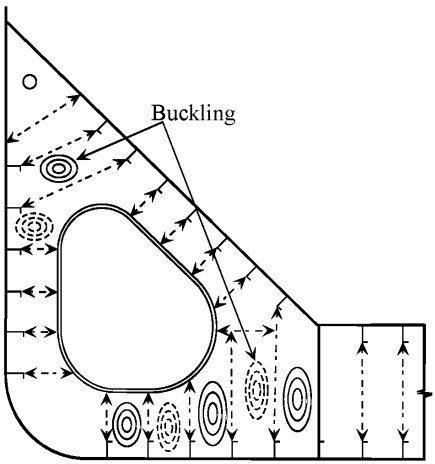
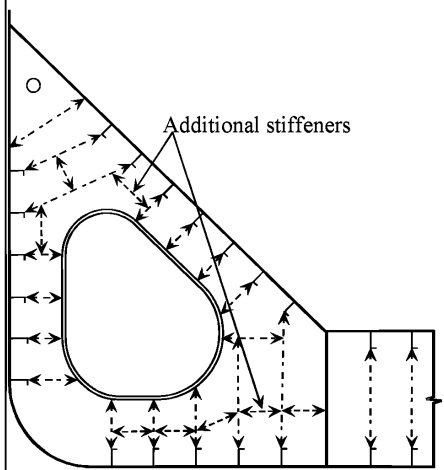
BULK CARRIERS	Guidelines for Surveys, Assessment and Repair of Hull Structure	
Part 1	Cargo hold region	Example No.
Area 5	Double bottom tank structure including hopper	10
Detail of damage	Buckling of transverse web

1. Insufficient buckling strength of transverse web plating.
2. Corrosion of high stress area.

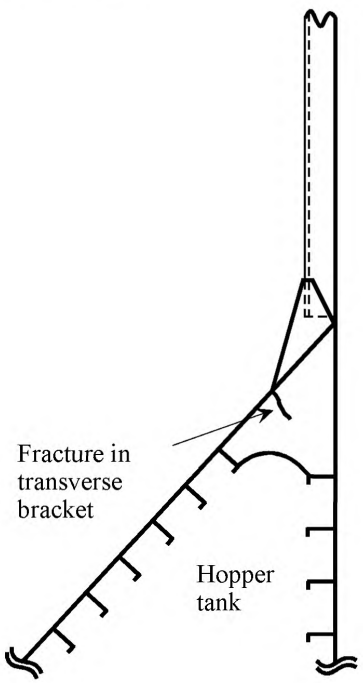
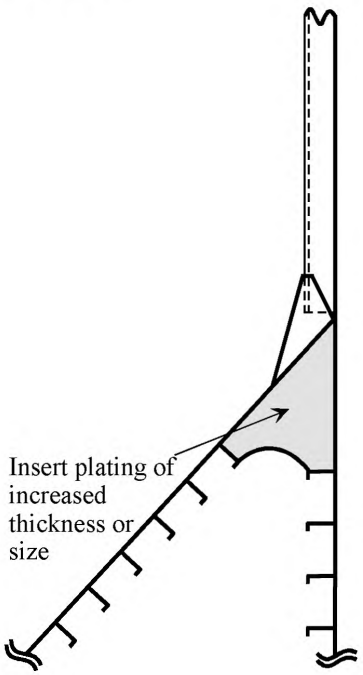
BULK CARRIERS	Guidelines for Surveys, Assessment and Repair of Hull Structure	
Part 1	**Cargo hold region**	**Example No.**
Area 5	**Double bottom tank structure including hopper**	**11**
Detail of damage	Fractures at weld connection of transverse brackets

1. General levels of corrosion and presence of stress concentration.
2. Misalignment of the brackets with adjoining structure e.g. frame brackets.
3. High shear stresses due to insufficient bracket.
4. Inadvertent overloading.

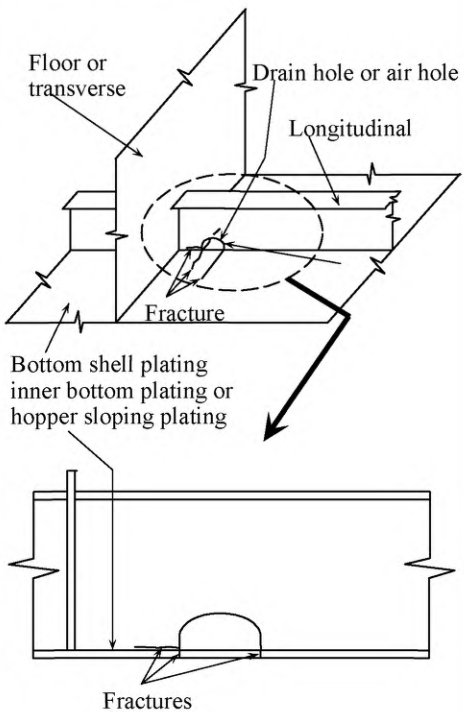
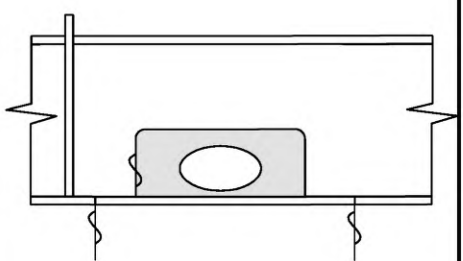
BULK CARRIERS	Guidelines for Surveys, Assessment and Repair of Hull Structure	
Part 1	**Cargo hold region**	**Example No.**
Area 5	**Double bottom tank structure including hopper**	**12**
Detail of damage	Fractures in bottom shell/side shell/hopper sloping plating at the corner drain hole/air hole in longitudinal

1. Stress concentration and/or corrosion due to stress concentration at the corner of drain hole/air hole.

1. Fractured plating should be cropped and part renewed.
2. If fatigue life is to be improved, change of drain hole/air hole shape is to be considered.

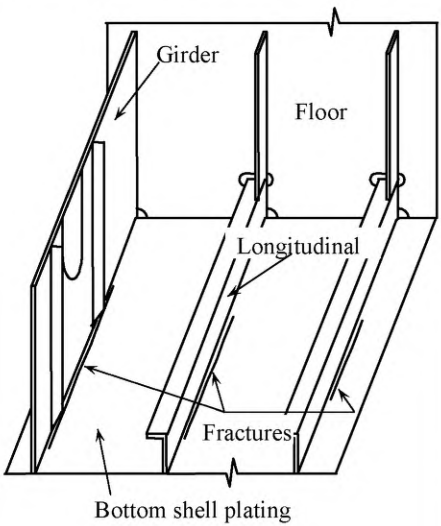
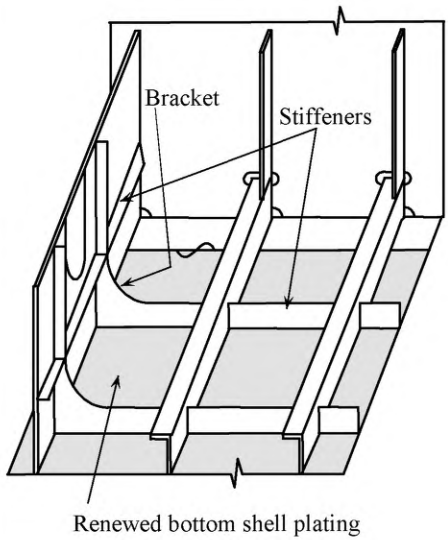
BULK CARRIERS	Guidelines for Surveys, Assessment and Repair of Hull Structure	
Part 1	**Cargo hold region**	**Example No.**
Area 5	**Double bottom tank structure including hopper**	**13**
Detail of damage	Fractures in bottom plating along side girder and/or bottom longitudinal

1. Vibration.

1. Fractured bottom shell plating should be cropped and renewed.
2. Natural frequency of the panel should be changed, e.g. reinforcement by additional stiffener/bracket.

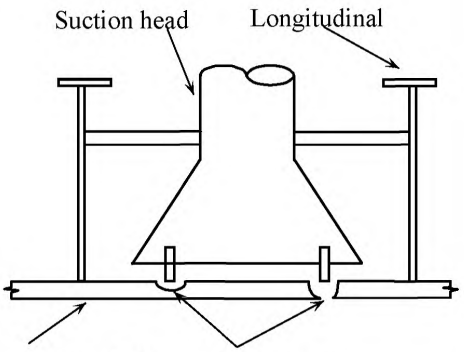
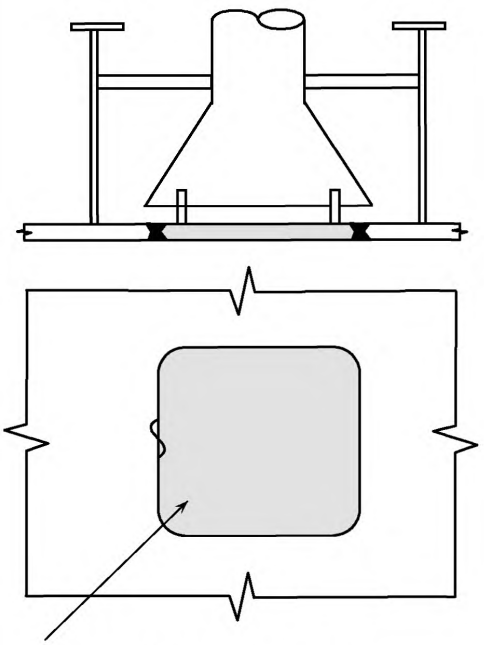
BULK CARRIERS	Guidelines for Surveys, Assessment and Repair of Hull Structure	
Part 1	Cargo hold region	Example No.
Area 5	Double bottom tank structure including hopper	14
Detail of damage	Corrosion in bottom plating below suction head

1. High flow rate associated with insufficient corrosion prevention system.
2. Galvanic action between dissimilar metals.

1. Insert to have round corners
2. Non-destructive examination to be applied after welding based on the Society's rules

1. Affected plating should be cropped and part renewed. Thicker plate and suitable beveling should be considered.
2. If the corrosion is limited to a small area,
   i. e. pitting corrosion, repair by welding is acceptable.

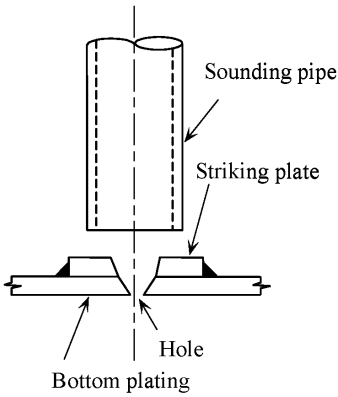
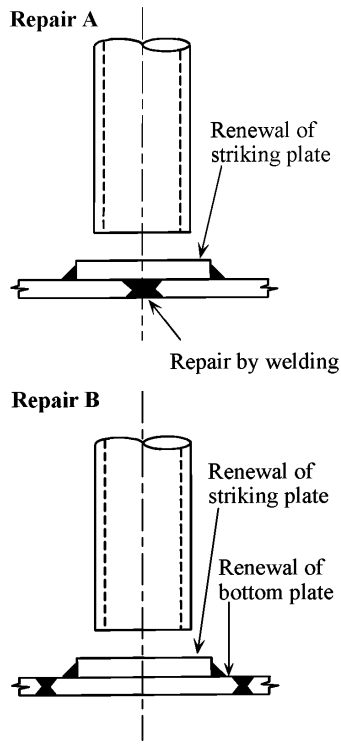
BULK CARRIERS	Guidelines for Surveys, Assessment and Repair of Hull Structure	
Part 1	**Cargo hold region**	**Example No.**
Area 5	**Double bottom tank structure including hopper**	**15**
Detail of damage	Corrosion in bottom plating below sounding pipe

1. Accelerated corrosion of striking plate by the striking of the weight of the sounding tape.

1. Corroded bottom plating should be welded or partly cropped and renewed if considered necessary.
2. Corroded striking plate should be renewed.

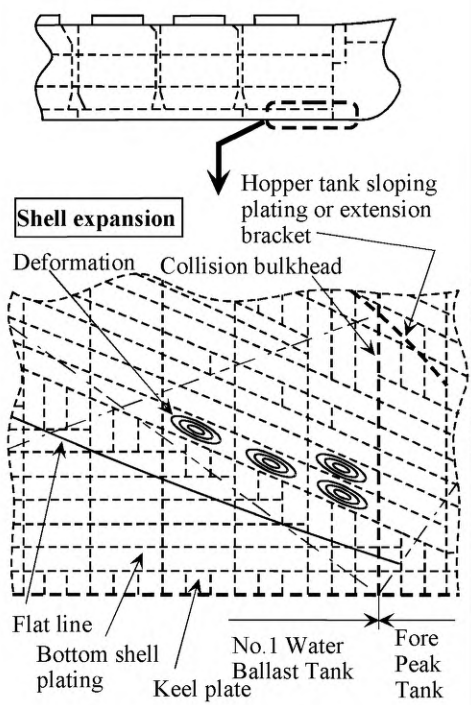
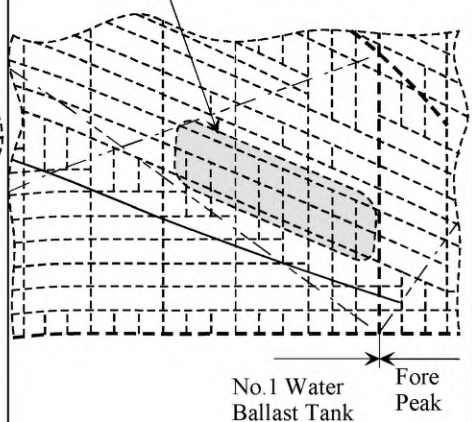
BULK CARRIERS	Guidelines for Surveys, Assessment and Repair of Hull Structure	
Part 1	Cargo hold region	Example No.
Area 5	Double bottom structure including hopper	16
Detail of damage	Deformation of forward bottom shell plate due to slamming

1. Heavy weather.
2. Poor design for slamming.
3. Poor operation, i.e. negligence of heavy ballast.

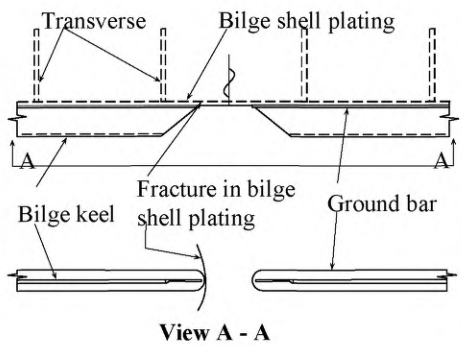
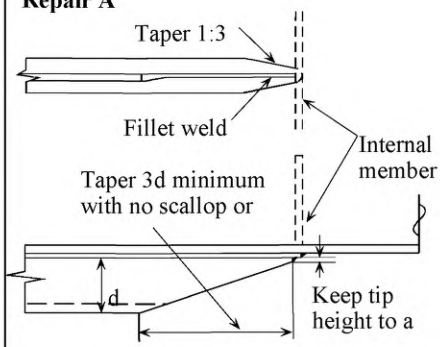
BULK CARRIERS	Guidelines for Surveys, Assessment and Repair of Hull Structure	
Part 1	**Cargo hold region**	**Example No.**
Area 5	**Double bottom structure including hopper**	**17**
Detail of damage	Fractures in shell plating at the termination of bilge keel

1. Fractured plating is to be cropped and renewed.
2. Reduction of stress concentration of the bilge keel end should be considered.
   Repair A: Modification of the detail of end
   Repair B: New internal stiffeners
   Repair C: Continuous ground bar (in connection with **Repair A**)
3. Instead of **Repair A** or **B** continuous ground bar and bilge keel should be considered.

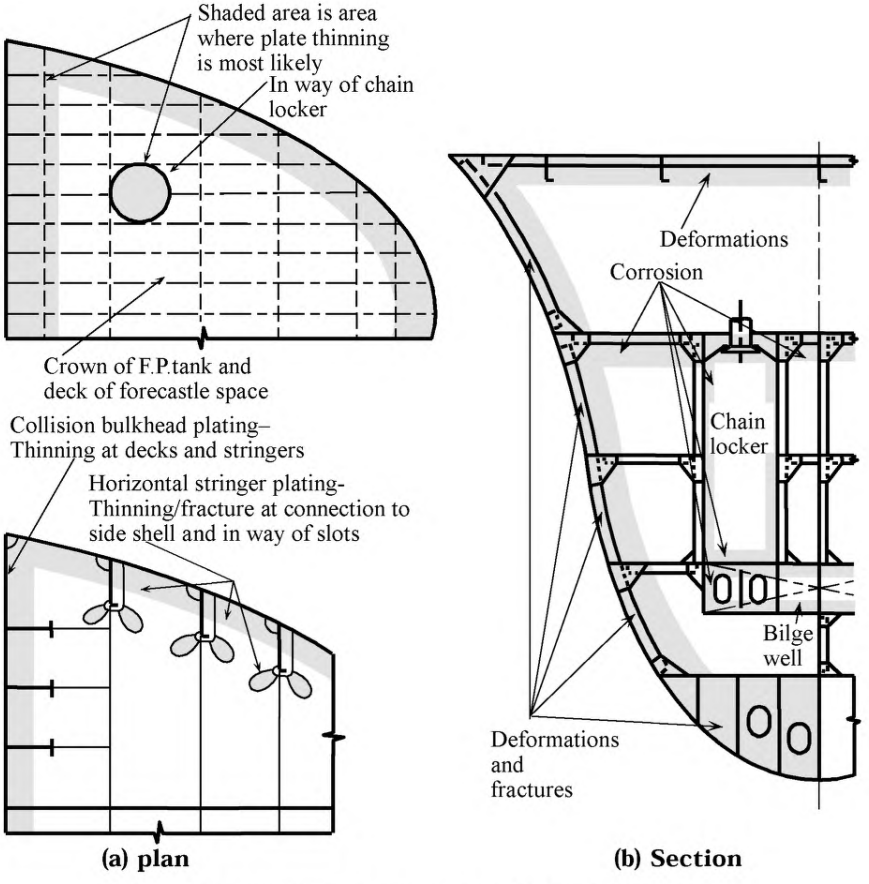
Fig 1 Fore end structure - Potential problem areas

2.1.1 Wastage (and possible subsequent fractures) is more likely to be initiated at the locations as indicated in **Figure 1** and particular attention should be given to these areas. A close-up inspection should be carried out with selection of representative thickness measurements to determine the extent of corrosion.

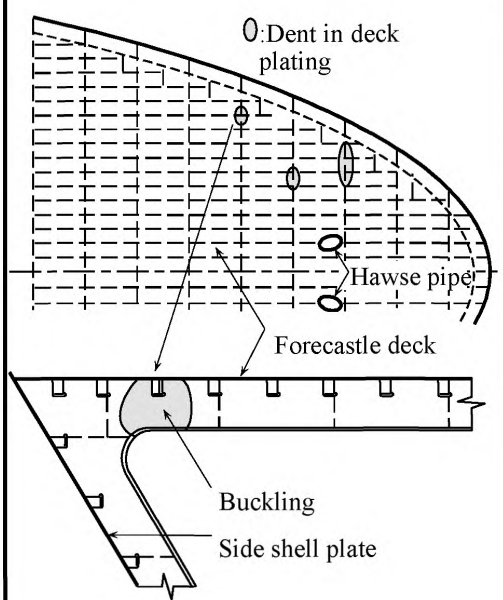
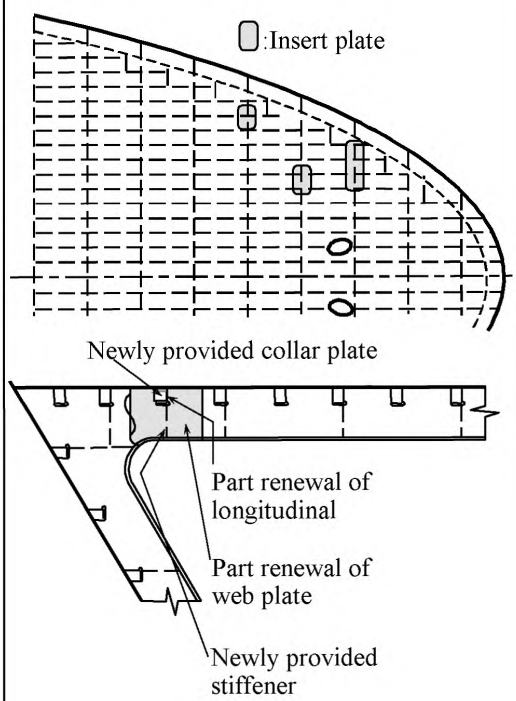
1. Green sea on deck.
2. Insufficient strength.

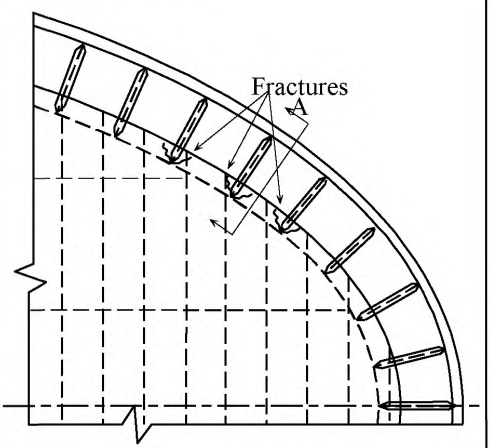
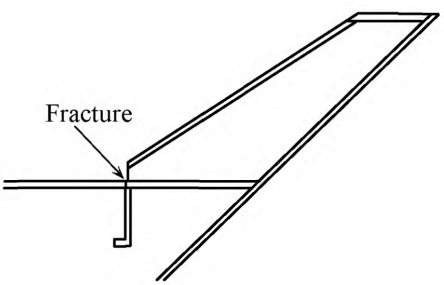
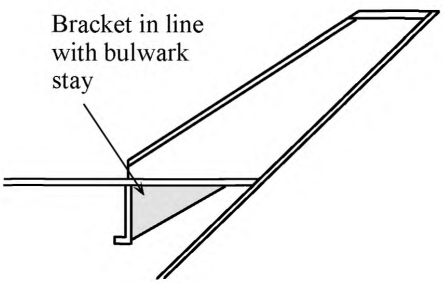
BULK CARRIERS	Guidelines for Surveys, Assessment and Repair of Hull Structure	
Part 2	Fore and aft end regions	Example No.
Area 1	Fore end structure	2
Detail of damage	Fractures in forecastle deck plating at bulwark

1. Fractured deck plating should be cropped and renewed.
2. Bracket in line with the bulwark stay to be fitted to reduce stress concentration.

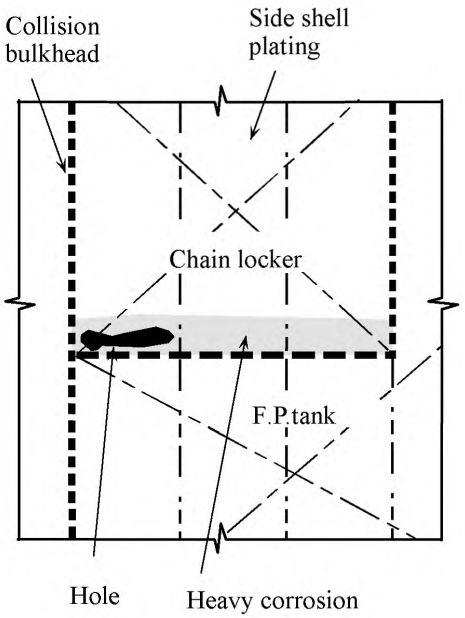
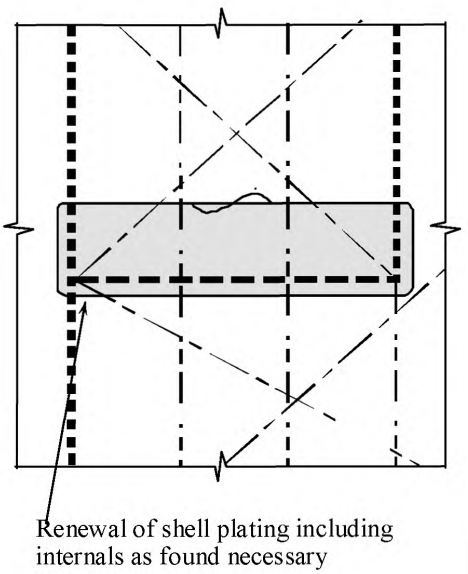
BULK CARRIERS	Guidelines for Surveys, Assessment and Repair of Hull Structure	
Part 2	Fore and aft end regions	Example No.
Area 1	Fore end structure	3
Detail of damage	Fractures in side shell plating in way of chain locker

1. Heavy corrosion in region where mud is accumulated.

1. Corroded plating should be cropped and renewed.
2. Protective coating should be applied.

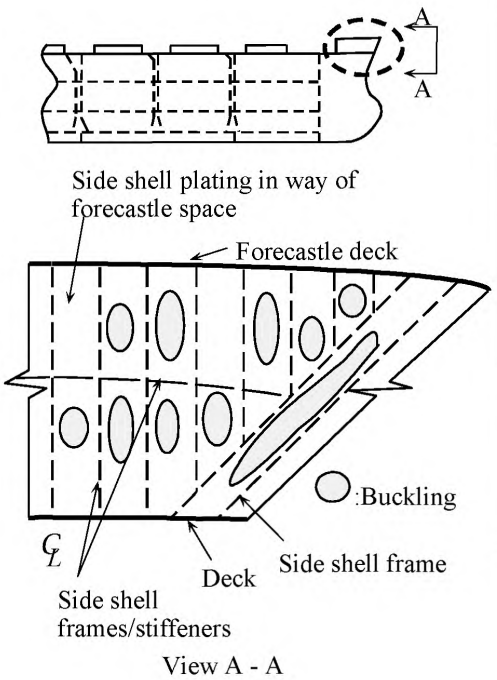
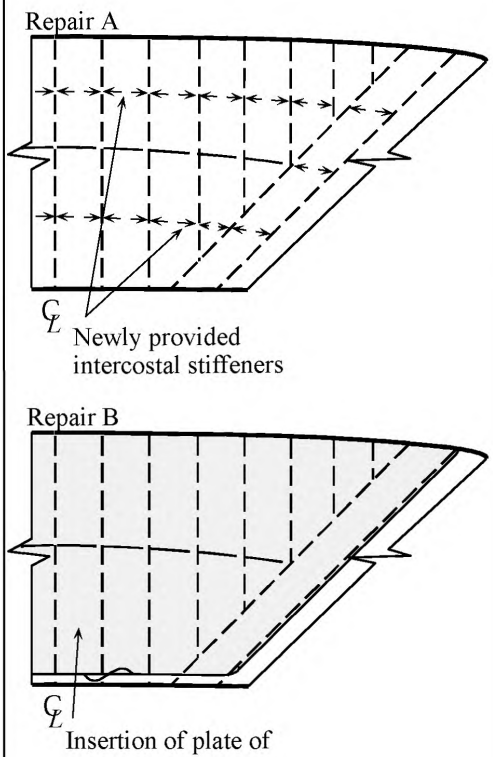
1. Heavy weather.
2. Insufficient strength.

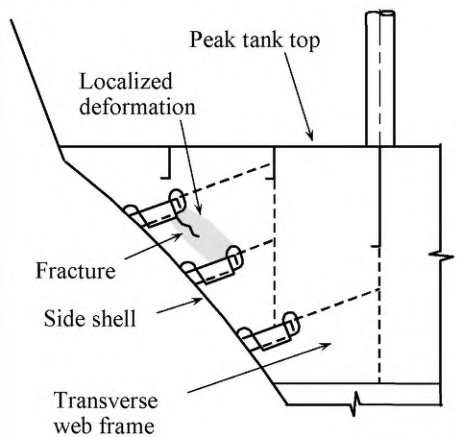
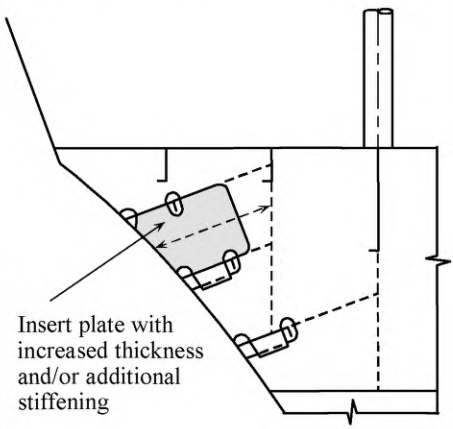
BULK CARRIERS	Guidelines for Surveys, Assessment and Repair of Hull Structure	
Part 2	**Fore and aft end regions**	**Example No.**
Area 1	**Fore end structure**	**5**
Detail of damage	Fracture and deformation of bow transverse web in way of cut-outs for side longitudinals

1. Localized material wastage in way of coating failure at cut-outs and sharp edges due to working of the structure.
2. Dynamic seaway loading in way of bow flare.
