No.76 IACS Guidelines for Surveys, Assessment and Repair of Hull Structure – Bulk Carriers

BULK CARRIERS

Guidelines for Surveys, Assessment and Repair of Hull Structure

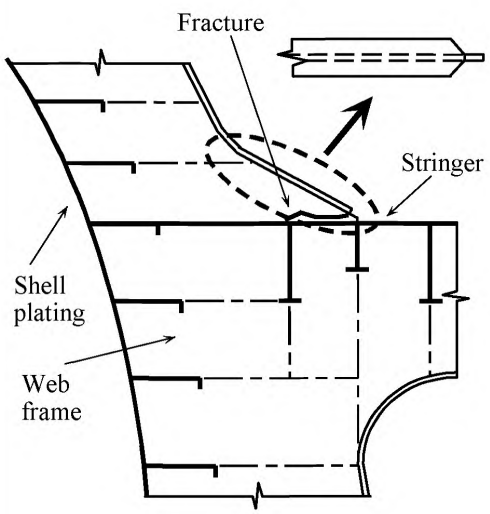
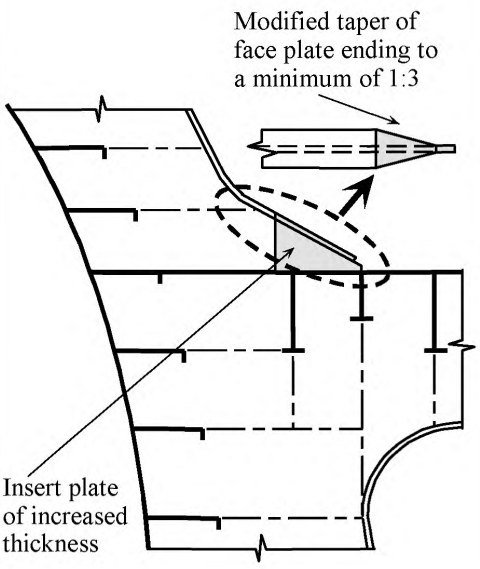
BULK CARRIERS	Guidelines for Surveys, Assessment and Repair of Hull Structure	
Part 2	Fore and aft end regions	Example No.
Area 1	Fore end structure	6
Detail of damage	Fractures at toe of web frame bracket connection to stringer platform bracket

1. Inadequate bracket forming the web frame connection to the stringer.
2. Localized material wastage in way of coating failure at bracket due to flexing of the structure.
3. Dynamic seaway loading in way of bow flare.

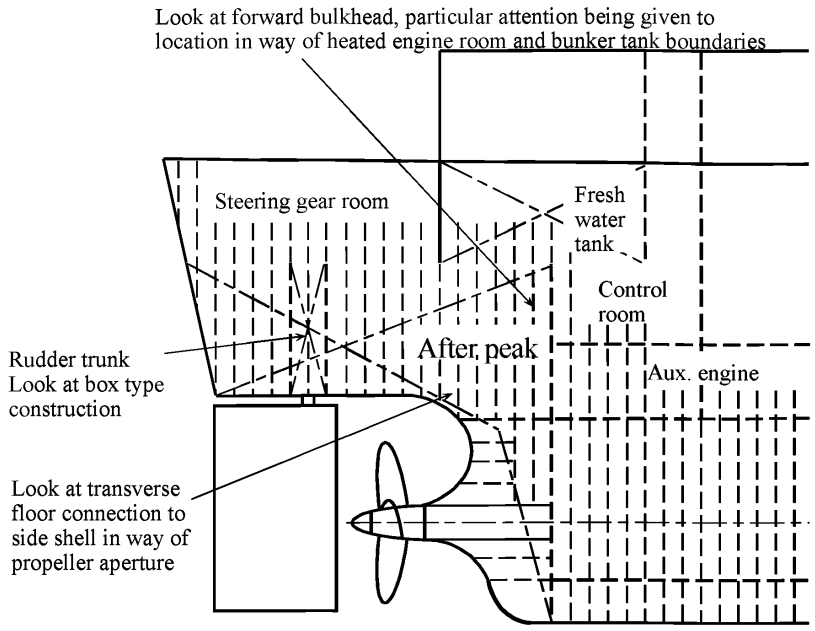
Figure 1 Aft end structure - Potential problem areas

2.3.1 Fractures in weld at floor connections and other locations in the aft peak tank and rudder trunk space can normally only be found by close-up inspection.

2.3.2 The structure supporting the rudder carrier may fracture and/or deform due to excessive load on the rudder. Bolts connecting the rudder carrier to the steering gear flat may also suffer damage under such load.

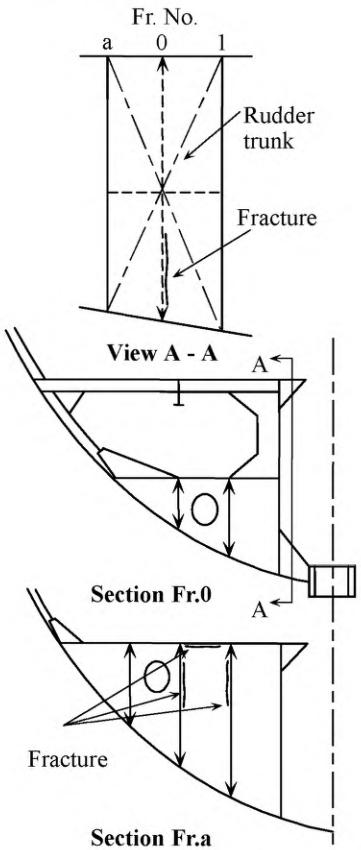
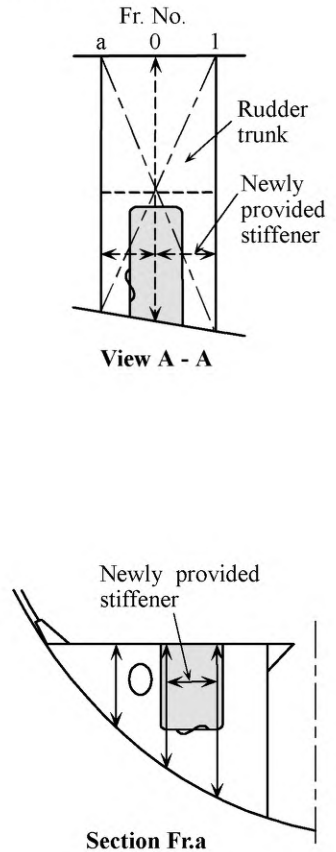
1. Vibration.

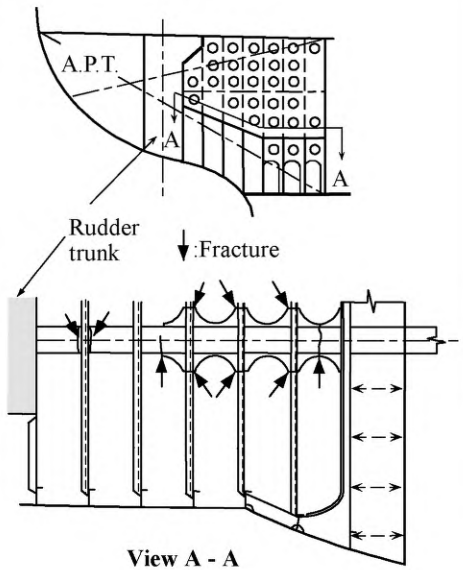
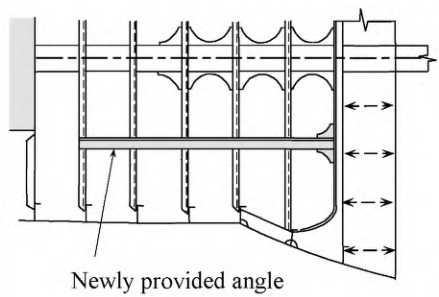
BULK CARRIERS	Guidelines for Surveys, Assessment and Repair of Hull Structure	
Part 2	**Fore and aft end regions**	**Example No.**
Area 2	**Aft end structure**	**2**
Detail of damage	Fractures at the connection of floors and girders/side brackets

1. Vibration.

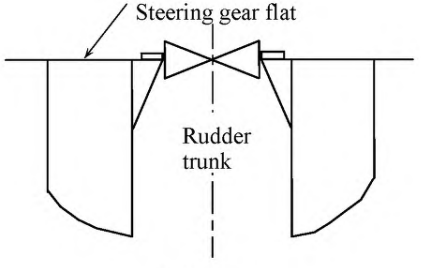
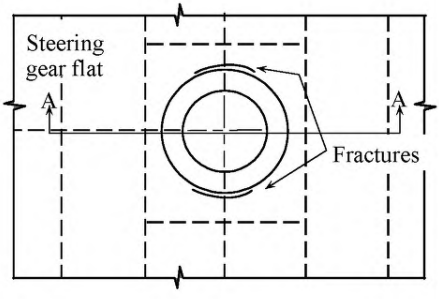
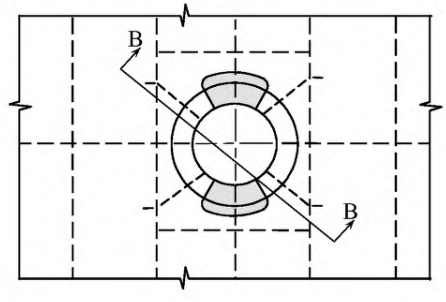
BULK CARRIERS	Guidelines for Surveys, Assessment and Repair of Hull Structure	
Part 2	Fore and aft end regions	Example No.
Area 2	Aft end structure	3-a
Detail of damage	Fractures in flat where rudder carrier is installed in steering gear room

1. Inadequate design.

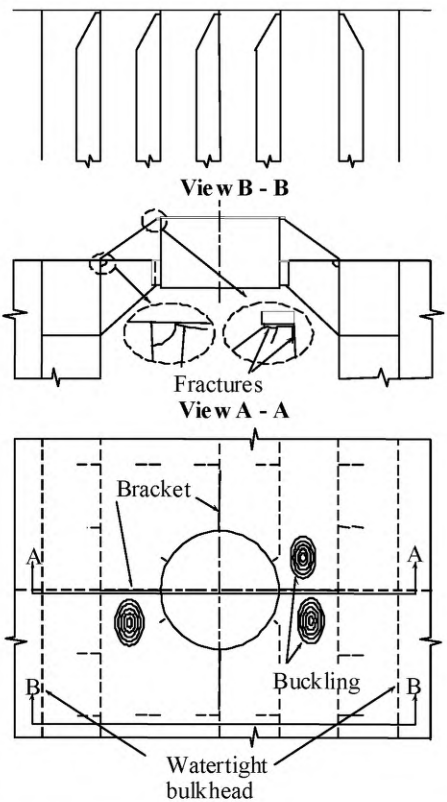
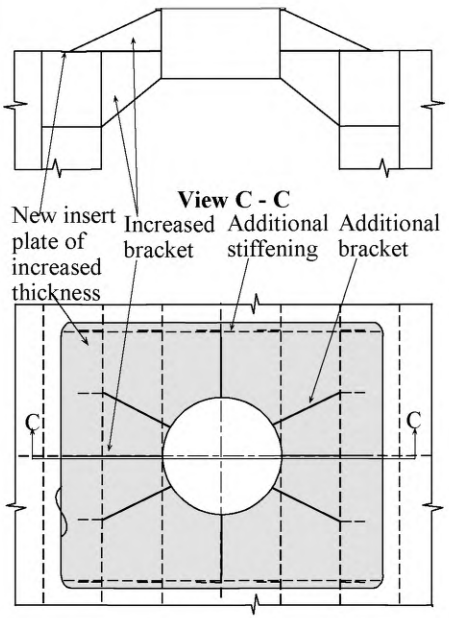
1. Insufficient deck strengthening (missing base plate).
2. Insufficient strengthening of steering gear foundation.
3. Bolts of steering gear were not sufficiently pre-loaded.

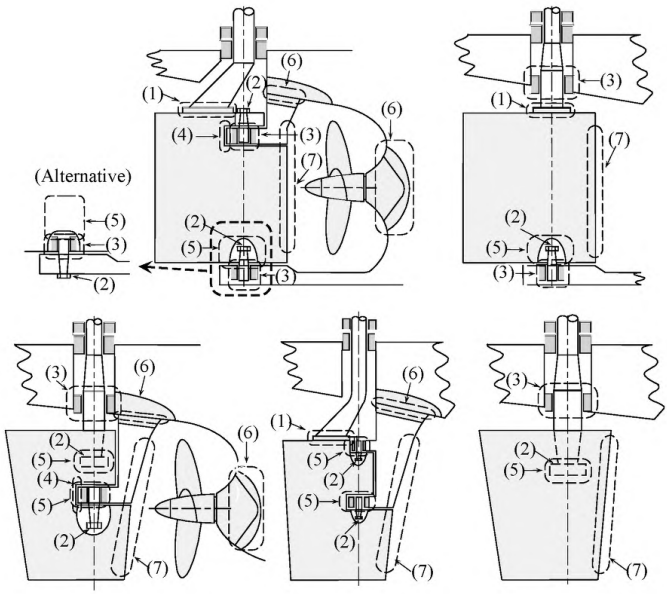
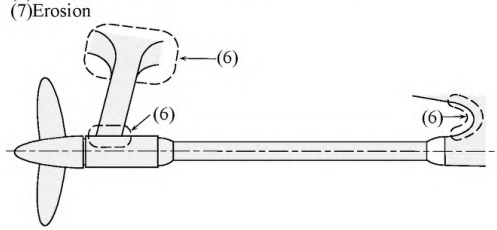
Figure 2 Potential problem areas

Damage to look for:
(1)Fractures and loose coupling bolts
(2)Loose nut
(3)Wear(excessive bearing clearance)
(4)Fractures in way of pintle cutout
(5)Fractures in way of removable access plate
(6)Fractures
(7)Erosion

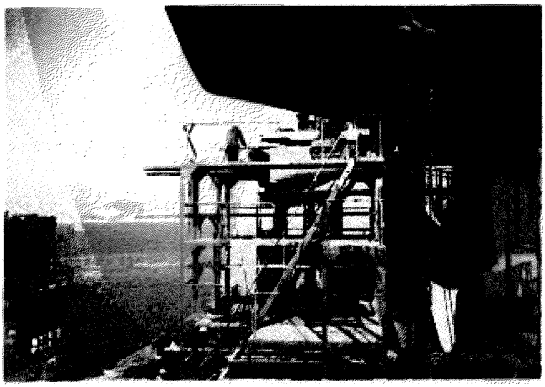
Photograph 1
Fractured rudder

2.3.1 Corrosion/erosion (such as deep pitting corrosion) should be looked for in rudder/rudder horn plating, especially in welds. In extreme cases the corrosion /erosion may cause a large fracture as shown in **Photograph**

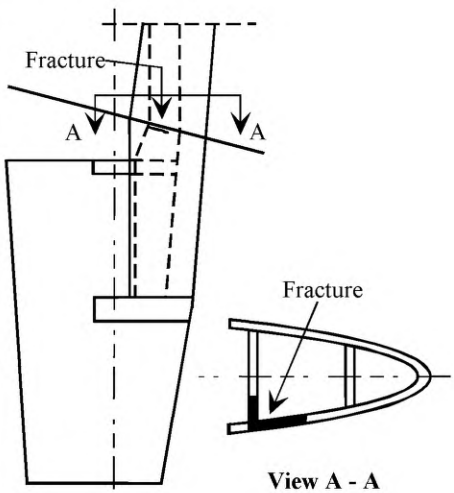
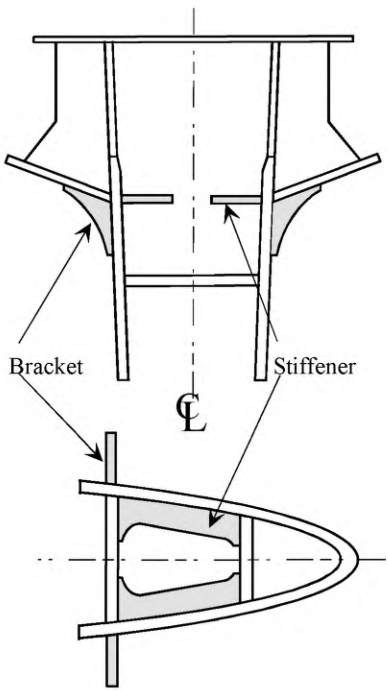
BULK CARRIERS	Guidelines for Surveys, Assessment and Repair of Hull Structure	
Part 2	**Fore and aft end regions**	**Example No.**
Area 3	**Stern frame, rudder arrangement and propeller shaft support**	**1**
Detail of damage	Fractures in rudder horn along bottom shell plating

1. Insufficient strength due to poor design.

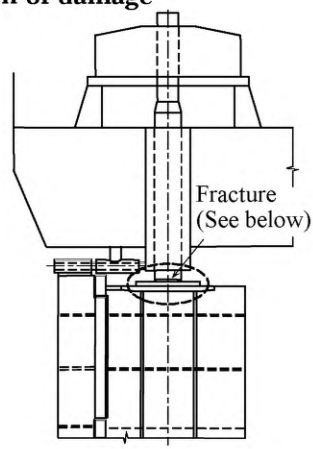
BULK CARRIERS	Guidelines for Surveys, Assessment and Repair of Hull Structure	
Part 2	Fore and aft end regions	Example No.
Area 3	Stern frame, rudder arrangement and propeller shaft support	2
Detail of damage	Fractures in rudder stock

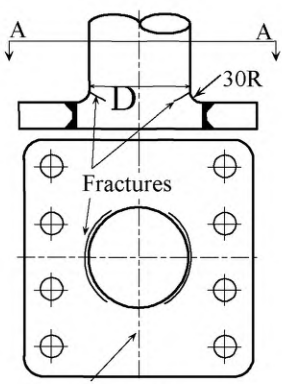
1. Inadequate design for stress concentration in rudder stock.

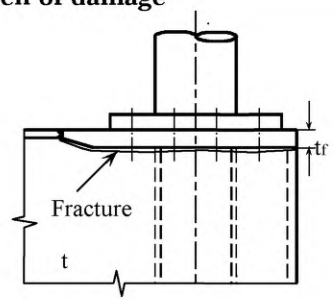
Sketch of damage

BULK CARRIERS	Guidelines for Surveys, Assessment and Repair of Hull Structure	
Part 2	**Fore and aft end regions**	**Example No.**
Area 3	**Stern frame, rudder arrangement and propeller shaft support**	**3**
Detail of damage	Fractures in connection of palm plate to rudder blade

1. Inadequate connection between palm plate and rudder blade plating (insufficient plating thickness and/or insufficient fillet weld).

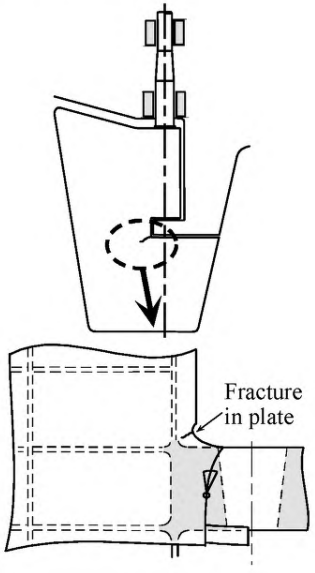
Sketch of damage

BULK CARRIERS	Guidelines for Surveys, Assessment and Repair of Hull Structure	
Part 2	Fore and aft end regions	Example No.
Area 3	Stern frame, rudder arrangement and propeller shaft support	4
Detail of damage	Fractures in rudder plating of semi-spade rudder (short fracture with end located forward of the vertical web)

1. Stress concentration due to inadequate local design and/or fabrication notches in way of the butt weld between cast piece and plating.

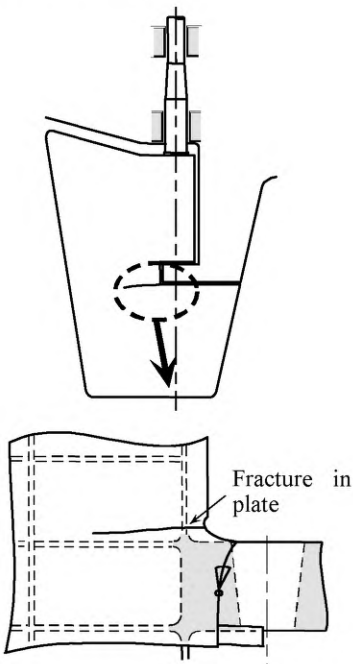
Sketch of damage

GENERAL CARGO SHIPS	Guidelines for Surveys, Assessment and Repair of Hull Structure	
Part 2	**Fore and aft end regions**	**Example No.**
Area 3	**Stern frame, rudder arrangement and propeller shaft support**	**5**
Detail of damage	Fractures in rudder plating of semi-spade rudder extending beyond the vertical web

1. Stress concentration due to inadequate local design and/or fabrication notches in way of the butt weld between cast piece and plating.

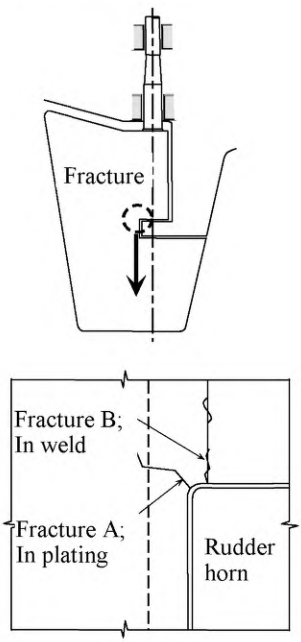
Sketch of damage

BULK CARRIERS	Guidelines for Surveys, Assessment and Repair of Hull Structure	
Part 2	**Fore and aft end regions**	**Example No.**
Area 3	**Stern frame, rudder arrangement and propeller shaft support**	**6**
Detail of damage	Fractures in rudder plating of semi-spade rudder in way of pintle cutout

1. Inadequate design for stress concentration in way of pintle bearing (**Fracture A**).
2. Imperfection in welding seam (**Fracture B**).

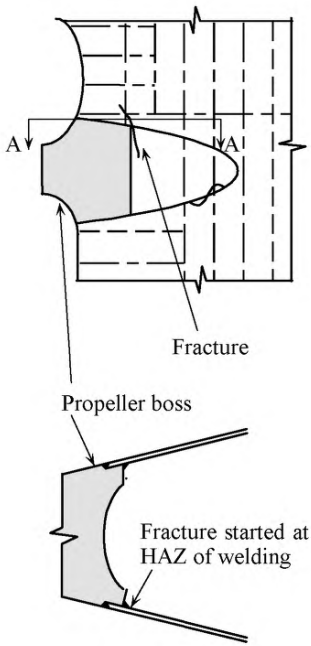
Sketch of damage

BULK CARRIERS	Guidelines for Surveys, Assessment and Repair of Hull Structure	
Part 2	Fore and aft end regions	Example No.
Area 3	Stern frame, rudder arrangement and propeller shaft support	7
Detail of damage	Fractures in side shell plating at the connection to propeller boss

1. Fatigue fracture due to vibration.

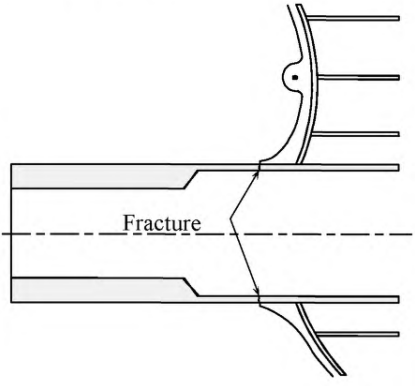
Sketch of damage

BULK CARRIERS	Guidelines for Surveys, Assessment and Repair of Hull Structure	
Part 2	Fore and aft end regions	Example No.
Area 3	Stern frame, rudder arrangement and propeller shaft support	8
Detail of damage	Fractures in stern tube at the connection to stern frame

1. Fatigue fracture due to vibration.

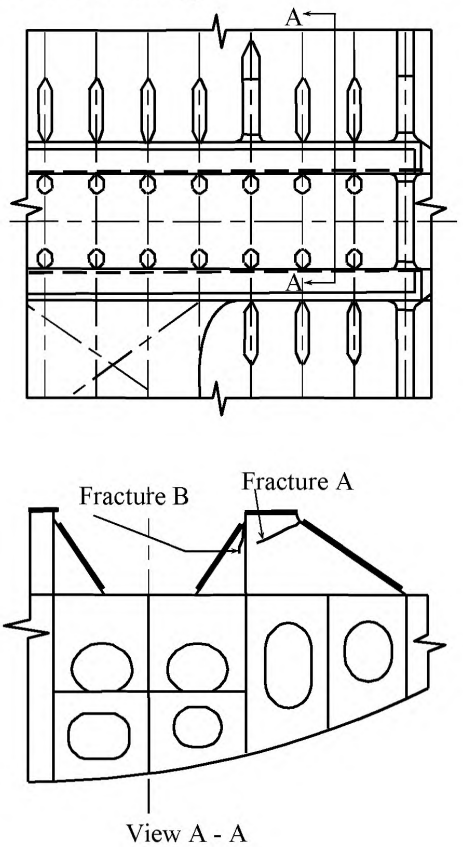
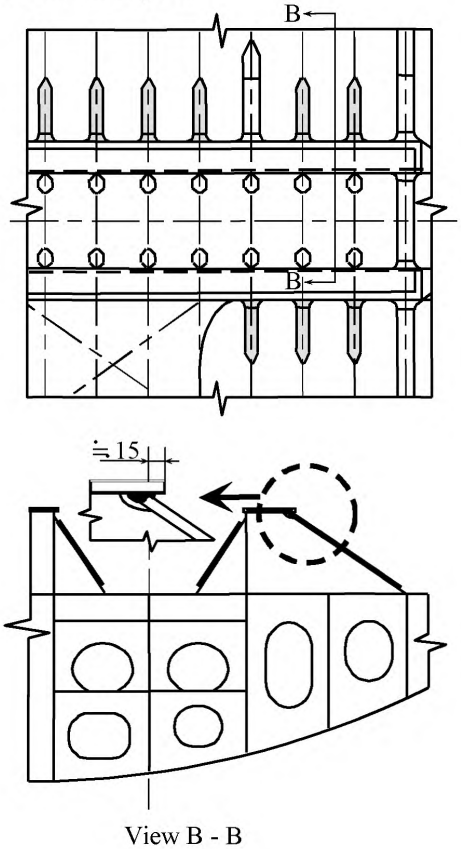
1. Vibration of main engine.
2. Insufficient strength of brackets at main engine foundation.
3. Insufficient pre-load bolts.

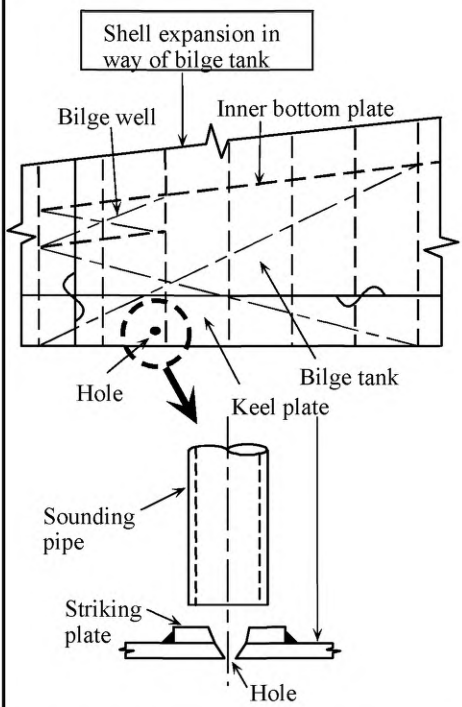
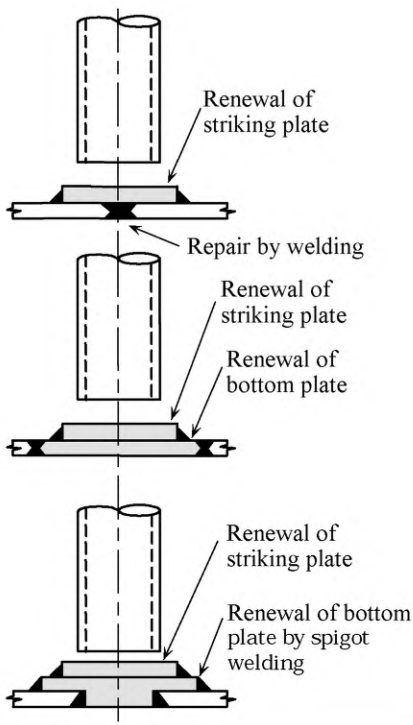
1. Heavy corrosion of bottom plating under sounding pipe.

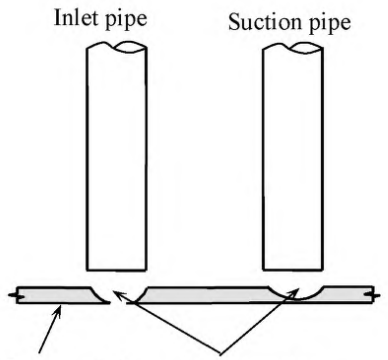
Sketch of damage

BULK CARRIERS	Guidelines for Surveys, Assessment and Repair of Hull Structure	
Part 3	**Machinery and accommodation spaces**	**Example No.**
Area 1	**Engine room structure**	**3**
Detail of damage	Corrosion in bottom plating under inlet/suction/pipe in way of bilge tank in engine room

1. Heavy corrosion of bottom plating under the inlet/suction pipe.
